On-scene Air Bag Related Child Passenger Fatality  
Dynamic Science, Inc. / Case Number: DS98025  
1995 Geo Prizm 4-door  
California  
September 1998

**Dynamic Science, Inc.**  
**Accident Investigation**  
**Case Number: DS98025**

**Description:** This case was initiated in response to a report of fatal injuries sustained by the front right occupant, a 2-year-old male child in a forward facing child restraint. The fatal injuries were caused by the deployment of the front right passenger's air bag. This case was conducted as an on scene investigation. The NHTSA notified DSI on September 24, 1998 as a result of several newspaper articles. The case vehicle was inspected close to six months after the date of the collision at a vehicle storage facility where the vehicle was being stored by the attorney representing the driver of the case vehicle. Present at the inspection were the attorney representing the driver of the case vehicle, and an engineer who also inspected the case vehicle. Prior to the case vehicle's inspection, the major crash investigation team for the state patrol had inspected the vehicle and were in possession of the child restraint and the case vehicle's front rig

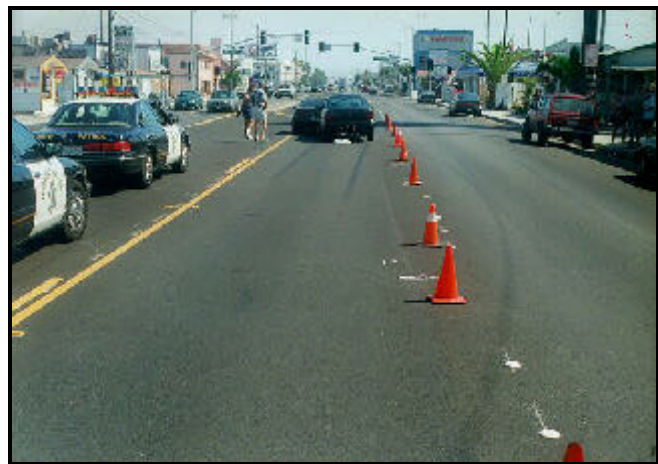
**Figure 1.** Scene of collision with vehicles at final rest.

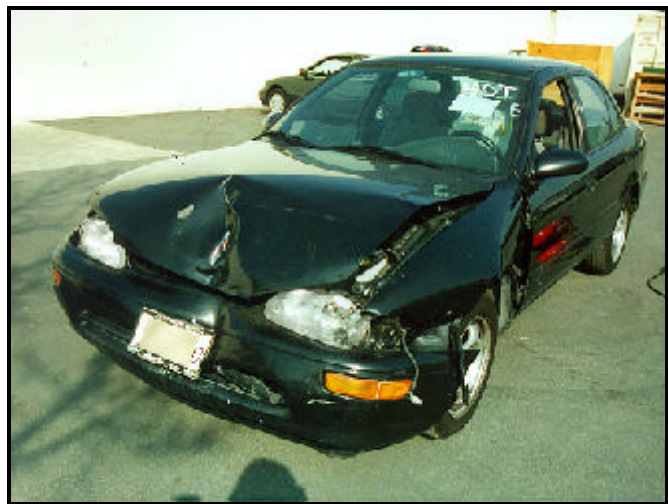
**Figure 2.** Exterior damage to case vehicle.

The case vehicle sustained moderate damage to its front end. A CDC of 12FYEW1 was assigned to the damage. The case vehicle sustained 61 cm (24.0 in.) of direct damage that began at the front left bumper corner. It sustained a maximum crush was 21.7 cm (8.5 in.) at C<sub>3</sub>. WinSmash<sup>2</sup> calculated a total delta V of 19.6 km/h (12.2 mph), a longitudinal delta V of -19.6 km/h (-12.2 mph), and a lateral delta V of 0.0 km/h (0.0 mph) for the case vehicle and a total delta V of 14.1 km/h (8.7 mph), a longitudinal delta V of 14.1 km/h (8.7 mph), and a lateral delta V of 0.0 km/h (0.0 mph) for the other vehicle. The results fit the collision model and appear reasonable. The case vehicle was towed from the scene.

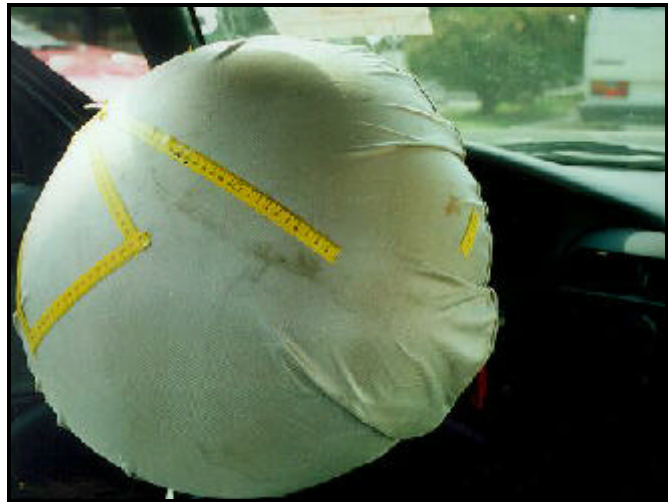
**Figure 3.** Driver's air bag—case vehicle.

The case vehicle was equipped with driver's side and front right passenger's airbags. The driver's airbag was housed in the steering wheel hub and measured 59.0 cm (23.2 in.) in diameter. It had two vent ports and was not tethered. The dual module covers opened in a H-configuration and were not damaged. The maximum post deflated excursion measured 38.5 cm (15.2 in.). The driver's airbag had makeup transfer on the left-mid area. There were also black linear smudges that were probably module cover contacts, and a possible blood spot on the upper right area. The front right passenger's airbag is mid-mounted and housed within the instrument panel. It measured 50.0 cm (19.9 in.) by 51.0 cm (20.1 in.). It had two vent ports and was not tethered. The single hinged module cover appeared to have been contacted by the child seat. There was a 5.0 cm (2.0 in.) vertical white transfer near the left corner and appeared to be "warped". The front right passenger's airbag had black smudges on the right-center area and above the right vent port that were probably caused by contact with the module cover. The front right passenger airbag was also abraded about the front center. There was no evidence of skin transfer. The maximum post deflated excursion measured 55.0 cm (21.7 in.), and 39.5 cm (15.6 in.) from maximum excursion to the seat back.

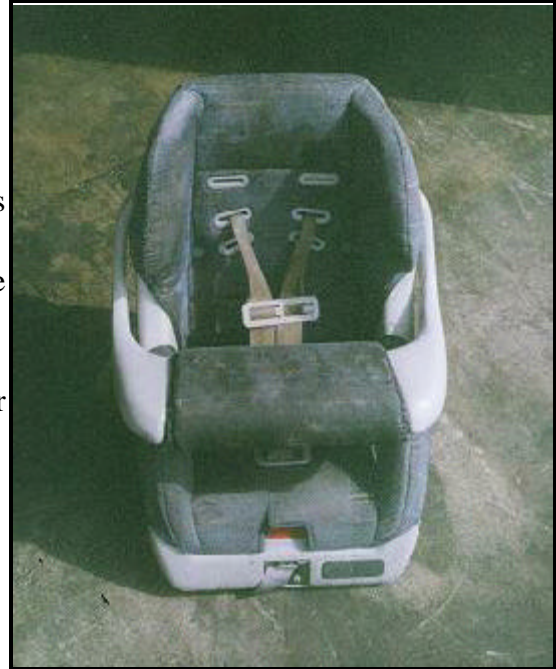
Figure 5. Child seat.

The child seat was in the possession of the police agency, and was never inspected by this investigator. The police did inspect the child seat and the following information was obtained from their report. The child seat was owned by the driver of the case vehicle since June 1996. The child seat was improperly anchored to the front right seat using the lap and shoulder belt. This was primarily because the child’s seat locking clip was not used with a sliding latch plate. It should be noted however that the case vehicle is equipped with switchable retractors from an emergency locking retractor (ELR) to an automatic locking retractor (ALR)<sup>3</sup>. A caution label on the front right seat indicates “... Before securing a forward-facing child restraint ALWAYS move the front passenger seat as far back as it will go. Then pull the safety belt out all the way to lock the belt, so you can use it with the forward-facing child restraint. Or, secure the child restraint in the rear seat.” Had the retractor been switched to the ALR position, the child’s seat locking clip would not have been required. The Police’s inspection of the ELR indicated that it was unremarkable indicating that it was more than likely not switched to the ALR position. The harness straps of the child seat were improperly looped through the middle positions. In a forward facing position (as the child seat was being used), the child seat harness straps should have been looped through the upper (top) positions for toddlers as is indicated in the child seat instructions.

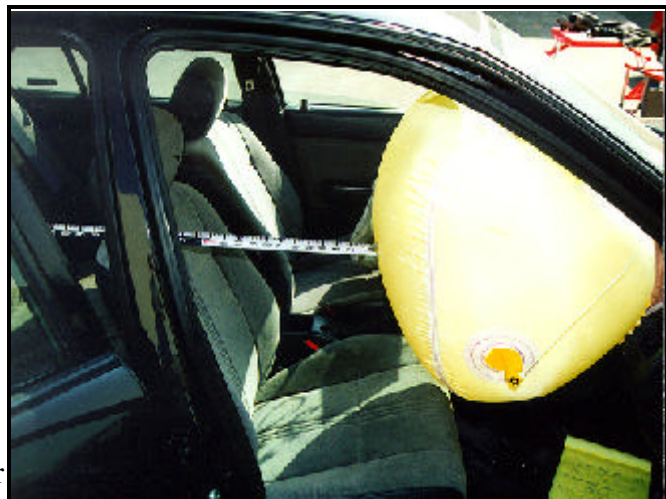
Figure 4. Front right passenger's air bag.

white transfer evidence on the lower right instrument panel area and similar colored transfer on the front right passenger's airbag module cover. The front right passenger's airbag module cover was also "warped". On impact with the rear end of the other vehicle, the front right passenger's airbag deployed. The front right passenger's airbag module cover probably struck the child seat; the police inspection of the child seat did not indicate any damage to the child seat. The deploying air bag came into contact with the anterior part of 2-year-old's neck and face. There was marked swelling of the neck with a large abrasion erythema going from one side of the external ear to the other side across the entire anterior neck and base of the chin area. This abraded area measures 17.15 cm (6.75 in.) x 6.35cm (2.5 in.). There was an abrasion on the left angle of the mouth and a contusion on the lower lip. The tongue showed a bite at the tip. As the air bag continued its unfolding pattern, the 2-year-old's head was rapidly accelerated rearward causing the fatal injuries of a complete transection of the upper cervical spinal cord with fractures of the second and fourth cervical vertebra with subdural and subarachnoid hemorrhages. The child came to final rest seated in the child seat.

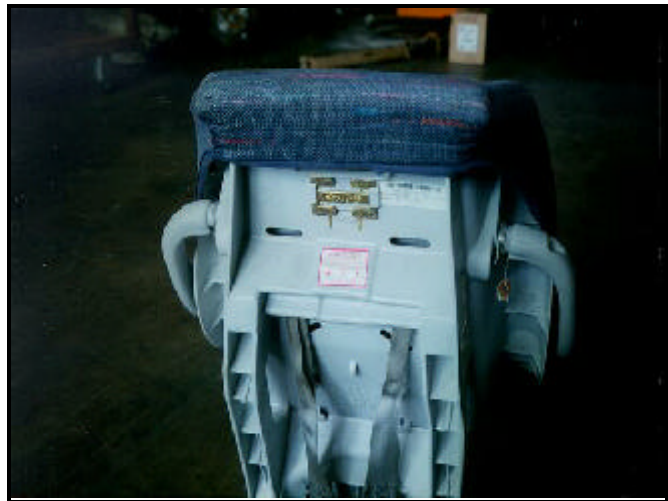
**Figure 6.** Improper harness slotting.

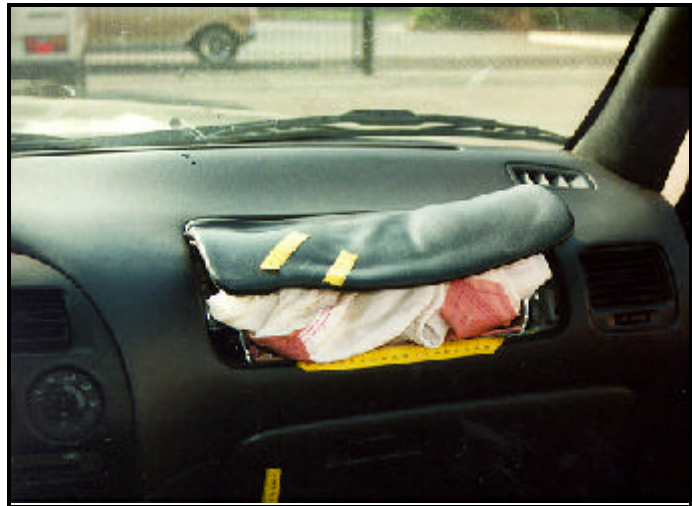
The police report concluded that the case vehicle’s front right seat was adjusted to the rear most track position. The lap and shoulder belt was used to anchor the child seat to the vehicle’s seat. There was a 30.5 cm (12.0 in.) long section of material transfer on the inboard

side of the shoulder belt webbing and mild curling. This material transfer was ingrained into the webbing fabric and along the edges of the webbing and was deposited by the plastic shell of the child seat during

occupant loading. The length of the material transfers on the webbing that were deposited by the child seat supports the opinion that the restraint webbing was not sufficiently tightened. This was primarily as a result of not switching the front right seat belt retractor from ELR to ALR mode.

**Figure 8.** Transfer from child seat.

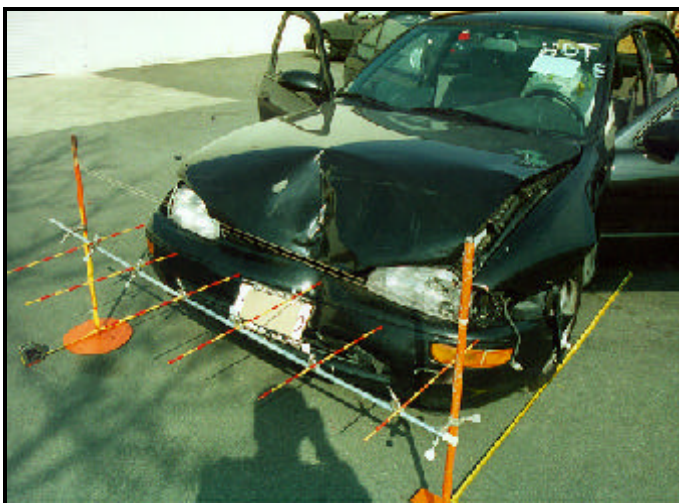
Description:	1995 Geo Prizm 4-door	
VIN:	1Y1SK5262SZXXXXXX	
Odometer:	79,297 kilometers (49,273 miles)	
Engine:	1.6 L V4	
Reported Defects:	None reported.	
Cargo:	None at vehicle inspection	
Damage Description:	Moderate damage to the front bumper, hood and grille area. The front left fender was induced outward.	
CDC:	12FYEW1	
Delta V:	Total	19.6 km/h ( 12.2 mph)
	Longitudinal	-19.6 km/h (-12.2 mph)
	Latitudinal	0.0 km/h ( 0.0 mph)
	Energy	21,025 joules (15,510 ft-lbs)

**Figure 11.** Exterior crush to case vehicle.

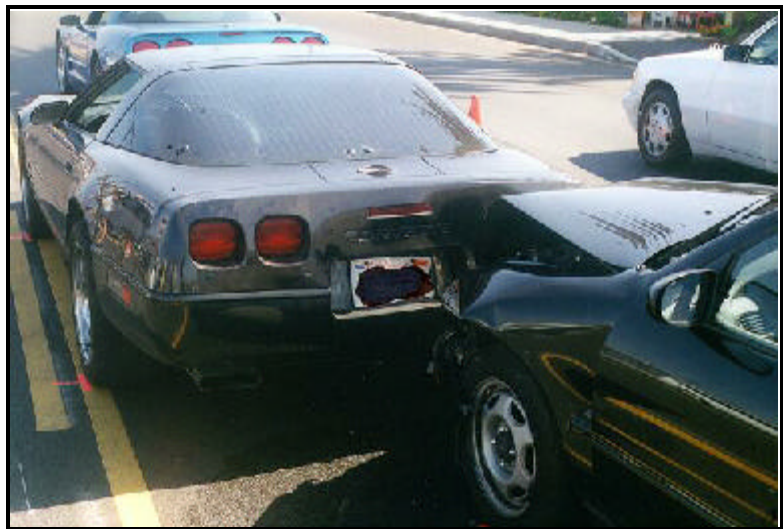
Description: 1992 Chevrolet Corvette  
 VIN: 1G1YY23P4N5XXXXXX  
 Odometer: Unknown  
 Engine: Unknown  
 Reported Defects: None noted on police report  
 Cargo: Unknown  
 Damage Description: Moderate damage to its rear end and minor damage to its front end. The rear end damage consisted of contact damage from the license plate towards the right side. The right rear quarter panel was cracked. There was minor damage to the front bumper consisting of a few nicks to the paint.

**Figure 12.** Exterior damage to other vehicle.

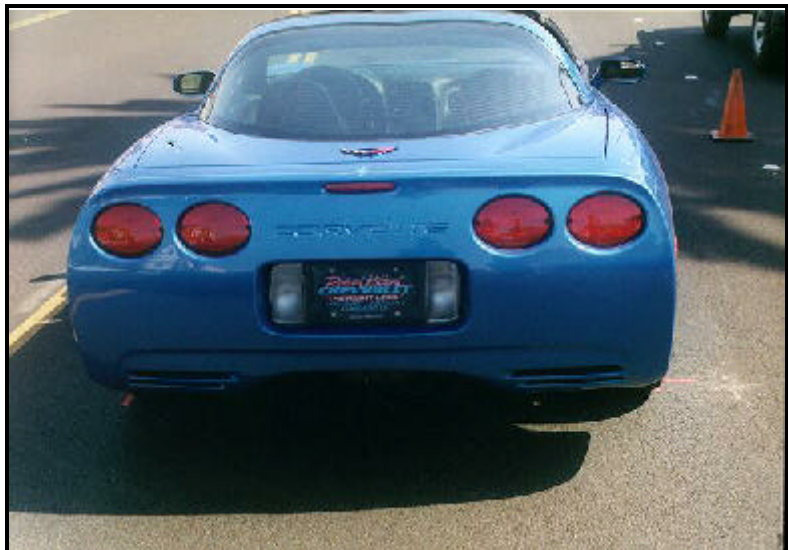
Description:	1998 Chevrolet Corvette	
VIN:	1G1YY22G4W5XXXXXX	
Odometer:	Unknown	
Engine:	Unknown	
Reported Defects:	None noted on police report	
Cargo:	Unknown	
Damage Description:	Minor damage to its rear end consisting of small scratches. No prior damage was noted or claimed.	
CDC (Estimated from police photographs):	Impact 2 - 06BZEW1	
Delta V (Not calculated):	Total	Unknown
	Longitudinal	Unknown
	Latitudinal	Unknown
	Energy	Unknown

**Figure 13.** Exterior damage to third vehicle.

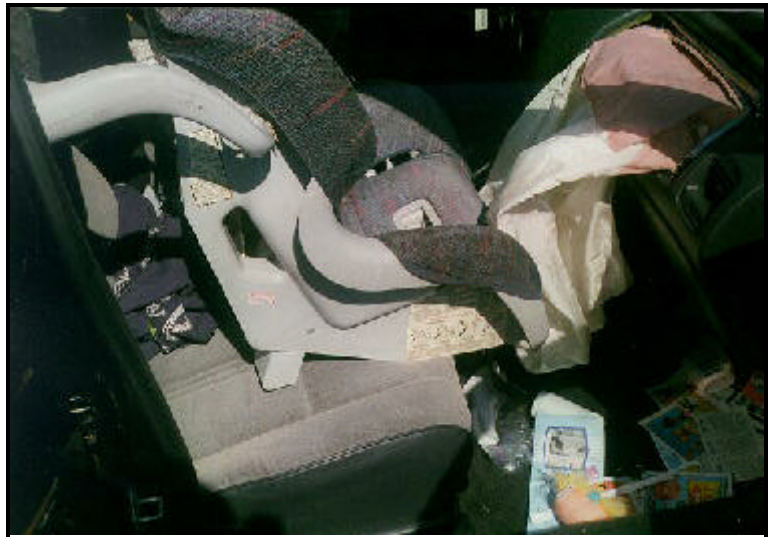
The 2-year-old child was seated on the front right seat position of the case vehicle in a forward facing child seat. The child was restrained by the child seat's harness with the harness tie improperly positioned above his belly as indicated by the driver of the case vehicle. The child seat was improperly anchored to the vehicle's front right seat. The seat belt retractor was not switched from ELR mode to ALR mode. As a result of the pre-impact braking, the child seat traveled forward prior to the case vehicle striking the second other vehicle. The child seat's improper installation, caused the child seat to move forward and strike the lower instrument panel and the front right passenger's airbag module cover.

**Figure 14.** Child seat at scene—note forward position.
