TRANSPORTATION RESEARCH CENTER

REMOTE ADULT AIR BAG-RELATED SERIOUS INJURY REPORT

CASE NUMBER - IN98-026
LOCATION - MISSISSIPPI
VEHICLE - 1998 VOLVO S70
CRASH DATE - September, 1997

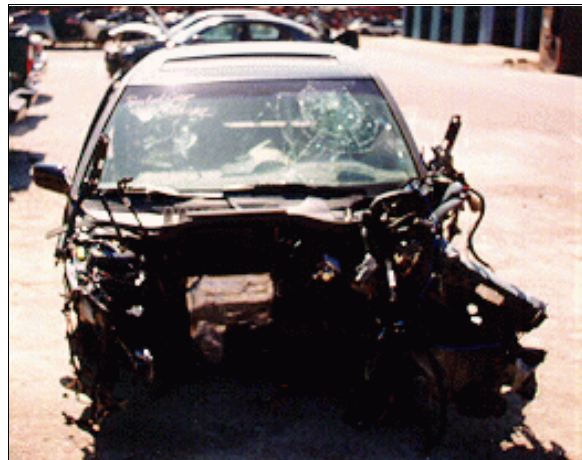
Figure 1: Case vehicle's damaged front; Note: damaged components have been removed and engine removed during salvage (case photo #01)

The front of the case vehicle (**Figures 1 and 2** above) impacted the left center and back of GMC minivan (**Figures 3 and 4**), causing the case vehicle's driver and front right passenger supplemental restraints (air bags) to deploy. This contractor believes it is likely that the case vehicle rotated counterclockwise post-crash, but its degree of rotation and its final rest position are unknown.

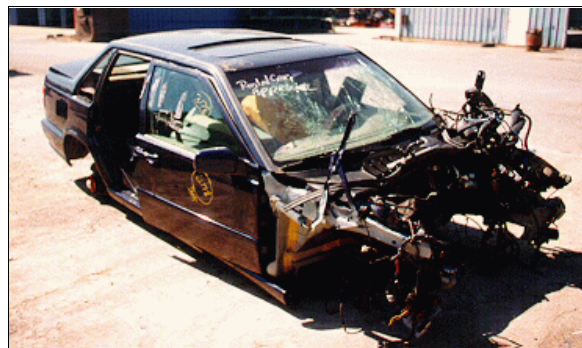
Figure 2: Case vehicle's damaged front viewed from right of front; Note: engine, wheels, etc. have been removed for salvage as well as missing crash damaged components (case photo #14)

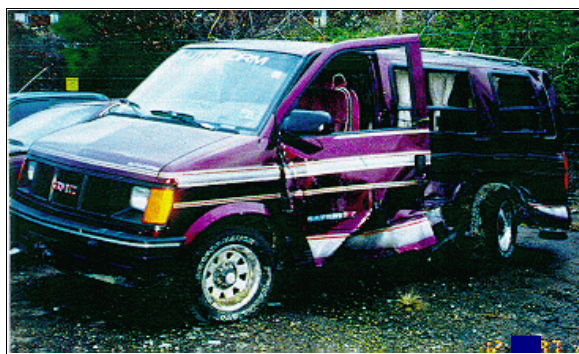
Figure 3: GMC minivan's left side damage viewed from left of front (case photo #34)

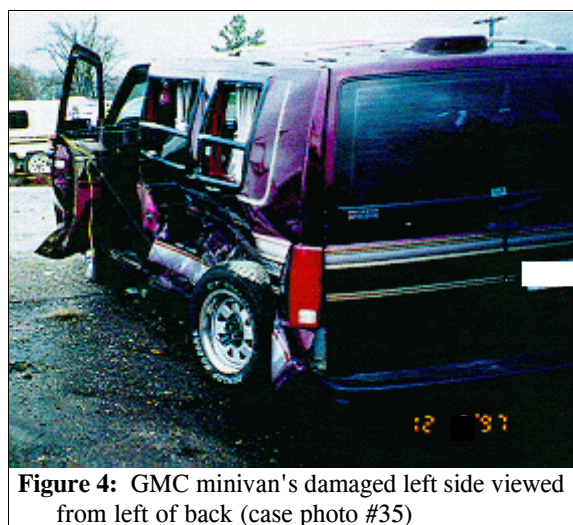
Figure 4: GMC minivan's damaged left side viewed from left of back (case photo #35)

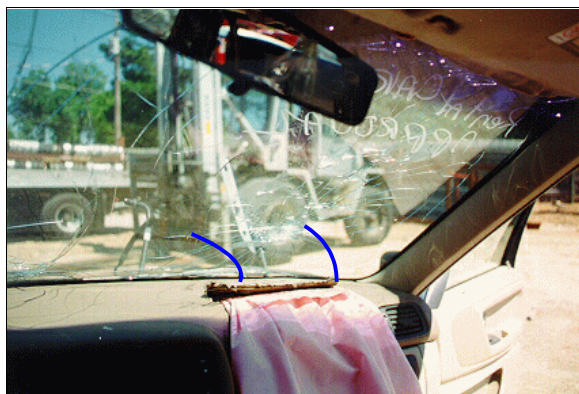
Figure 5: Case vehicle's front right air bag which deployed from the top of the right dash/instrument panel; Note: the right windshield was cracked by the air bag module's cover flap (case photo #21)

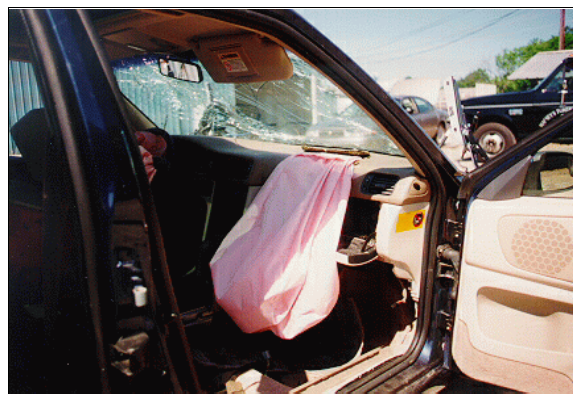
Figure 6: Case vehicle's deployed front right passenger air bag showing approximate size and shape of air bag's fabric (case photo #28)

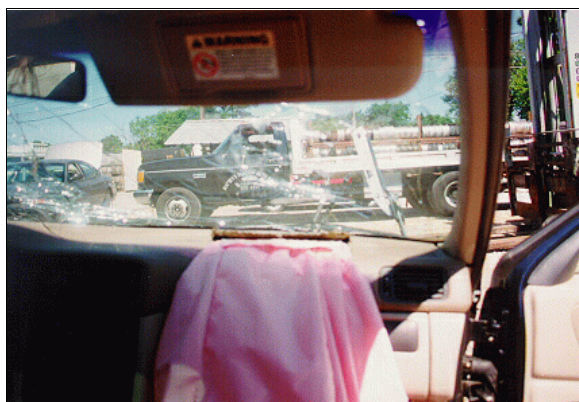
Figure 7: Case vehicle's deployed front right air bag and greenhouse area; Note: cracked right windshield directly corresponds to module's cover flap and sun visor is down in this photo but was most likely up at time of crash (case photo #26)

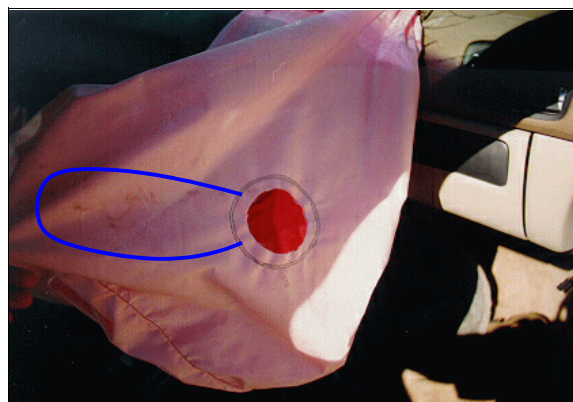
Figure 8: Close-up of case vehicle's deployed front right passenger air bag showing a vent hole and marks (highlighted) on underneath surface of air bag that are of unknown origin (case photo #29)

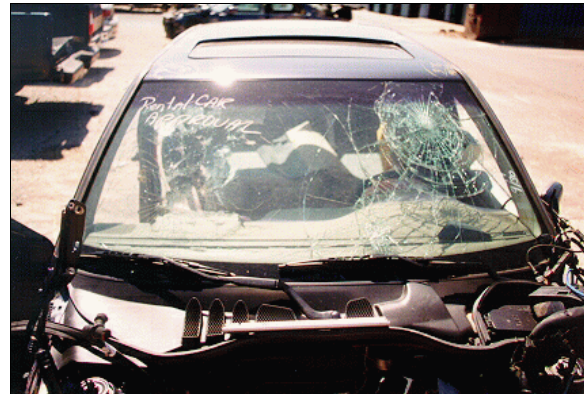
The only other evidence of possible occupant contacts on the interior surfaces included a classic spider web impact near the top of the windshield (Figure 9), a contact point near the base of the windshield on the driver's side (Figure 10), a crack to the rearview mirror, and some vertical marks on the interior surface of the right front window glazing (Figure 11).

Figure 9: Case vehicle's cracked windshield; Note: spider web on driver's side indicates that the driver contacted the windshield while the crack on the passenger's side is from the air bag module's cover flap (case photo #02)

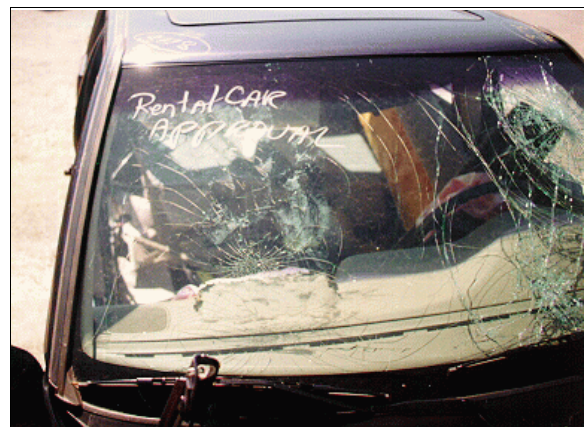
Figure 10: Close-up of case vehicle's windshield damage showing front right air bag module's cover flap lining up with cracked windshield; Note: driver's side appears to have two contact points, one near the header from the driver and one near the base from an unidentified source (case photo #16)

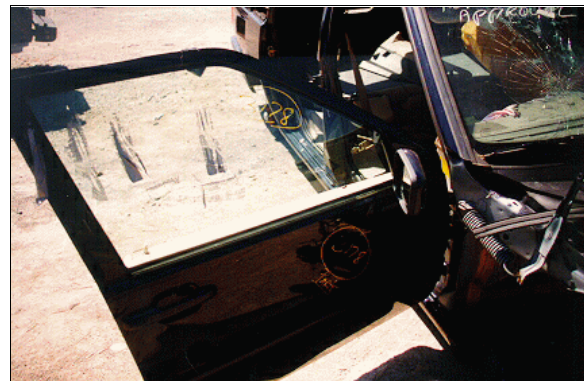
Figure 11: Case vehicle's right front window showing vertical marks on interior surface of glazing (case photo #15)

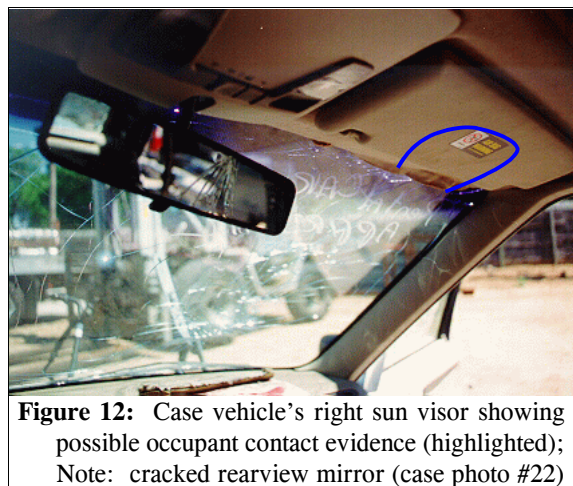
Figure 12: Case vehicle's right sun visor showing possible occupant contact evidence (highlighted); Note: cracked rearview mirror (case photo #22)
