CALSPAN ON-SITE AIR BAG CHILD FATALITY INVESTIGATION

CALSPAN CASE NO. CA98-027

VEHICLE - 1995 VOLKSWAGEN JETTA

LOCATION - MISSISSIPPI

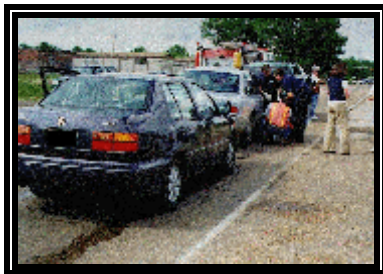
Figure 1: On-scene photograph.

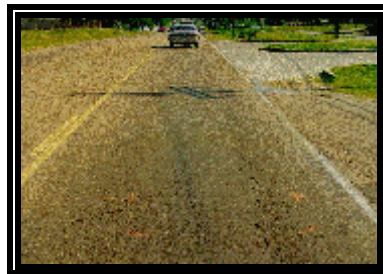
Figure 2: View of the final rest positions.

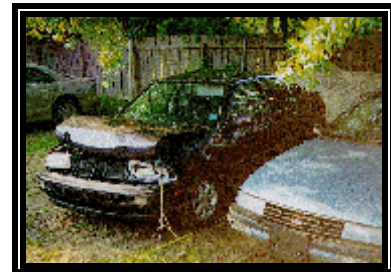
Figure 3 is the left front view of the Volkswagen Jetta. The frontal area of the Jetta sustained no measurable deformation at the bumper elevation, indicative of the underride. The direct contact damage to the bumper fascia consisted of a series of scrapes and scratches distributed over a 124 cm (49 in) width of the fascia's frontal and top surfaces. The scrapes began 46 cm (18 in) left of center and extended to the left bumper corner. The front surface of the fascia was penetrated by the tail pipe of the Ford's exhaust system 23 cm (9 in) right of center. There was no damage to the bumper's mounting structures. The deformation at the elevation of the Jetta's upper radiator support was 112 cm (44 in) in width. The upper support direct contact began 33 cm (13 in) right of center and extended to the left front corner. The crush profile of the upper radiator support was as follows (less assumed free space): C1=12.7 cm (5.0 in), C2=5.1 cm (2.0 in), C3=5.1 cm (2.0 in), C4=5.1 cm (2.0 in), C5=5.1 cm (2.0 in), C6=0. The hood deformed rearward in the typical V pattern and the left front fender was buckled. The left front fender also shifted rearward (slightly) restricting the opening of the left front door. There was no measurable change in the wheelbase dimensions. There was no damage to the windshield nor to any windows glazings. The Collision Deformation Classification (CDC) of the Jetta was 12-FDEW-1. The delta V of the Jetta calculated by the Roldmiss model of the SMASH program was 18.7 km/h (11.6 mph).

Figure 3: Left front view of the Volkswagen Jetta.

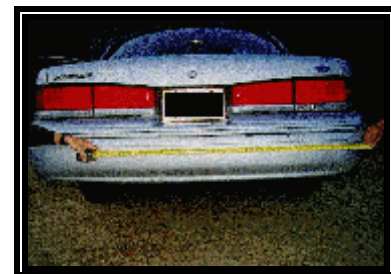
The CDC of the 1995 Ford Crown Victoria was 06-BDEW-1. The direct contact damage to the vehicle consisted of abrasions on the vertical surface of the rear bumper fascia (**Figure 4**). The direct contact measured 124 cm (49 in) in width, that began 38 cm (15 in) left of center and extended to the right rear bumper corner. There was no residual bumper deformation. The rear bumper of the Ford was mounted to the vehicle's frame by energy absorbing devices (EAD's). Both EAD's showed signs of having compressed during the impact but had returned to their original length through full restitution. The maximum allowable stroke was 3.6 cm (1.4 in). The left and right struts had compressed 1.1 cm (0.4 in) and

Figure 4: Rear view of the Ford Crown Victoria.

3.6 cm (1.4 in) respectively. The tail pipe and rear exhaust pipe were deformed forward due to the contact with the Jetta's front bumper fascia.

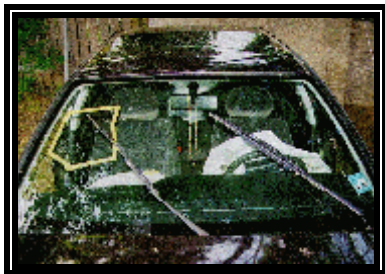
A 19.1 cm x 25.0 cm (7.5 in x 10.0 in) area of smeared skin oil was noted on the right center aspect of the windshield (**Figure 5**). The area was located 27.9 cm to 47.0 cm (11.0 in to 18.5 in) right of center and extended 17.3 cm to 42.7 cm (6.8 in to 16.8 in) below the windshield header. This contact was attributed to at-impact bracing by the right hand of the child occupant. **Figure 6** is a view of the right front interior contacts. The lower flap of the front passenger air bag module exhibited a (1.0 in x 0.5 in) scuff attributed to contact with the right upper extremity of the child occupant. This scuff was located 26.2 cm (10.3 in) right of the inboard edge of the flap and 54.6 cm (21.5 in) above the floor. The padded right side knee bolster exhibited two scuffs attributed to contact from the child passenger's lower extremities. The two scuffs were located 17.8 cm (7.0 in) right of center and 36.8 cm (14.5 in) above the floor and 38.9cm (15.3 in) right of center and 45.7 cm (18 in) above the floor respectively.

Figure 5: Location of the windshield contact.

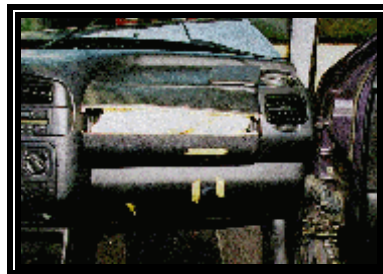
Figure 6: Right front interior contacts.

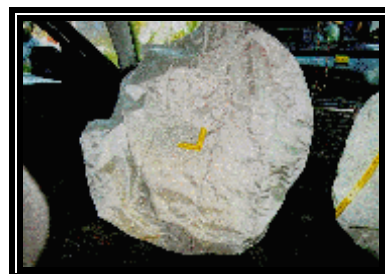
The driver air bag measured 71 cm (28 in) in its deflated state, **Figure 7**. The air bag was tethered by four 6.4 cm (2.5 in) wide internal straps sewn to the face of the bag. The air bag was vented by two 3.8 cm (1.5 in) diameter vent ports located in the 10/2 o'clock sectors on the back side of the bag. The following manufacturer's label were fixed to the inflator in the 6 o'clock sector:

Figure 7: Driver air bag.

The only contact evidence on the driver air bag consisted of a flesh tone make-up transfer on the face of the bag. The transfer measured 3.3 cm x 1.3 cm (1.3 in x 0.5 in) and was located 3.3 cm (1.3 in) right of the center of the air bag.

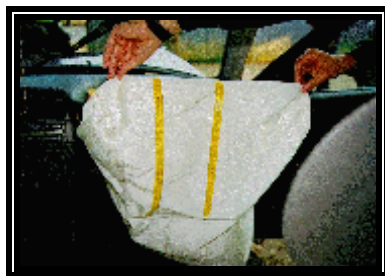
The front passenger air bag was untethered and unvented (no external vent port). The face of the air bag membrane measured 46 cm x 46 cm (18 in x 18 in) in its deflated state and extended 46 cm (18 in) from the inflator. The maximum rearward projection of the center aspect of the air bag face was 61 cm (24 in). A large tissue transfer was identified on the face of the bag. The transfer measured approximate 6.4 cm x 36.8 cm (2.5 in x 14.5 in), **Figures 8 and 9**. The transfer began 35.6 cm (14.0 in) rearward of the inflator (10 cm (4 in) forward of the bag face) and 23 cm (9 in) right of the inboard side panel, on the top surface of the air bag membrane. The transfer extended 26.7 cm (10.5 in) onto the face of the bag. The end of the transfer was located 11.4 cm (4.5 in) right of the inboard side panel. The tissue transfer was associated with the air bag membrane contact with the child occupant's neck and chin during the deployment sequence. On the bottom surface of the air bag membrane scattered faint black transfers were noted. These transfer were most likely caused by the friction heating between the membrane and the vulcanized liner during the altered air bag deployment.

Figure 8: View of the tissue transfer on the front passenger air bag.

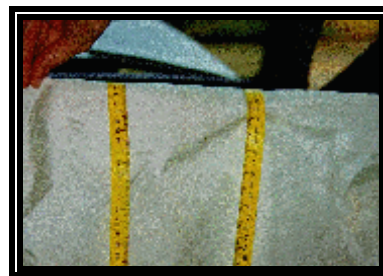
Figure 9: Close-up view of the tissue transfer.
