On-scene Investigation / Vehicle to Vehicle  
Dynamic Science, Inc. / Case Number: DS98027  
1998 Chevrolet Cavalier v. 1998 Chevrolet Cavalier  
Oregon  
November 1998

1. Report No. DS98027		2. Government Accession No.		3. Recipient Catalog No.	
4. Title and Subtitle In-Depth Accident Investigation				5. Report Date December 10, 1999

**Dynamic Science, Inc.**  
**Accident Investigation**  
**Case Number: DS98027**

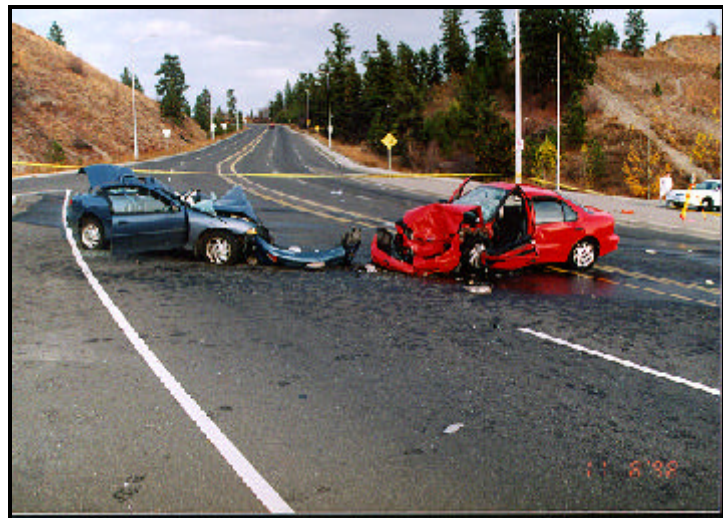
**Figure 1.** Final rest, facing north.

Vehicle 1 was pushed into a counterclockwise rotation and came to rest facing generally west. Vehicle 2 was diverted into a counterclockwise rotation and came to rest facing southeast.

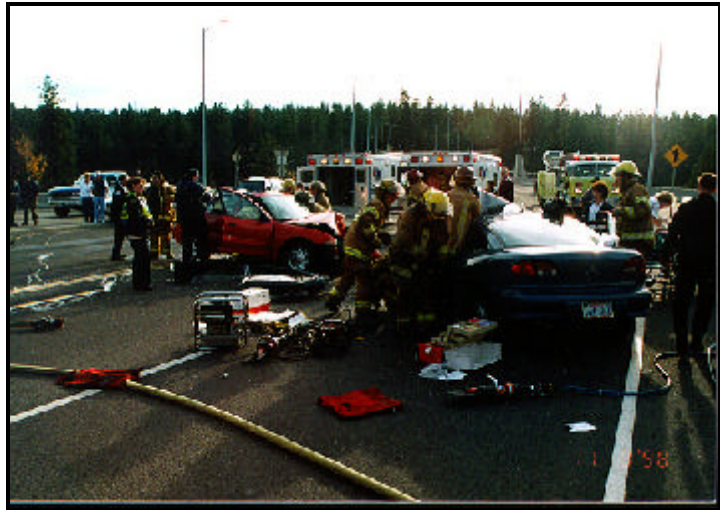
**Figure 2.** Rescue efforts, facing south

The driver of Vehicle 1 was entrapped by the lower instrument panel. There was 40 cm (15 in.) of instrument panel intrusion and 31 cm (12 in.) of toe pan intrusion. The driver required extrication by the fire department. He sustained a fractured right femur, a left ankle fracture, and a dislocated right big toe. All of the injuries appear to have occurred due to the toe pan intrusion. He was transported by ambulance to a local hospital where he was reported to be in stable condition.

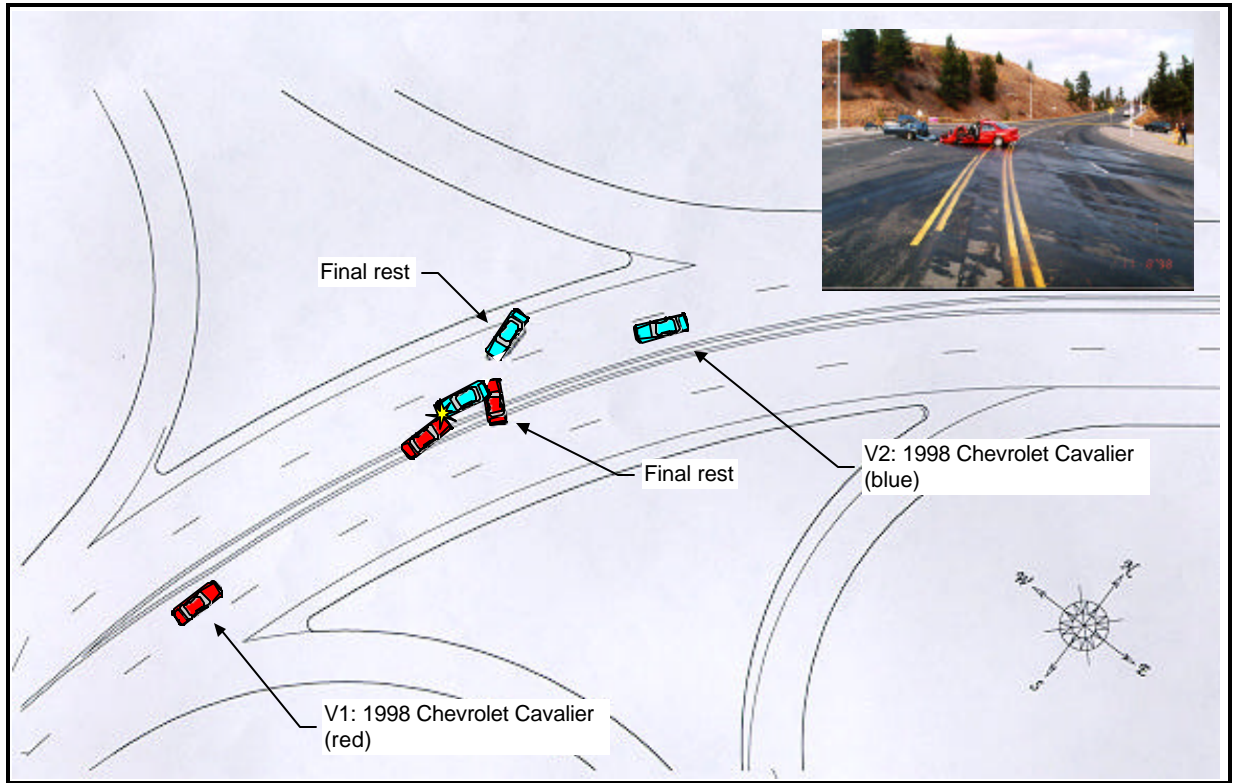
The driver of Vehicle 1 reported that he was distracted by a spider which dropped onto his face. This took his attention away from the roadway and his vehicle veered into the path of oncoming traffic. There were no indications of pre-impact braking—both vehicles were ABS-equipped. The left front of Vehicle 1 struck the left front of Vehicle 2 in an off-set type configuration. There was substantial

**Figure 3.** Scene diagram (adapted from police diagram—not to scale)

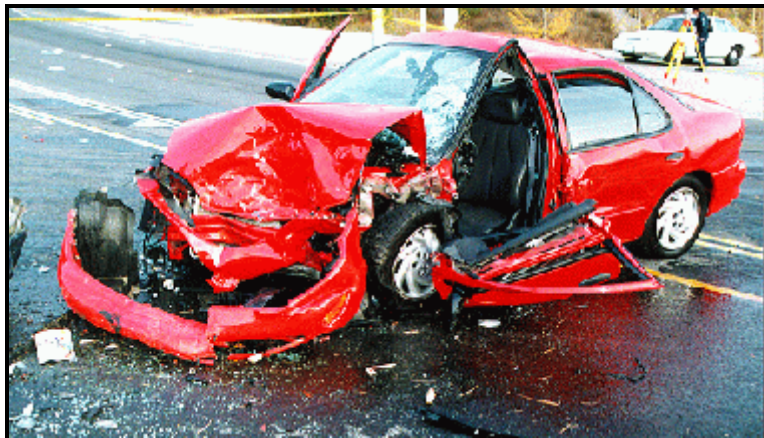
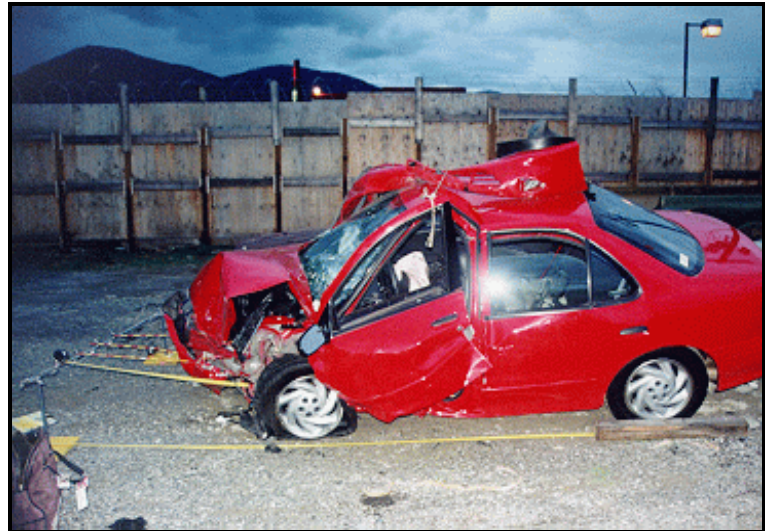
Description:	1998 Chevrolet Cavalier 4-door	
VIN:	1G1JC5246W7XXXXXX	
Odometer:	Unknown	
Engine:	2.2 L 4	
Brakes:	Four wheel ABS	
Reported Defects:	None noted	
Cargo:	None noted	
Damage Description:	Extensive frontal crush. Direct damage begins at the left front corner and extends to the midpoint. The left front tire was pushed rearward. There was intrusion of the instrument panel and toe pan. All four doors were jammed post-impact.	
CDC:	12FYEW4	
Delta V:	Total	59.3 km/h (33.5 mph)
	Longitudinal	-59.1 km/h (-33.4 mph)
	Latitudinal	5.2 km/h (2.9 mph)
	Energy	222,445 joules (164,162 ft-lbs)

**Figure 4.** Exterior, Vehicle 1

Figure 5. Exterior, Vehicle 1

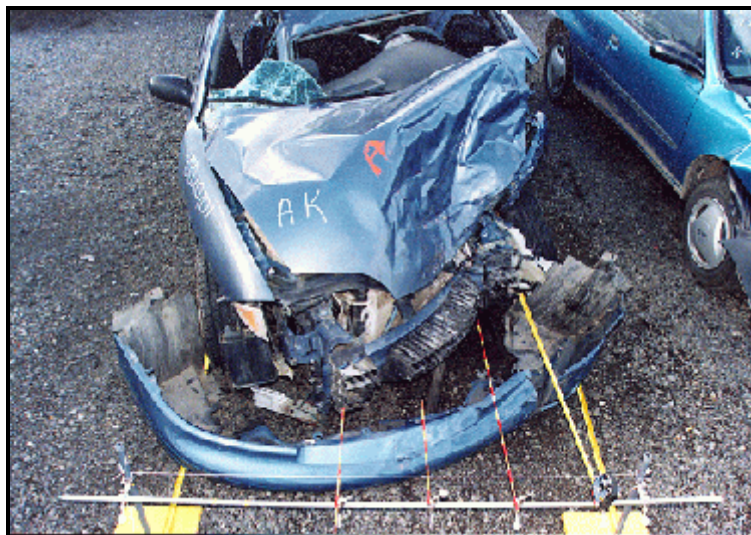
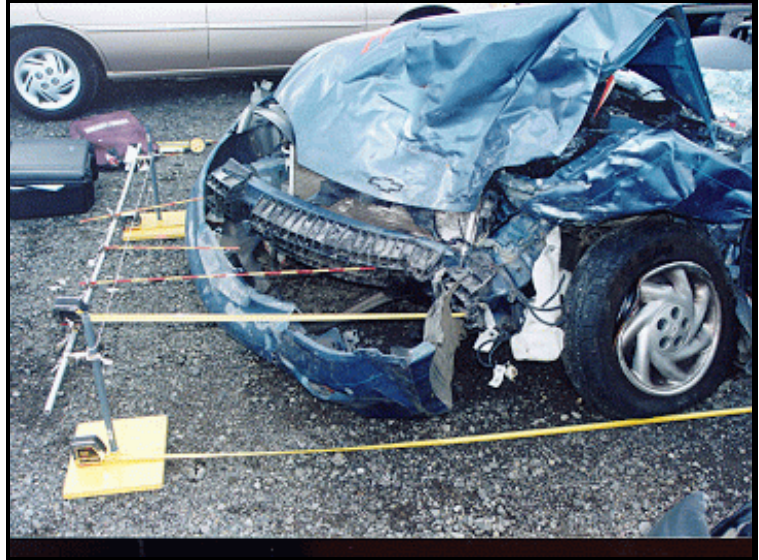
Damage Description: Extensive frontal crush. Direct damage begins at the left front corner and extends to the midpoint. There was intrusion of the instrument panel and toe pan.

Figure 7. Exterior, Vehicle 2

**Figure 8.** Exterior, Vehicle 2

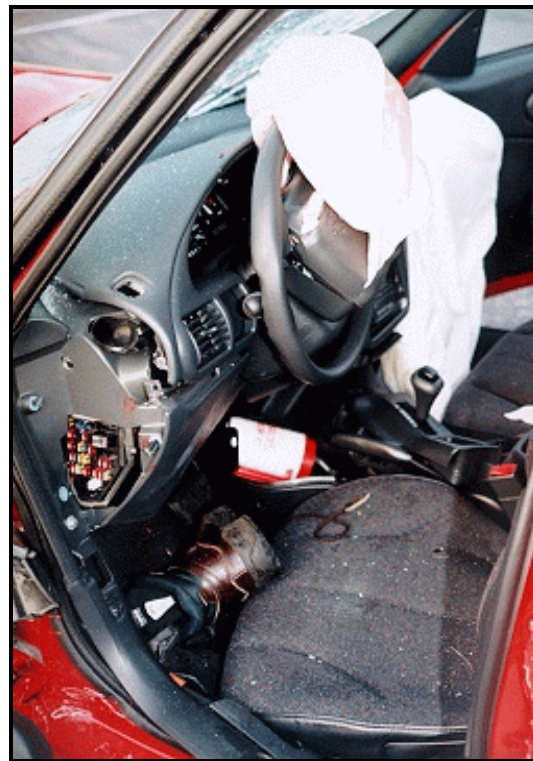
The driver of Vehicle 1 was seated in a normal, upright position. The bucket seat was adjusted the full upright position and the seat track was positioned between full and middle back. The driver was wearing the available lap and shoulder belt. The driver reported that he was distracted by a spider which dropped onto his face. This took his attention away from the roadway and his vehicle veered into the path of oncoming traffic. There were no indications of pre-impact braking—both vehicles were ABS-equipped—but appears likely that there was some braking by both parties. At impact, this occupant reacted to the 350E direction of force by moving forward and slight to the left. The seat belt restricted the forward motion as he engaged the deployed air bag with his face and chest—loading through the air bag and slightly deforming the upper rim of the steering wheel. His right foot engaged the toe pan as it was being deformed inward, causing the toe dislocation, then loading the knee on the instrument panel and fracturing the right femur. The left foot also engaged the toe pan, causing the left ankle fracture.

**Figure 9.** Interior, Vehicle 1

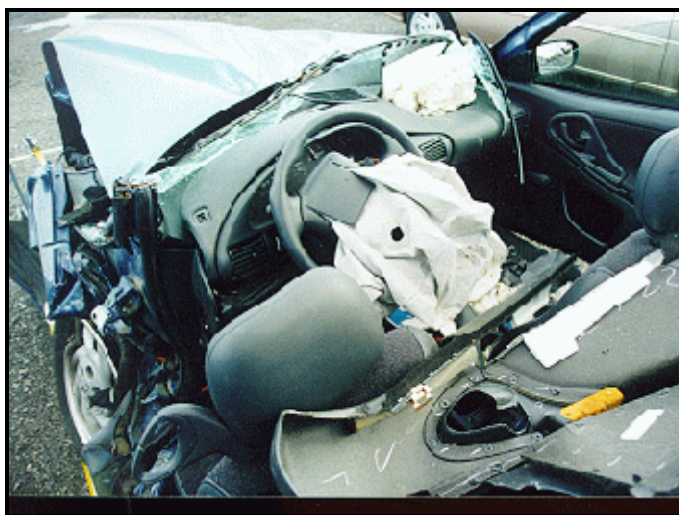
The driver was wearing the available lap and shoulder belt. As stated earlier, there was no indication of braking, but some braking seems likely. At impact, the driver reacted to the 350E direction of force by moving forward and slight to the left. The seat belt restricted the forward motion as she engaged the deployed air bag with her face—deposited a make up transfer on the face of the air bag and caused the concussive injury. The driver slid forward and contacted both sides of the knee bolster with both knees. The encroaching lower instrument panel pinned the driver in the vehicle. As the air bag deployed, it likely pushed the driver's left arm into the A-pillar area, which caused the arm fracture. The left ankle was injured as the toe pan intruded into the vehicle.

**Figure 10.** Interior, Vehicle 2

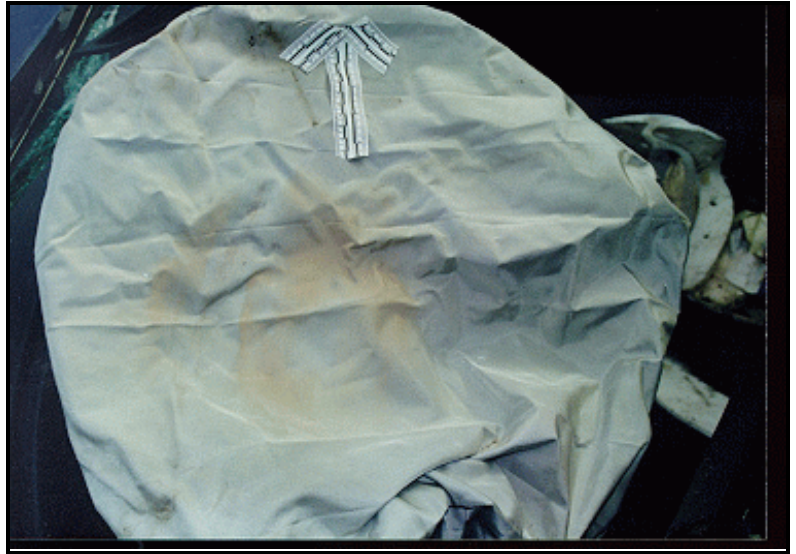
This vehicle was equipped with dual front air bags. The circular driver's side front air bag was mounted in the steering wheel hub and measured 53 cm at its widest point. The air bag was equipped with two vents ports and it was not tethered. There was no damage to the air bag. Make-up evidence was found near the center of the air bag. The "T" type module cover opened at the designed tear points and there was no damage to the cover.

**Figure 11.** Interior, Vehicle 2. Shows make-up transfer from driver.
