ON-SITE AIR BAG INVESTIGATION

CASE NUMBER - IN98-028

VEHICLE - 1995 FORD B800 WITH WAYNE BODY

CRASH DATE - November, 1998

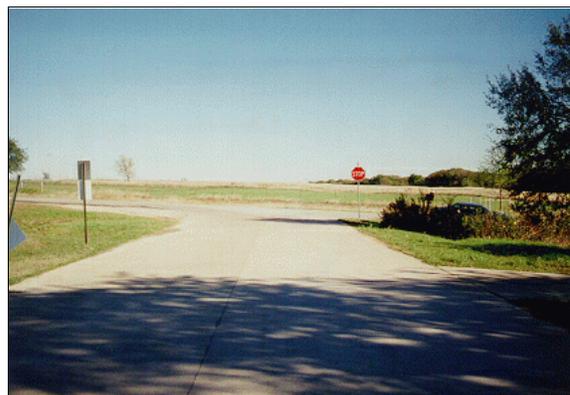
Figure 1: Case vehicle's eastbound travel path on west leg of "T"-intersection (case photo #01)

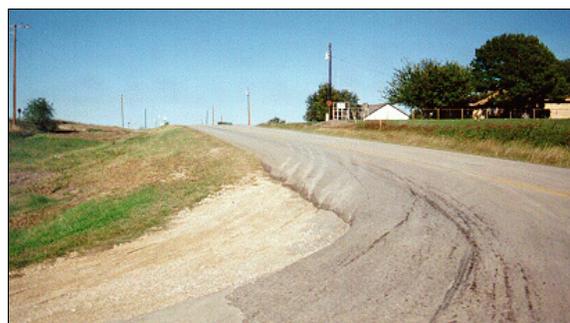
Figure 2: Case vehicle's northward view from west leg of "T"-intersection; Note hillcrest and negative grade for southbound traffic, unimproved shoulders, and drop off along west pavement edge (case photo #04)

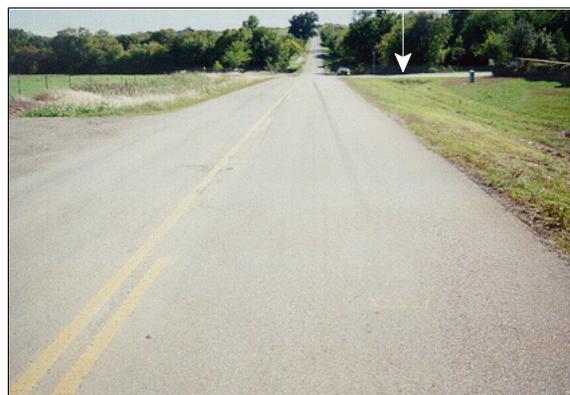
Figure 3: Chevrolet's southbound travel path approaching west leg (arrow) of "T"-intersection (case photo #09)

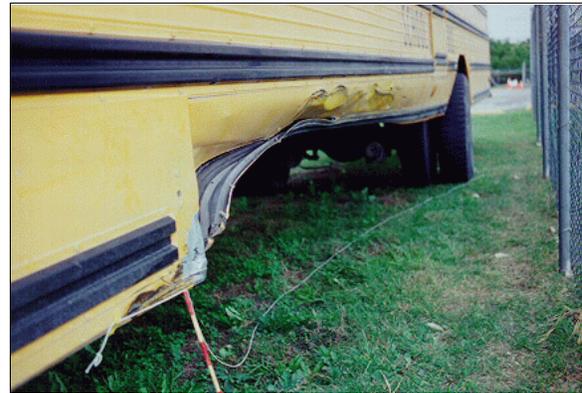
The left side of the case vehicle (**Figure 4**) was impacted by the front and hood top of the Chevrolet (**Figures 5 and 6**), in an underride configuration, with the Chevrolet contacting the case vehicle's left frame rail and drive shaft after impacting the bottom of the left side panel. Post-impact the case vehicle continued in a north-northeasterly direction and came to rest, primarily on the east roadside of the trafficway. The Chevrolet rotated approximately 40 degrees counterclockwise and was driven backwards as the case vehicle continued in its forward movement. The Chevrolet came to rest diagonal to the roadway and heading southeast, with the case vehicle's left rear dual wheels atop its hood (**Figure 7** below). With the case vehicle's right rear tandem wheels on the down slope of the east drainage ditch and the left rear tandem wheels resting on the Chevrolet's hood, the case vehicle was tilted at a severe angle (i.e., left side high and right side low).

Figure 4: Underride damage to case vehicle's left side (case photo #19)

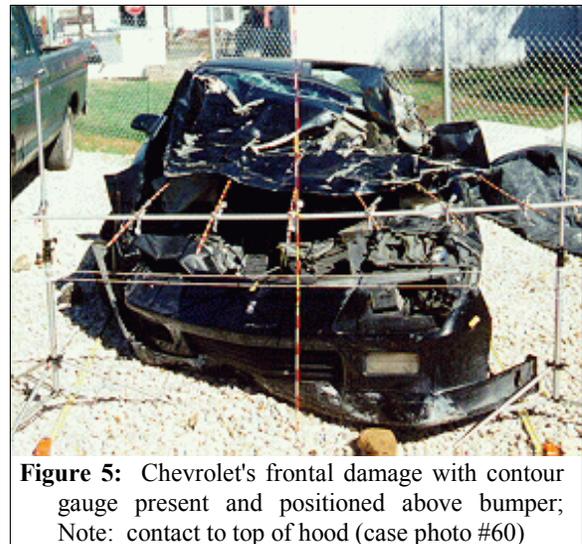
Figure 5: Chevrolet's frontal damage with contour gauge present and positioned above bumper; Note: contact to top of hood (case photo #60)

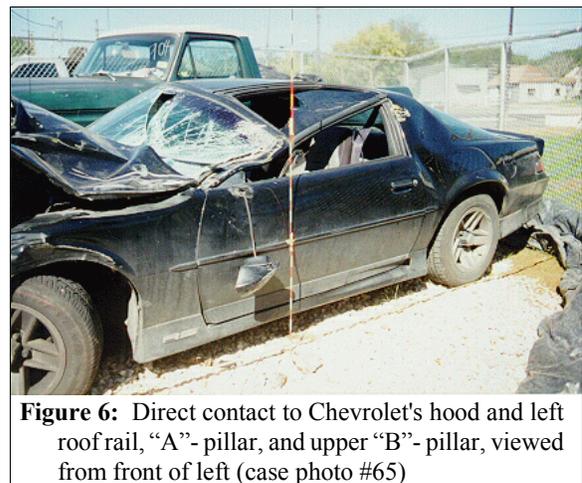
Figure 6: Direct contact to Chevrolet's hood and left roof rail, "A"-pillar, and upper "B"-pillar, viewed from front of left (case photo #65)

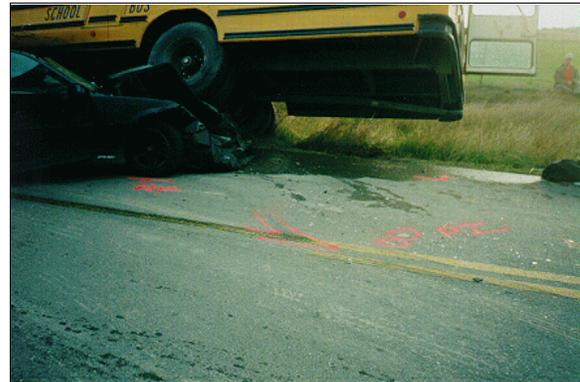
Figure 7: On-scene view of case vehicle and the Chevrolet in contact at final rest; Note: angle of case vehicle and position of its left rear tandem wheels on the Chevrolet's hood (case photo #14)

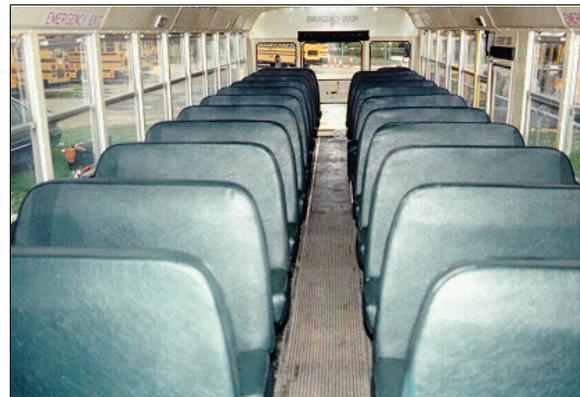
The passenger portion of the case vehicle's occupant compartment consisted of 11 rows of cushioned bench seats (**Figure 8**), with the last left side seat being a shortened seat (i.e., only two positions). Each bench seat, except the shortened seat, was 99 centimeters (39.0 inches) wide and 38 centimeters (15.0 inches) deep, with the seat cushion's bottom 36 centimeters (14.2 inches) off the floor. The shortened seat was 66 centimeters (26.0 inches) wide, with the rest of the measurements the same as the other seats. Seat backs were 99 centimeters (39.0 inches) high, measured from the floor to the cushion's top. The distance from the seat backs to the back of the seat immediately ahead of it ranged from 67 to 69 centimeters (26.4 to 27.2 inches) for right side seats, and from 60 to 71 centimeters (23.6 to 28.0 inches) for left side seats; row 3 (left) had the 60 centimeter distance and row 6 (left), the left-side emergency exit door location, had the 71 centimeter distance. Interior width of the passenger compartment was 230 centimeters (90.6 inches), window sill to window sill. The center aisle was 34 centimeters (13.4 inches) wide at seat cushion height and 56 centimeters (22.0 inches) wide at the top of the seat backs. For the side windows, the window sills measured 82 centimeters (32.3 inches) from the floor, while the top of the side windows were 150 centimeters (59.1 inches) from the floor. The window sills were 35 centimeters (13.8 inches) from the top of the seat cushions. Each seat cushion was approximately 8 centimeters (3.1 inches) thick.

Figure 8: Case vehicle's interior seating area showing 65 passenger seating positions (case photo #45)

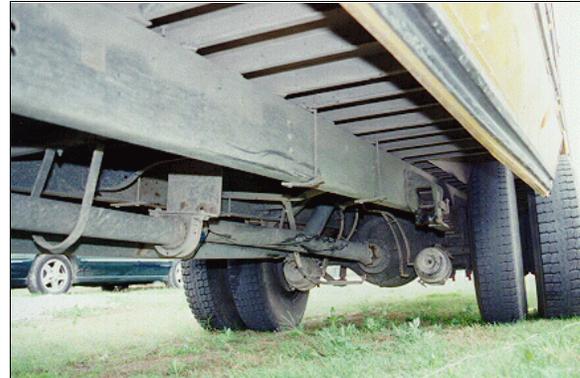
The left side of the case vehicle was impacted by the front and hood top of the Chevrolet, in an underride configuration. Beginning 208 centimeters (81.9 inches) rearward of the left front axle, the damage extended rearwards 507 centimeters (199.6 inches) to the left rear axle (**Figure 4** above). Underride contact by the Chevrolet reached the case vehicle's left frame rail and the drive shaft after impacting the bottom of the left side panel. Left frame rail contact was measured 81 centimeters (31.9 inches) inward from the case vehicle's left side panel, while the drive shaft contact measured 122 centimeters (48.0 inches) inward (**Figure 9**). The case vehicle's drive shaft was separated at the rearmost universal connection, just forward of the differential, and the left rear tandem wheels were pushed rearward an estimated 16 centimeters (6.3 inches). The case vehicle is neither CDC nor TDC applicable. Other than the foregoing damage descriptions, crash severity estimates for medium and large trucks and buses (which includes the case vehicle) are currently undefined. In addition, there was no evidence of intrusion to the case vehicle. The case vehicle was towed due to disabling damage.

Figure 9: Contacts to case vehicle's left frame rail and drive train; Note: the positioning of the left rear tandem wheels (case photo #20)

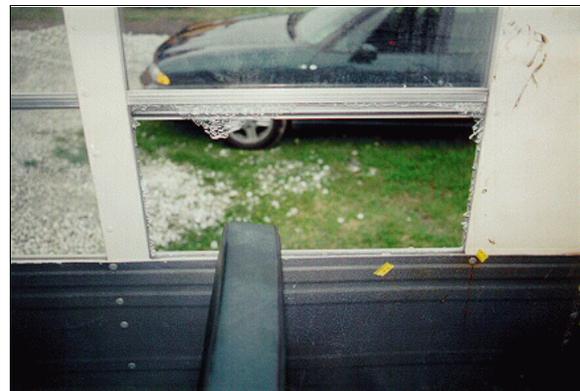
There was no evidence that the case vehicle's driver contacted any interior surface. In addition, no contacts were noted on the left interior side surface, glazing, or left side seats of the case vehicle. However, for the case vehicle's right side, the lower half of row 11's window glazing was disintegrated from occupant contact (**Figure 10**). Also, a small trace of blood was present around and slightly forward of a rivet to the bottom rear of the row 11's damaged right side window. A possible contact smudge on the center of that window's upper glazing was also noted. Immediately below that window on the side panel was a possible skin transfer, and rearward of the window were possible black contact smudges.

Figure 10: Case vehicle's rearmost window on the right side; Note: disintegrated window glazing and blood stains (yellow tape) on the interior side panel (case photo #56)
