**TRANSPORTATION SCIENCES  
CRASH RESEARCH SECTION**

**CALSPAN ON-SITE AIR BAG/INFANT FATALITY INVESTIGATION  
CALSPAN CASE NO. CA98-028  
VEHICLE: 1995 SATURN SC1  
LOCATION: FLORIDA  
CRASH DATE: APRIL, 1998**

| 15. <i>Supplementary Notes</i><br>On-site investigation of an air bag deployment death that involved a 3 week old infant positioned in a rear-facing child safety seat in a 1995 Saturn SC1. | | | |

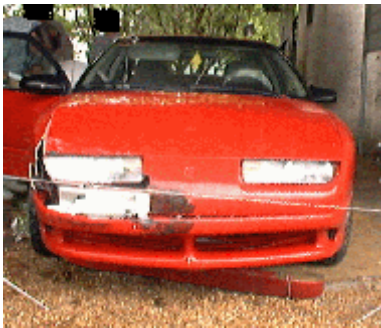
**Figure 1. Frontal damage to the 1995 Saturn SC1.**

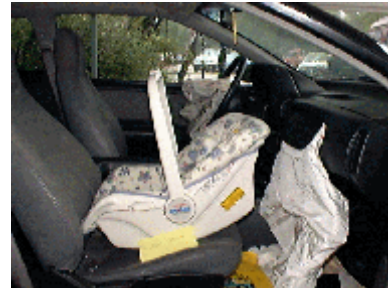
**Figure 2. Rear-facing child safety seat and the deployed front right air bag.**

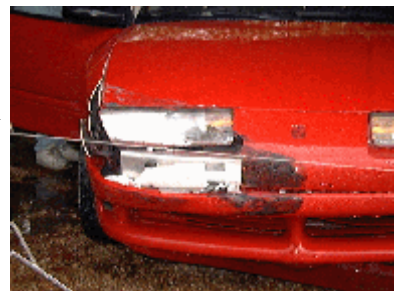
The 1995 Saturn sustained moderate frontal damage as a result of the crash (**Figure 5**). The direct contact damage on the bumper fascia began 2.8 cm (1.1") left of center and extended approximately 59.7 cm (23.5") to the right corner. The fascia was fractured in the area below the right headlamp assembly. The contact damage consisted of black paint transfers from the side surface of the pickup truck. As previously noted, there was no residual crush at the bumper reinforcement bar. The styrofoam energy absorbing filler material positioned between the fascia and the aluminum bumper reinforcement bar was fragmented at the impact site.

**Figure 5. Frontal damage to the Saturn SC1.**

Compression of the fascia and the styrofoam filler resulted in engagement of the leading edge of the right hood edge against the side surface of the pickup truck. Contact damage on the hood edge consisted of laterally oriented abrasions over the area of the right headlamp assembly. There was no residual crush to the hood. The leading edge of the composite right front fender was fractured due to the engagement against the pickup truck. There was no deformation observed to the sub-structure for the right front fender. The Collision Deformation Classification (CDC) for this impact sequence was 11-FZEW-1.

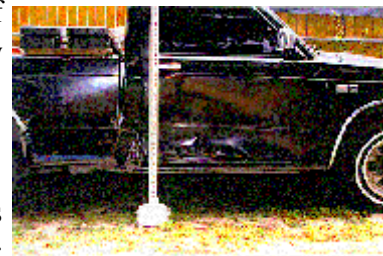
The Chevrolet pickup truck was not available for inspection at the time of the SCI on-site investigation. The vehicle was subsequently inspected by the ESIS representative who provided photographs of the damage profile. Based on these photographs, the direct contact damage began on the forward aspect of the lower right door panel and extended rearward onto the lower right B-pillar and quarter panel. The depth of crush was estimated at 12.7 cm (5.0") located at the leading edge of the right quarter panel. The CDC was estimated at 02-RZEW-2 (**Figure 6**) .

**Figure 6. Right side damage to the Chevrolet S-10 pickup truck.**

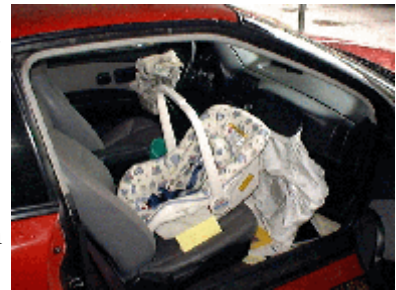
The front right passenger air bag deployed from a mid mount module that was vertically oriented in the right instrument panel (**Figure 7**). The padded instrument panel above the mid mount module was curved in a brow configuration to direct the deployment path of the bag membrane. The brow protruded 3.2 cm (1.25") rearward of the module cover flap. The single cover flap was oval in shape with an overall height of 12.7 cm (5.0") and width of 30.5 cm (12.0"). The cover flap was hinged at the top horizontal surface and the word AIRBAG was molded into the lower right corner area of the flap. There was no damage or contact evidence to the black vinyl flap.

**Figure 7. Overall view of the deployed mid mount front right air bag and the child safety seat.**

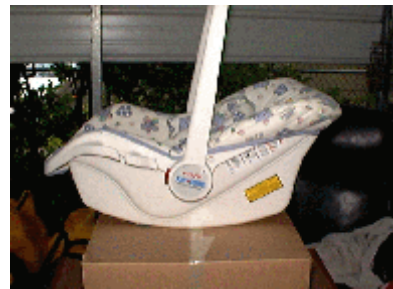
The child safety seat involved in this crash was an Evenflo JoyRide Car Seat/carrier (**Figure 8**). The restraint was manufactured on October 21, 1997, and was identified by number 2031D1P2102197 and Model No. 2031D1P2. The driver stated that she received the safety seat as a baby shower gift on March 21, 1998, therefore the restraint had no prior usage. The restraint was designed specifically as a rear-facing restraint for infants up to 9 kg (20 lb).

**Figure 8. Overall view of the Evenflo child safety seat.**

The child restraint was constructed of a one-piece ABS-type plastic shell with a carrying handle affixed to the mid point of the shell. The handle pivoted in both directions and locked into several detent positions. The driver noted that at the time of the crash, the handle was positioned forward, toward the front of the vehicle. There was no damage and/or contact evidence to the shell or carrying handle of the restraint.

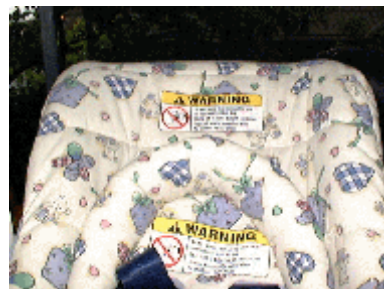
A foam pad provided cushioning to the infant. The padding was covered by a fitted padded fabric cover that wrapped around the edges of the restraint. A warning label was affixed to the fabric cover in the area of the infants head which advised the following (**Figure 9**):

**Figure 9. Warning labels on the fabric of the child safety seat.**

This warning label was 12.7 cm (5.0") in length and 5.4 cm (2.125") in height. A second label that contained the identical language was affixed to a head stabilizer collar that was used by the mother to provide lateral stability to the infant's head. The collar fabric matched the fabric of the liner, however, it was unknown if the collar was supplied with the restraint, or was a separately purchased item. The edge of the fabric liner at the top of the shell (area above the infant's head) contained a blackish abrasion. The abrasion was consistent with contact by the front right air bag module cover flap.

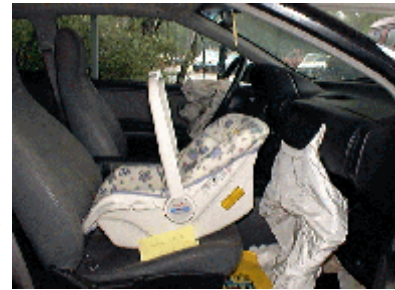
At impact, the supplemental frontal air bag system deployed. The leading edge of the module cover flap contacted the top surface of the child safety seat. A blackish-type transfer was located on the wrap-around aspect of the fabric at the leading edge of the shell of the restraint. There was no evidence of contact on the module cover flap, therefore the contact with the restraint was minimal. The front right passenger air bag membrane expanded from the mid mount module assembly against the upper aspect of the shell of the rear-facing child safety seat (**Figure 10**). As a result of the contact, the infant sustained depressed skull fractures of the right occipital/parietal areas, a macerated brain, and diffuse subdural and subarachnoid hemorrhage.

**Figure 10. Profile view of the deployed front right air bag and the rear-facing child safety seat. (Seat track adjusted to the full rear position).**

The air bag expansion rotated the rear-facing restraint rearward against the seat back support. The infant was not properly restrained within the child safety seat and probably moved rearward as the shell of the restraint contacted the seat back support. The right aspect of the infant's face and scalp impacted the seat back support which resulted in a 1.5 x 1.5 cm contusion over the right temporo-frontal scalp area, bilateral orbital ecchymosis, blue discoloration of the right side of the head and face, skull fractures of the fronto-temporal areas, bilaterally, scalpular hemorrhage of the right fronto-parietal, right parietal, and right occipital areas. The location of these injuries suggest that the infant's head was turned to her left exposing the right facial area to the seat back support.
