ON-SITE SIDE AIR BAG INVESTIGATION

CASE NUMBER - IN98-029
LOCATION - TEXAS
VEHICLE - 1999 INFINITI G20T
CRASH DATE - November, 1998

1. <i>Report No.</i> IN98-029		2. <i>Government Accession No.</i>		3. <i>Recipient's Catalog No.</i>	
4. <i>Title and Subtitle</i> On-Site Side Air Bag Fatality Investigation Vehicle - 1999 Infiniti G20t Location - Texas			5. <i>Report Date:</i> August 25, 2002

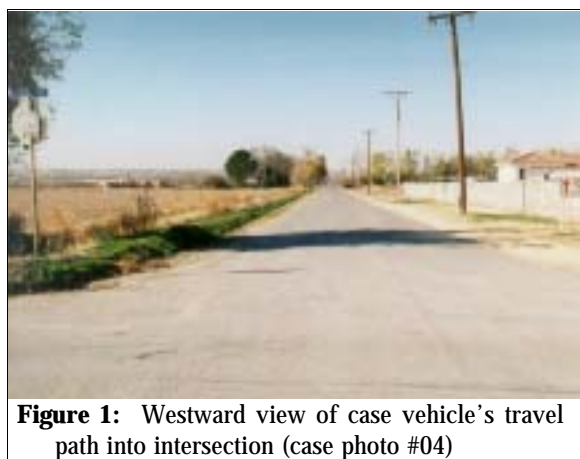
Figure 1: Westward view of case vehicle's travel path into intersection (case photo #04)

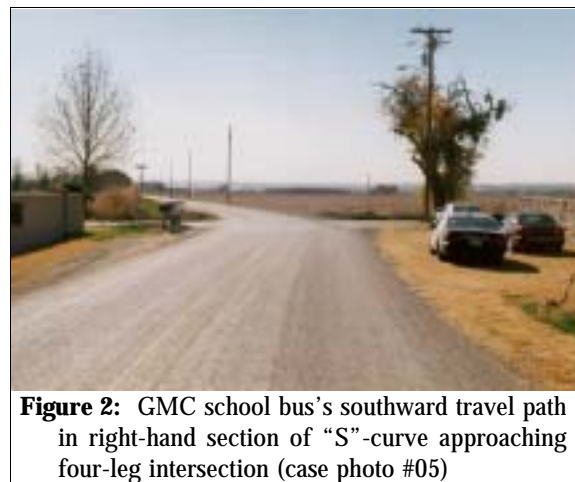
Figure 2: GMC school bus's southward travel path in right-hand section of "S"-curve approaching four-leg intersection (case photo #05)

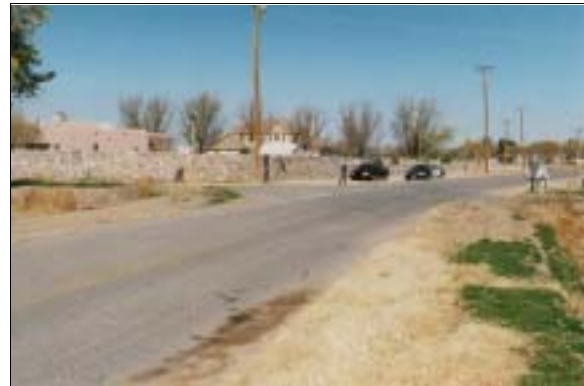
48 km.p.h. (30 m.p.h.). No regulatory speed limit sign was posted near the crash site. The roadway on the north leg of the intersection also had only grass/dirt shoulders, no pavement markings were present, and estimated coefficient of friction was also 0.75. The south leg of the intersection began curving leftward a short distance south of the intersection. There were no visible traffic controls for the north-south roadway. The statutory speed limit was 64 km.p.h. (40 m.p.h.). No regulatory speed limit sign was posted near the crash site. At the time of the crash the light condition was daylight, the atmospheric condition was clear, and the road pavement was dry. Traffic density on both roadways is unknown, and the site of the crash was primarily urban residential. As mention above, the properties on the northwest and northeast corners of the intersection were surrounded by a 2.4 meter (8.0 foot) high rock fence, reducing the sight lines for east, west, and southbound traffic (**Figure 3**).

Figure 3: North-northwestward view from beyond case vehicle's final rest position showing crash location and 2.4 meter (8 foot) high stone wall that limited each driver's view of the other vehicle's approaching trajectory (case photo #11)

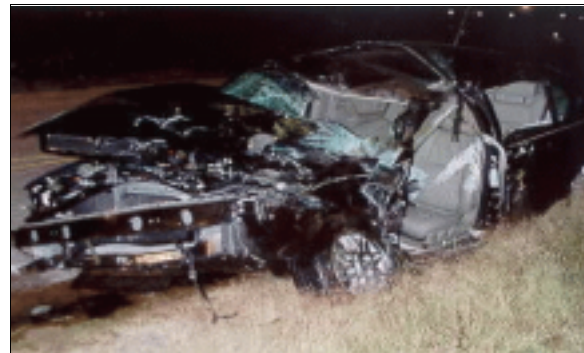
The left side of the case vehicle (**Figure 4**) was impacted by the front (**Figure 5**) of the school bus, causing the case vehicle's driver and front right passenger supplemental restraints (air bags) to deploy. Furthermore, the driver's side impact air bag also deployed. The severity of the crash was so great that the front wheel/axle assembly of the bus was torn away from the school bus, leaving the bus without any steering control.

Figure 4: On-scene view of case vehicle at final rest showing damage to left side; Note: driver's seat belt extended and side air bag (case photo #73)

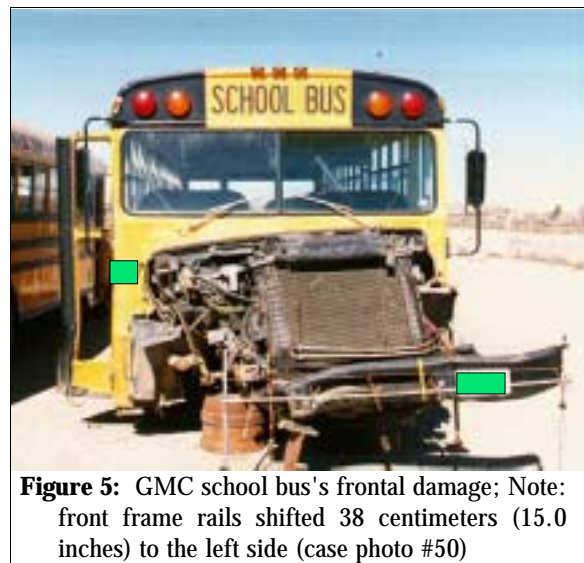
Figure 5: GMC school bus's frontal damage; Note: front frame rails shifted 38 centimeters (15.0 inches) to the left side (case photo #50)

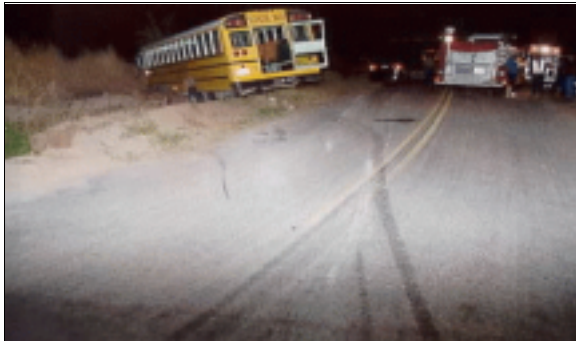
Figure 7: On-scene view looking south at tire marks and pavement gouges from both vehicles traveling to their final rest positions (case photo #75)

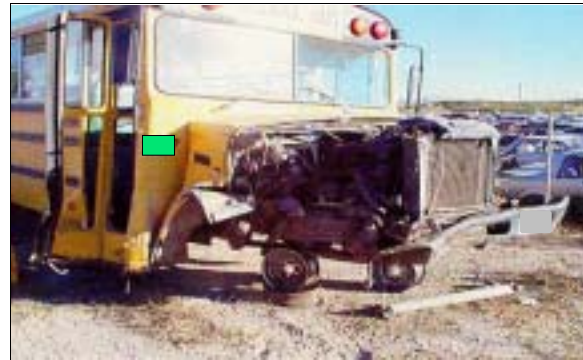
Figure 6: GMC school bus's frontal damage; Note: front axle and wheels were torn away, front shift, and side slap damage to folding entrance/exit door (case photo #72)

extending back to the bus's front cowl and folding entrance/exit doors (**Figure 6** above). The frontal impact to the school bus was so severe that the front axle and tire assembly was torn from the bus during the crash. The torn axle and assembly damaged the left side body panel that protected the outside of the LPG cylinder (**Figure 17** above). An inspection of the 82 gallon cylinder revealed scrapes to the underside of the front portion of the cylinder (**Figure 18** above). This damage to the cylinder was also caused by the vehicle's front axle and tire assembly as a consequence of being driven over during the bus's movement to final rest (**Figures 19** and **20**).

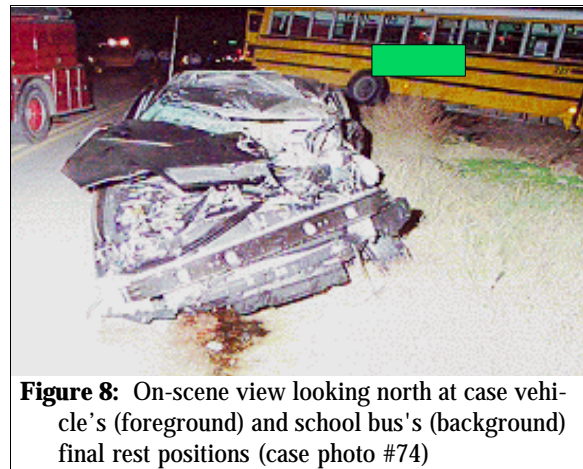
Figure 8: On-scene view looking north at case vehicle's (foreground) and school bus's (background) final rest positions (case photo #74)

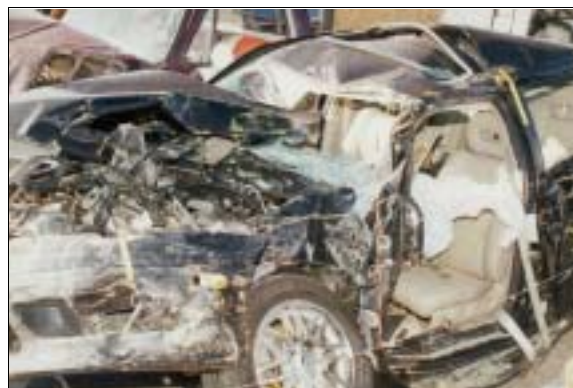
The case vehicle's initial contact with the school bus involved its left side forward of the "B"-pillar. Direct damage began at the front left bumper corner and extended rearward 182 centimeters (71.7 inches) down the left side to just forward of the "B"-pillar (**Figure 9**). Residual maximum crush was 29 centimeters (11.4 inches) below the belt line and 85 centimeters (33.5 inches) above the belt line, both at C₅. The wheelbase on the case vehicle's left side was shortened 24 centimeters (9.5 inches) while the right side was extended 5 centimeters (2.0 inches). The school bus's high profile front bumper overrode the side of the case vehicle, directly contacting the case vehicle's hood, left "A"-pillar, windshield, and roof. The damage from the case vehicle's side slap with the school bus started at the left "B"-pillar and extended to the left rear bumper corner, a distance of 224 centimeters (88.2 inches). Maximum crush for the side slap impact was measured as 24 centimeters (9.5 inches). There was a small separation or break in the side slap damage near the left rear wheel, a distance of 70 centimeters (27.6 inches). The case vehicle's left front and rear tires were physically restricted and deflated from the crash. There was integrity loss to left front door's glazing and to over half of the windshield's glazing [i.e., 45 x 28 centimeters (17.7 x 11.0 inches)]; the windshield was separated from its bond. The case vehicle's driver door panel, left instrument panel, "A"-pillar, and steering wheel column had over 30 centimeters (11.8 inches) of intrusion into the case vehicle's driver seating position. The driver's door was taken off during the extrication process.

Figure 9: Case vehicle's extensive left side damage from impact with school bus; Note: yellow tape between left front bumper and "B"-pillar marks direct damage area (case photo #17)

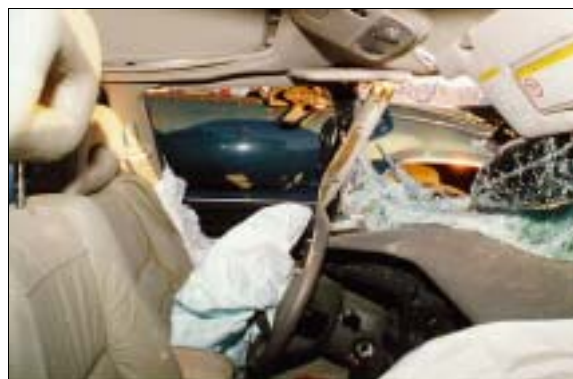
Inspection of the case vehicle's interior revealed dark scuffs along the left roof side rail (**Figure 10**), deformation to the left instrument panel from contact by the driver's knee, scuffs and deformation to the interior surface of the driver's door (**Figure 11**), and skin and blood on the residue of the left windshield's glazing. The rearview mirror was knocked off the windshield from the force of the impact. The instrument panel on the whole left half of the interior was damaged from intrusion (**Figure 12** below). In

Figure 10: Case vehicle's front seating area viewed from right front passenger door; Note: extensive intrusion into driver's seating area (case photo #29)

panel (**Figure 11** above), left instrument panel, and steering wheel (**Figure 10** above) sent the driver back into her seat back and to the right most likely contacting the center console. The case vehicle’s left side, side slap impact sent the driver back to the left, with the intruding left front door panel keeping the driver’s head from contacting the right side of the bus. As the two vehicles separated, the driver rebounded backwards into her seat back and then forward and to the right where her bloodied right hand came in contact with the front right passenger air bag, near its left seam. At final rest the driver was found sitting slumped forward between the intruded steering wheel and seat back.

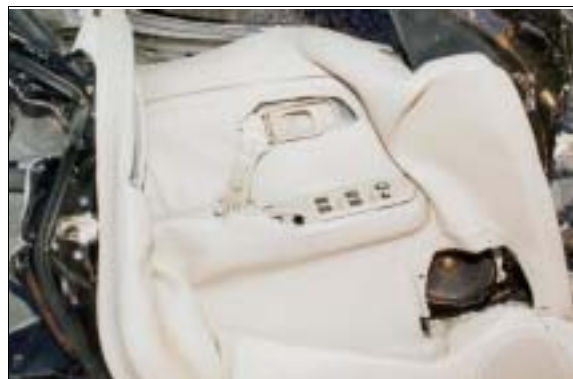
Figure 11: Interior surface of case vehicle's driver door showing extensive deformity (case photo #26)

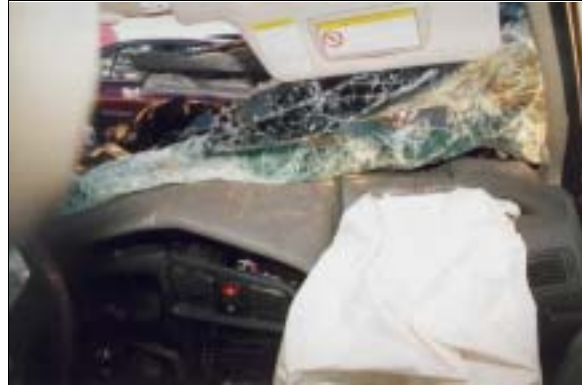
Figure 12: Case vehicle’s front right seating area showing deployed front right passenger air bag and extensive intrusion front instrument panel (case photo #34)

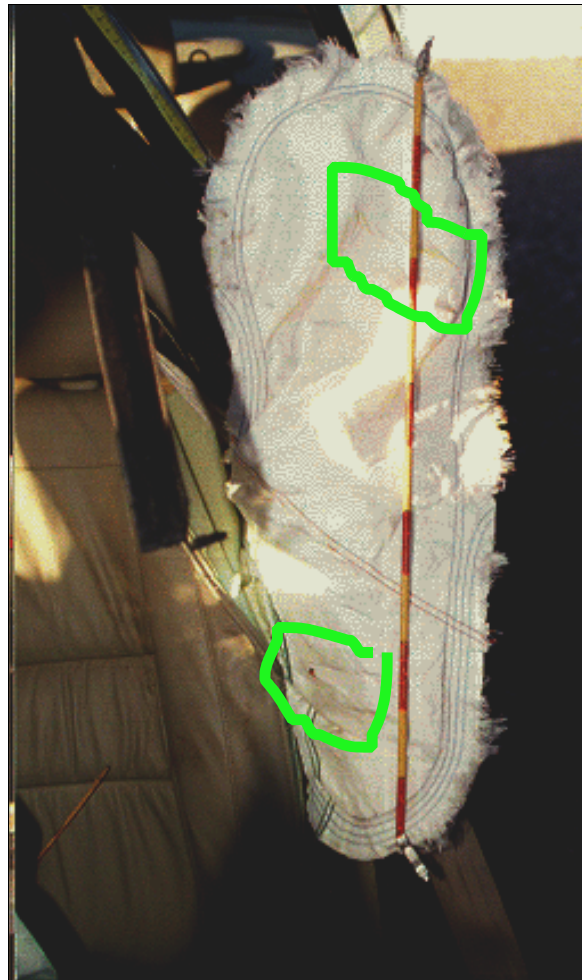
Figure 13: Vertical view of interior (medial) surface case vehicle’s driver seat back-mounted side impact air bag; Note: yellow paint transfers to top half, glass punctures to middle, and blood and oil transfer to lower half (case photo #45)

bottom portion. The air bag was split in half by diagonal stitching that created an upper and lower air chamber. The separate chambers and lack of vent ports kept the air bag partially inflated for a few moments post crash. The inspection also revealed an area towards the top medial half of the side air bag [i.e., the inside (facing driver) portion] had yellow paint transfers from the school bus. This most likely occurred during the side slap event, possibly from the school bus's shattered fiberglass hood. There were also three glass punctures to the inside portion towards the center of the side air bag (**Figure 13** above).

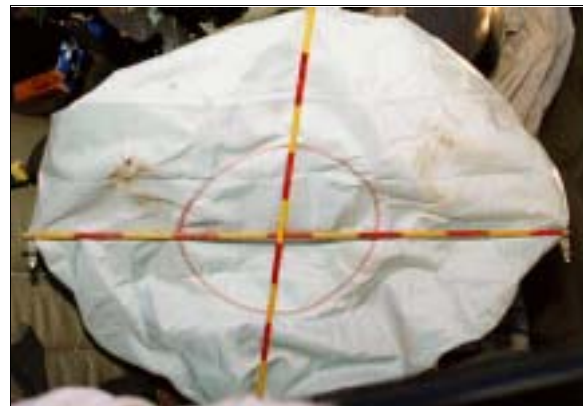
The case vehicle's driver air bag was located in the steering wheel hub. The module cover consisted of asymmetrical "H"-configuration cover flaps made of thick vinyl. The top flap was rectangular with overall dimensions of 15 centimeters (5.9 inches) at the horizontal seam and 7 centimeters (2.8 inches) vertically. The lower flap was trapezoidal with overall dimensions of 15 centimeters (5.9 inches) at the upper horizontal seam and 8 centimeters (3.1 inches) vertically. An inspection of the air bag module's cover flaps and air bag revealed that the cover flaps opened at the designated tear points, and there was no evidence of damage during the deployment to the air bag or the cover flaps. The driver's air bag was designed with two tethers, each approximately 10 centimeters (3.9 inches) in width. The driver's air bag had two vent ports, approximately 2.5 centimeters (1.0 inch) in diameter, located at the 11 and 1 o'clock positions. The deployed driver's air bag was round with a diameter of 63 centimeters (24.8 inches). An inspection of the driver's air bag fabric revealed contact evidence readily apparent on the air bag's fabric (**Figure 14**) on the upper left and right quarter sections.

Figure 14: Case vehicle's driver (front) air bag showing blood on upper left quadrant and body fluids on upper right quadrant (case photo #35)

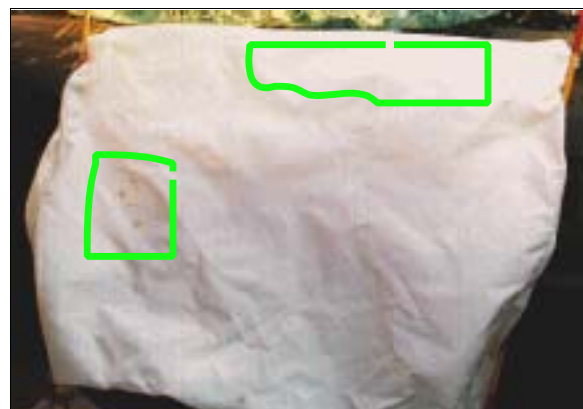
Figure 15: Front surface of case vehicle's front right passenger air bag showing blood evidence to left side and punctures along top (case photo #40)

9:30 and 2:30 o'clock positions. The deployed front right air bag was rectangular with a height of approximately 42 centimeters (16.5 inches) and a width of approximately 52 centimeters (20.5 inches). An inspection of the front right passenger's air bag fabric revealed apparent blood evidence on the front surface of the air bag's fabric toward the far left side, just inside the left seam. Furthermore, there were several punctures to the top and front surfaces of the air bag from coming in contact with the intruding windshield (**Figure 15** above).

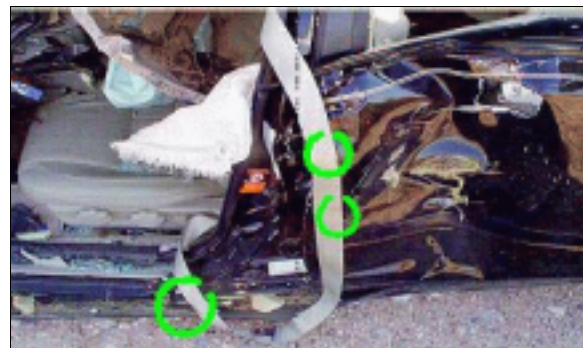
Figure 16: Close-up of case vehicle's left side impact showing driver's deployed seat back-mounted side impact air bag protruding from seat cushion and extended safety belt with blood spots highlighted on webbing (case photo #28)

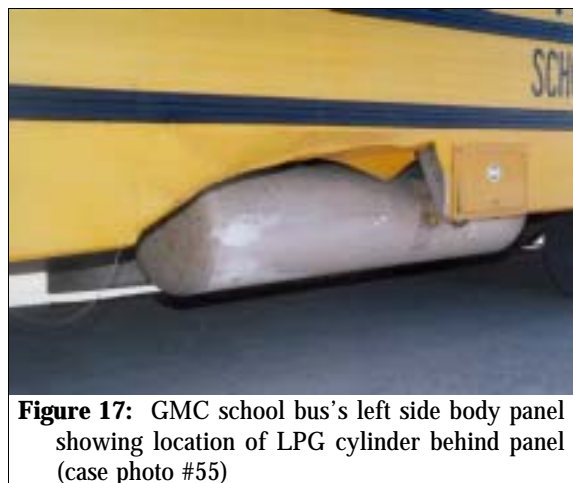
Figure 17: GMC school bus's left side body panel showing location of LPG cylinder behind panel (case photo #55)

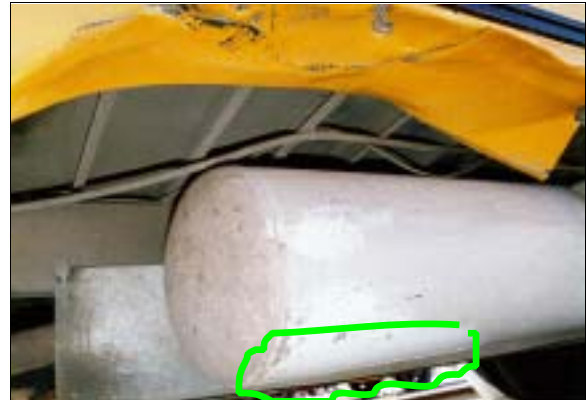
Figure 18: Close-up of GMC school bus's LPG gas cylinder under left body panel showing scrapes and yellow paint transfers (highlighted) to underneath side (case photo #59)

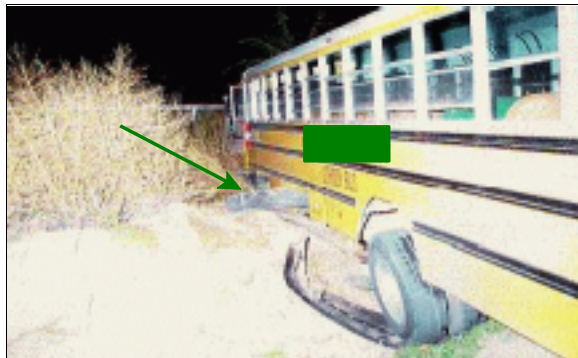
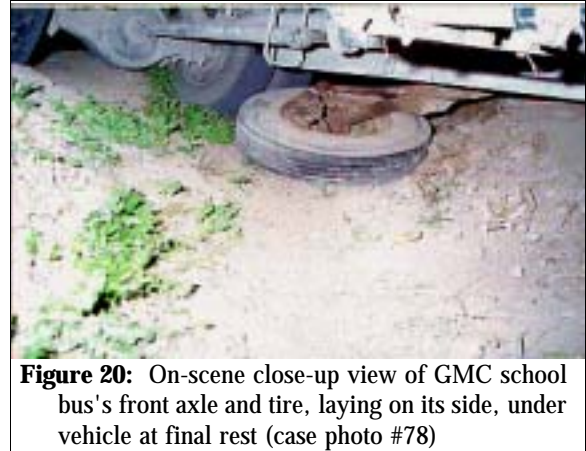
Figure 19: On-scene view of GMC school bus at final rest; Note: case vehicle's bumper under left rear dual wheels and bus's broken away front axle and tires laying under LPG cylinder towards front (case photo #77)

Figure 20: On-scene close-up view of GMC school bus's front axle and tire, laying on its side, under vehicle at final rest (case photo #78)
