**TRANSPORTATION SCIENCES  
CRASH RESEARCH SECTION**

**CALSPAN REMOTE DRIVER AIR BAG FATALITY INVESTIGATION  
CALSPAN CASE NO. CA98-32  
VEHICLE: 1997 LINCOLN CONTINENTAL  
LOCATION: PENNSYLVANIA  
CRASH DATE: JULY, 1997**

<p>1. <i>Report No.</i> CA98-32</p>	<p>2. <i>Government Accession No.</i></p>	<p>3. <i>Recipient's Catalog No.</i></p>	
<p>4. <i>Title and Subtitle</i> Calspan Remote Driver Air Bag fatality Investigation Vehicle: 1997 Lincoln Continental Location: Pennsylvania</p>		<p>5. <i>Report Date:</i> October, 1998</p>	
		<p>6. <i>Performing Organization Code</i></p>	
<p>7. <i>Author(s)</i> Crash Research Section</p>		<p>8. <i>Performing Organization Report No.</i></p>	
<p>9. <i>Performing Organization Name and Address</i> Transportation Sciences Crash Research Section Calspan Operations P.O. Box 400 Buffalo, New York 14225</p>		<p>10. <i>Work Unit No.</i> 1115 (8570-8579)</p>	
		<p>11. <i>Contract or Grant No.</i> DTNH22-94-D-07058</p>	
<p>12. <i>Sponsoring Agency Name and Address</i> U.S. Department of Transportation National Highway Traffic Safety Administration Washington, D.C. 20590</p>		<p>13. <i>Type of Report and Period Covered</i> Technical Report Crash Date: Ju

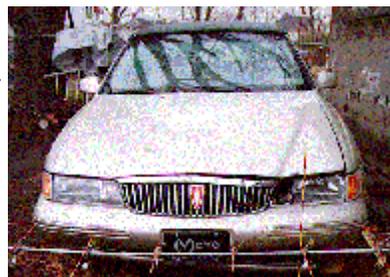
This crash involved a 1997 Lincoln Continental and a 1985 Buick LeSabre in an off-set frontal impact at an intersection. The crash occurred as the driver of the Lincoln attempted to initiate a left turn in front of the Buick. The impact involved the left frontal area of the Lincoln (**Figure 1**) and the left frontal area of the Buick.

**Figure 1. Frontal view of the 1997 Lincoln Continental.**

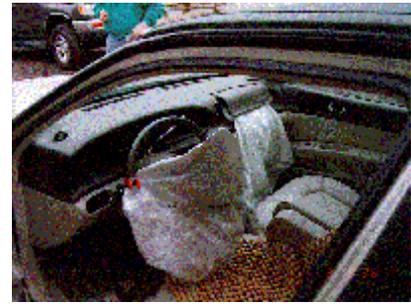
**Figure 2. Overall view of the driver's compartment and the deployed air bags.**

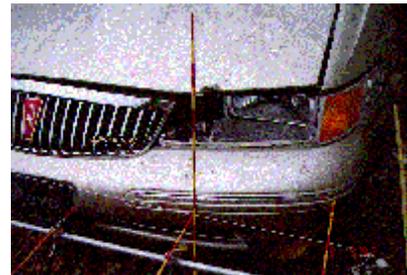
Exterior damage to the Lincoln consisted of abrasions to the left front bumper fascia, a fractured left headlamp and turn signal assembly, deformation of the left side of the grille, and a small dent located on the leading edge of the hood. The direction of force associated with this damage was within the 12 o'clock sector and a CDC of 12-FLEW-1 was assigned. The width of direct and induced damage across the frontal plane was 68.6 cm (27.0") as measured from the left corner to the right (**Figure 3**). There was no residual crush to the bumper. Based on the minor severity level of the exterior damage, it was estimated that the Lincoln experienced a velocity change during the crash which was in the range of 11 to 14 km/h (7-9 mph). In addition, the crash pulse was probably elongated resulting in air bag deployment late in the crash event.

**Figure 3. Close-up view of the damage.**

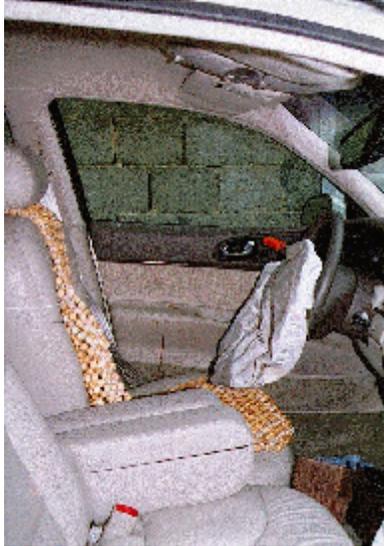
**Figure 4. Profile view of the horizontal distance between the seat back support and the driver air bag module as documented by the officer.**

officer measured the horizontal distance between the left front seat back support and the mid point of the driver air bag module cover at 55.9 cm (22.0") (**Figure 4**). An inspection of an exemplar vehicle by a Calspan SCI investigator determined that this seat track position was adjusted 4.4 cm (1.75") forward of the full rear position. Driver contact was noted with the module upper cover flap. This contact consisted of a vertically oriented abrasion on the lower third of the upper flap. Driver contact was also noted to the driver's air bag. A small cloth transfer was noted in the left upper quadrant of the frontal bag surface (**Figure 5**).

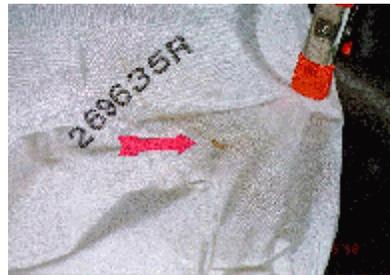
**Figure 5. Close-up view of the driver air bag.**

The driver was contacted by the expanding air bag as it deployed. A small cloth transfer was noted in the left upper quadrant of the front surface of the air bag (**Figure 5**). The driver sustained critical severity level injuries as a result of contact with the driver air bag module upper cover flap and the expanding air bag.

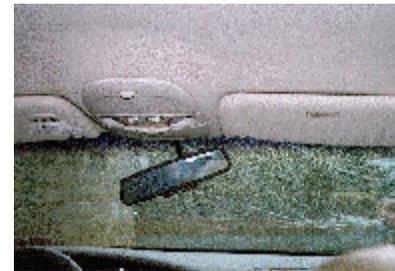
**Figure 6. Rear view mirror.**

The windshield of the Lincoln was fractured as a result of being struck by the right front passenger air bag module cover flap (mid-mount design). The expanding right front air bag subsequently contacted the rearview mirror, forcing the right side of the mirror upward (**Figure 6**). No other interior damage was noted or reported as a result of the this crash sequence.

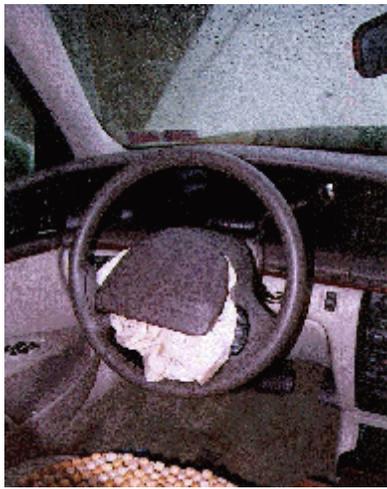
The driver air bag module was mounted within a 2-spoke steering wheel rim. The steering wheel spokes were located at the 4 and 8 o'clock positions. This installation utilized asymmetrical module cover flaps with the upper flap being much larger than the lower flap. A vertically oriented abrasion pattern was visible on the lower third of the upper module cover flap (**Figure 7**). This pattern indicated that the module flap struck the driver's chest as it swung upward during the deployment sequence.

**Figure 7. Vertically oriented abrasion pattern on the lower third of the upper module cover flap.**

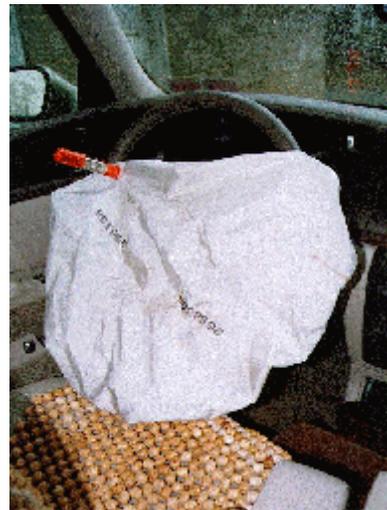
The driver air bag (**Figure 8**) deployed as designed with no tears or perforations noted to the woven nylon-type fabric. The bag was constructed of two panels that were sewn with an internal peripheral seam. This was a tethered bag design. There were four internal tether straps that were sewn to the front of the bag. The bag was vented by two 1.3 cm (0.5") diameter ports that were located on the rear surface of the bag in the 11 and 1 o'clock sectors. The serial number of the component was 269635R. The number was stamped on the front surface of the bag.

**Figure 8. Driver air bag.**
