# INDIANA UNIVERSITY

### ON-SITE REDESIGNED AIR BAG INVESTIGATION

CASE NUMBER - IN98-032  
LOCATION - ILLINOIS  
VEHICLE - 1998 DODGE CARAVAN  
CRASH DATE - December, 1998

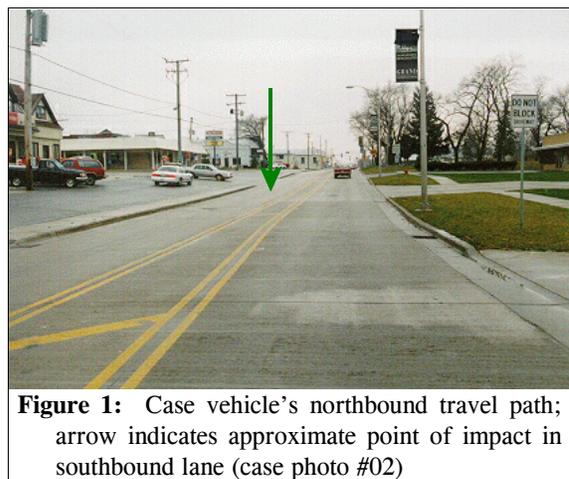
The case vehicle was traveling north in the northbound lane of a two-lane, divided (**Figure 1**), city street and intended to continue its northerly travel path [i.e., both the north and southbound roadways had only one travel lane, and the lanes were separated by two double-solid-yellow center lines, spaced approximately 1.3 meters (4.3 feet) apart at the point of impact]. The Suburban was traveling south in the southbound roadway of the same two-lane, divided, city street and intended to continue its southerly travel path. The case vehicle's driver made no avoidance maneuvers prior to the crash. The Suburban's driver braked attempting to avoid the crash. The crash occurred in the southbound roadway of the trafficway; see **CRASH DIAGRAM** below.

**Figure 1:** Case vehicle's northbound travel path; arrow indicates approximate point of impact in southbound lane (case photo #02)

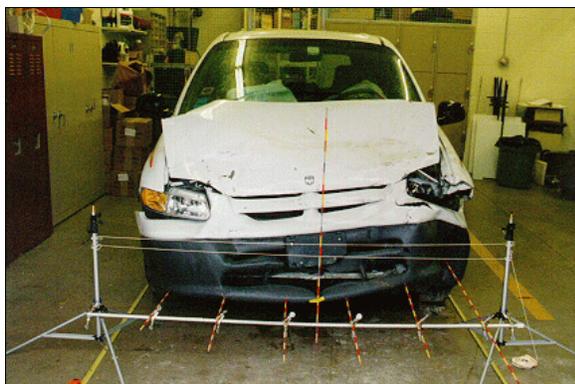
The front of the case vehicle (**Figure 2**) impacted the front of the Suburban (**Figure 3**), causing the case vehicle's driver (i.e., first generation) and front right passenger (i.e., redesigned-next generation) supplemental restraints (air bags) to deploy. The Suburban was pushed rearward by the head-on impact. The case vehicle rotated slightly counterclockwise as a result of the impact and then continued north-northwestward off the west side of the southbound roadway. The case vehicle came to rest with all tires, except the right rear, on the west sidewalk. The Suburban was pushed backwards in the southbound lane and rotated slightly clockwise before coming to rest in the southbound lane with its left rear tire straddling the median's double- solid-yellow lines.

**Figure 2:** Case vehicle's frontal damage from impact with GMC Suburban; Note: contour gauge present at bumper level (case photo #09)

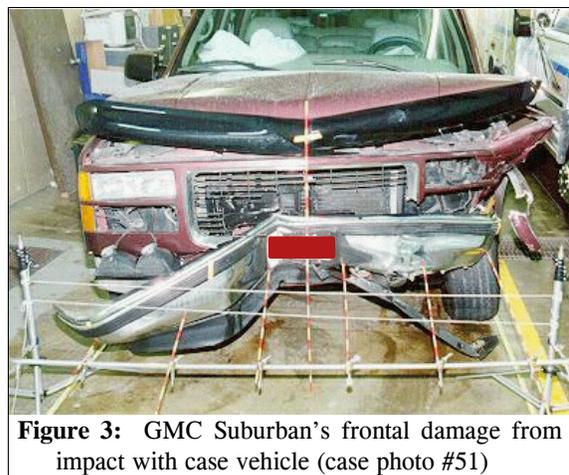
**Figure 3:** GMC Suburban's frontal damage from impact with case vehicle (case photo #51)

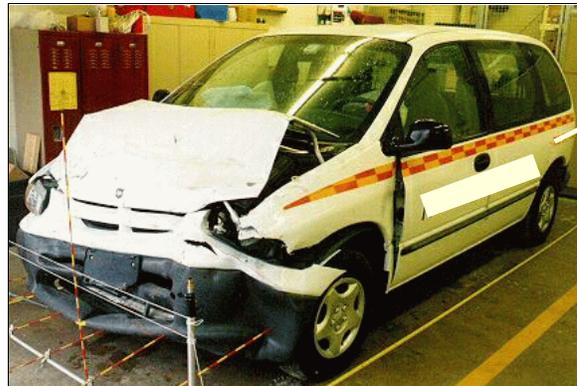
The case vehicle’s initial contact with the Suburban involved its front left half (**Figure 4**); however, as the case vehicle pushed the Suburban backwards while continuing in its north-northwesterly direction, the remaining width of the front bumper was directly damaged (**Figure 5**). Direct damage began at the front left bumper corner and extended, a measured distance of 152 centimeters (59.8 inches), along the front bumper to the front right bumper corner. Residual maximum crush was measured as 32 centimeters (12.6 inches) at C<sub>1</sub>. The case vehicle’s wheelbase was unaltered from the crash. The case vehicle’s front bumper, bumper fascia, grille, hood, left headlight and turn signal assemblies, and left fender were directly damaged and crushed rearward. The case vehicle’s left front tire was physically restricted from the crash. The right headlight and turn signal assemblies sustained induced damage as well as both the right and left fenders.

**Figure 4:** Case vehicle’s frontal damage viewed from left of front showing maximum crush at C<sub>1</sub> (case photo #11)

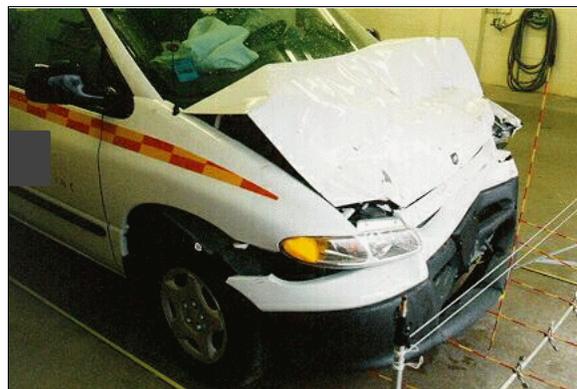
**Figure 5:** Case vehicle’s frontal damage viewed from right of front (case photo #23)

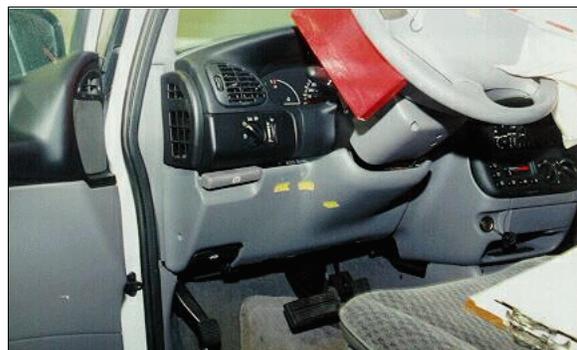
Inspection of the case vehicle’s interior revealed possible knee contacts to the driver’s knee bolster on both sides of the steering column (**Figure 6**) and scratches on the interior surface of the driver’s door at the window sill and on the armrest. In addition, the upper portion of the steering wheel rim was bent toward the left instrument panel, 3 centimeters (1.2 inches), as a result of the driver loading the air bag, momentarily blocking the air bag’s forward expansion, and causing the air bag to expand

**Figure 6:** Case vehicle’s driver seating area showing contact evidence on driver’s knee bolster, left of steering column (case photo #31)

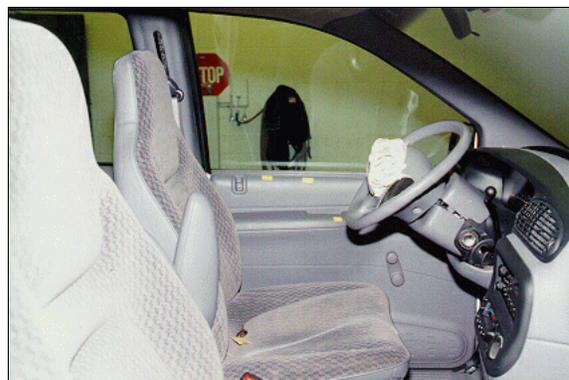
against and bend the steering wheel rim (Figure 7).

**Figure 7:** Case vehicle's front seating area showing scratches on interior surface of driver's door and deformed steering wheel rim (case photo #35a)

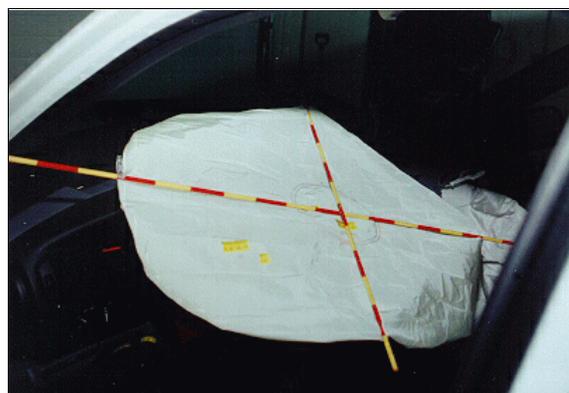
The case vehicle was equipped with a Supplemental Restraint System (SRS) that contained frontal air bags at the driver and front right passenger positions. The driver's air bag was a 1<sup>st</sup> generation air bag while the front right passenger air bag was redesigned. Both air bags deployed as a result of the frontal impact with the Suburban. The case vehicle's driver air bag was located in the steering wheel hub. The module cover consisted of asymmetrical "H"-configuration cover flaps made of thick vinyl with overall dimensions of 18 centimeters (7.1 inches) at the horizontal seam and 10 centimeters (3.9 inches) vertically for the upper flap and 2 centimeters (0.8 inches) vertically for the lower flap. An inspection of the air bag module's cover flaps and air bag revealed that the cover flaps opened at the designated tear points, and there was no evidence of damage during the deployment to the air bag or the cover flaps. The driver's air bag was designed with two tethers, each approximately 6 centimeter (2.4 inches) in width. The driver's air bag had no vent ports. The deployed driver's air bag was elliptical with a height of approximately 54 centimeters (21.3 inches) and a width of approximately 65 centimeters (25.6 inches). An inspection of the driver's air bag fabric revealed a lipstick smear at the lower midline of the circular center stitching, several black scratches adjacent to the center stitching at the top left quadrant of the bag's fabric, and clear body fluid stains to the middle of the bottom left quadrant of the air bag (Figure 8 and Figure 9 below).

**Figure 8:** Case vehicle's deployed driver air bag; Note: yellow tape marks contact evidence (case photo #40)

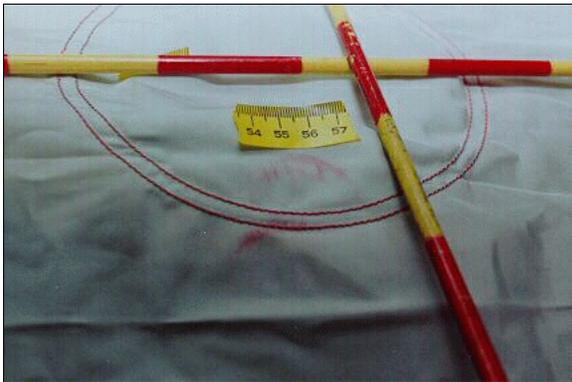
**Figure 9:** Close-up of case vehicle's deployed driver air bag showing lipstick imprint (case photo #42)

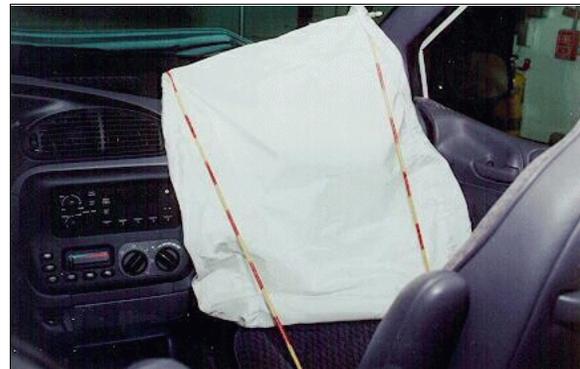
inches) vertically for both the upper and lower flaps. The profile of the case vehicle's instrument panel was flush with the leading edge of the cover flap. An inspection of the front right air bag module's cover flaps and air bag revealed that the cover flaps opened at the designated tear points, and there was no evidence of damage during the deployment to the air bag or the cover flaps. The front right passenger's air bag was designed without any tethers. The front right air bag had no vent ports. The deployed front right air bag was rectangular with a height of approximately 72 centimeters (28.3 inches) and a width of 46 centimeters (18.1 inches). An inspection of the front right passenger's air bag fabric revealed no contact evidence readily apparent on the air bag's fabric (**Figure 10**).

**Figure 10:** Case vehicle's deployed front right passenger air bag showing no occupant contact evidence (case photo #45)

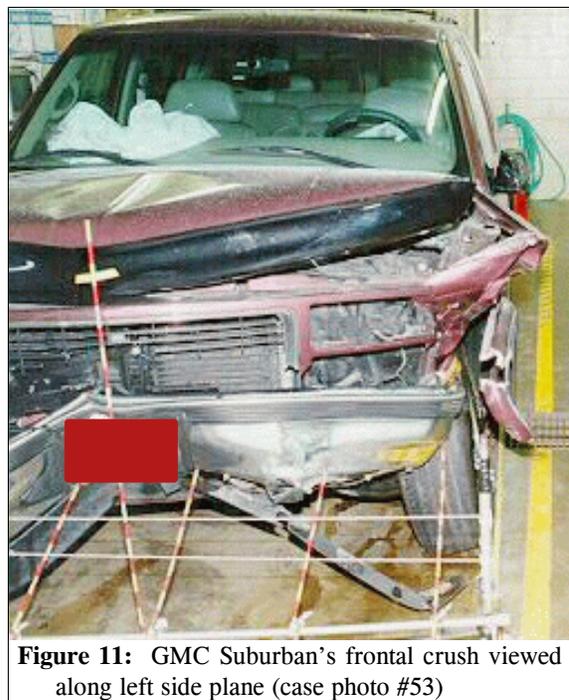
were directly damaged and crushed rearward. The case vehicle's left front tire was physically restricted, and the top of the tire was rotated inward from the crash (**Figure 11**). The right headlight and turn signal assemblies sustained induced damage as well as the left fender.

**Figure 11:** GMC Suburban's frontal crush viewed along left side plane (case photo #53)

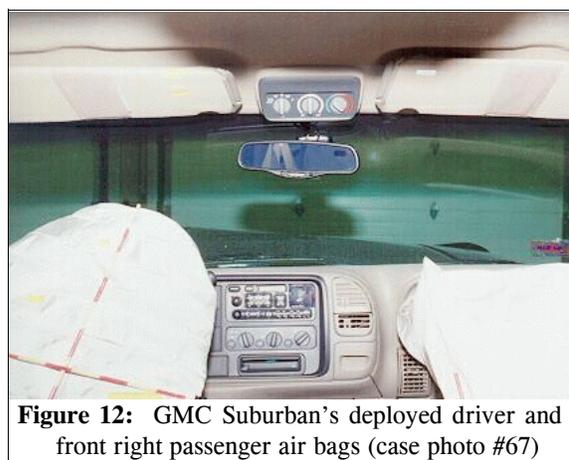
Inspection of the Suburban's interior revealed scratches on the steering wheel rim just to the left of top-center. Furthermore, cloth transfers were found on the left lower instrument panel, and a slight depression was detected to the right side of the driver's sun visor (**Figure 12**).

**Figure 12:** GMC Suburban's deployed driver and front right passenger air bags (case photo #67)

on the left lower quadrant, toward the center of the air bag, and near the center of the right lower quadrant (**Figures 12 and 13** above).

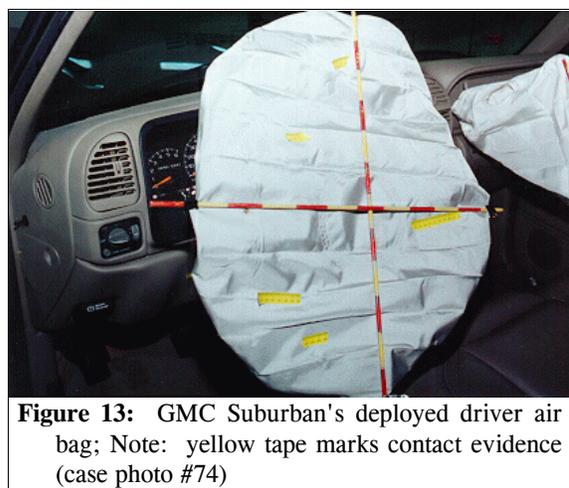
The Suburban's driver air bag was located in the steering wheel hub. An inspection of the air bag module's cover flaps and air bag revealed that the cover flaps opened at the designated tear points, and there was no evidence of damage during the deployment to the air bag or the cover flaps. The driver's air bag was designed with two tethers, each approximately 9 centimeter (3.5 inches) in width. The driver's air bag had two vent ports, approximately 2 centimeters (0.8 inches) in diameter, located at the 11 and 1 o'clock positions. The deployed driver's air bag was elliptical with a height of approximately 64 centimeters (25.2 inches) and a width of approximately 54 centimeters (21.3 inches). An inspection of the driver's air bag fabric revealed black scratch marks near the air bag's lower seam

**Figure 13:** GMC Suburban's deployed driver air bag; Note: yellow tape marks contact evidence (case photo #74)
