**TRANSPORTATION SCIENCES  
CRASH RESEARCH SECTION**

**CALSPAN ON-SITE AIR BAG/CHILD FATALITY INVESTIGATION  
CALSPAN CASE NO. CA98-035  
VEHICLE: 1995 MERCURY COUGAR  
LOCATION: KENTUCKY  
CRASH DATE: APRIL, 1998**

<p>14. <i>Sponsoring Agency Code</i></p>	
<p>15. <i>Supplementary Notes</i> On-site investigation of an air bag deployment death of a 9 year old child front right passenger in a 1995 Mercury Cougar.</p>			
<p>16. <i>Abstract</i> This on-site air bag deployment investigation focused on the death of a 9 year old female right front passenger of a 1995 Mercury Cougar. The Cougar was equipped with frontal air bags for the driver and right passenger positions. The front right area of the vehicle impacted a small deer which resulted in deployment of the frontal air bag system. The child passenger was probably improperly restrained by the manual 3-point lap and shoulder belt system which allowed her torso and head to pitch forward as a result of pre-crash braking. At impact, the child passenger was positioned within the deployment path of the front right passenger air bag. The expanding air bag contacted the child passenger's chest and anterior neck which resulted in abrasion

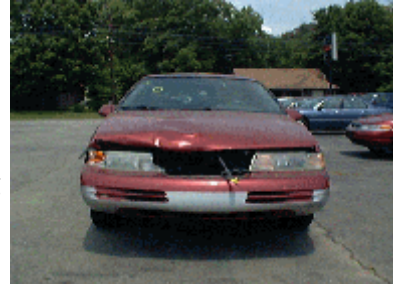
**Figure 1. Frontal damage to the Mercury Cougar.**

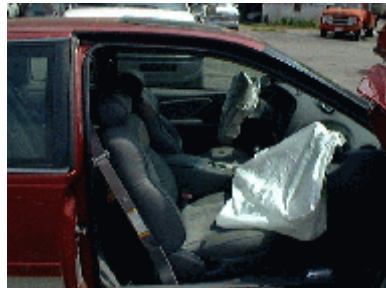
**Figure 2. Profile view of the child passenger's position and the deployed air bag.**

right passenger air bag (**Figure 2**).

The expanding air bag contacted the child passenger's chest and anterior neck which resulted in abrasions of the mid chest, anterior neck and chin, bilateral pneumothoraces, pneumomediastinum, a possible crush-type injury of the larynx, subluxation of C1 on C2, cerebral edema with midline shift to the right, and small left subdural hematoma. The child passenger was initially transported from the scene of the crash by ambulance to a local hospital where she was evaluated and prepared for air transfer to a children's trauma center. She was pronounced brain dead approximately 16 hours following the crash. All injuries were associated with deployment of the front right passenger air bag.

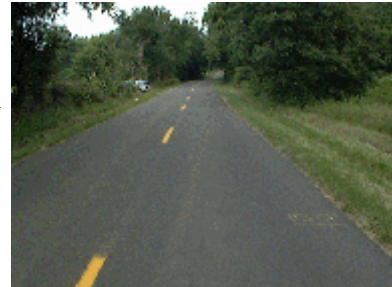
field (**Figure 3**). Two deer paths were evident in the wooded area which bordered the north side of the roadway and these paths were located opposite of the agricultural driveway. There were no surface defects noted in the area. At the time of the crash, the asphalt road surface was dry, with clear visibility, and the light conditions were police reported as daylight.

**Figure 3. Overall view of the Mercury's trajectory to the crash site.**

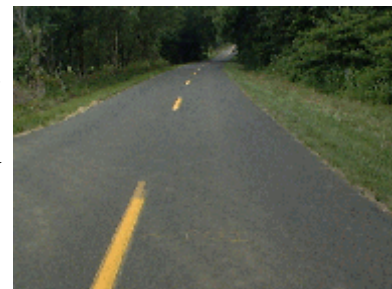
The front center and right area of the Mercury Cougar impacted the left side of the deer as the animal entered the westbound travel lane (**Figure 4**). The 12 o'clock direction of force impact resulted in an estimated velocity change of 5-8 km/h (3-5) mph. The impact fractured the plastic grille and deformed the leading edge of the hood of the Mercury. The rearward displacement of the fractured grille and the impact with the deer resulted in direct contact to the front right air bag crash sensor and mounting bracket. As a result of the impact induced deceleration and sensor contact, the supplemental frontal driver and passenger air bags deployed. The air bag system probably deployed late in the crash sequence due to the minor severity impact with the deer. The driver stated that at impact, she heard two distinct loud noises. The first was

**Figure 4. Point of impact with deer.**

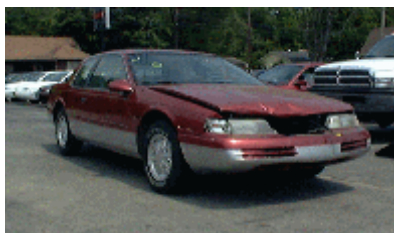
A front leg contact of the deer was noted to the lower aspect of the front bumper fascia, located 20.3 cm (8.0") right of center. A second rear leg contact was noted to the right corner area of the front fascia. This contact fractured the fascia and was evidenced by fur embedded into the fracture site. The contact began 68.8 cm (27.1") right of center and extended 9.5 cm (3.75") to the front right corner (**Figure 5**). There was no residual crush to the front bumper system. It should be noted that the bumper was supported by rigid convoluted brackets with no compressible energy absorbing units.

**Figure 5. Front right view of the impact damage.**

The grill and hood face areas of the Mercury Cougar impacted the left side of the deer as the vehicle continued in a forward direction. The impact fractured the plastic grille and dislodged the right headlamp/turn signal assembly. The grille was displaced into the front right air bag sensor and mounting

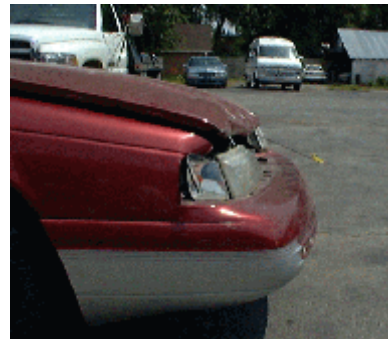
**Figure 6. Perpendicular view of the crush profile.**

The hood face was crushed as a result of engagement with the left side of the deer. The damage began 11.4 cm (4.5") left of center and extended 74.7 cm (29.4") to the right edge of the hood. Maximum residual crush at the hood face was 5.3 cm (2.1") located 20.3 cm (8.0") inboard of the right hood edge (**Figure 6**). Additional crush values at the hood face were as follows:

- at 15.2 cm (6.0") right of center, the hood face was crushed to a depth of 4.4 cm (1.75").
- at 25.1 cm (10") right of center, the hood face was crushed to a depth of 5.1 cm (2.0").
- at the right corner of the hood face, residual crush was 1.3 cm (0.5").
- the leading edge of the right front fender was crushed to a depth of 2.9 cm (1.125").

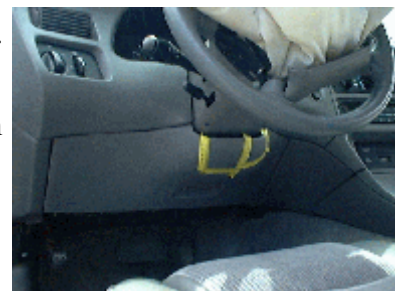
The driver's knees contacted the knee bolster which scuffed the bolster on each side of the steering column (**Figure 7**). The right knee scuff was located 29.2-33.0 cm (11.5-13.0") left of center and 31.8-34.9 cm (12.5-13.75") below the top surface of the instrument panel. The left knee scuff was located 38.1-43.2 cm (15.0-17.0") left of center and 31.1-35.6 cm (12.25-14.0") below the referenced panel. There was no deformation to the bolster panel.

**Figure 8. Driver knee contacts to the bolster.**

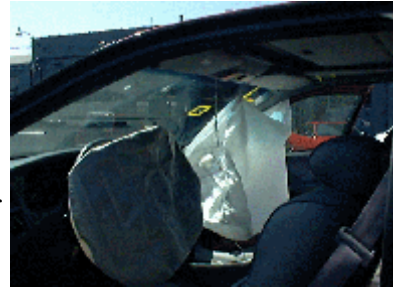
**Figure 8. Transfer/scuff mark on windshield.**

A vertically oriented scuff mark with tissue-like fragments located at the top and bottom areas of the scuff was located at the upper right quadrant of the windshield. The scuff mark was located 58.4-63.5 cm (23.0-25.0") right of center and 30.5-35.6 cm (12.0-14.0") above in instrument panel. The scuff appeared to be related to an upper extremity contact, however, no corresponding soft tissue injury was noted to the child passenger. It was also possible that the mark was a nasal expulsion from the child passenger as the air bag contacted her chest and neck areas.

A vertically oriented scuff mark was documented to the right upper quadrant of the windshield with tissue-like fragments at the bottom and top areas of the mark. This contact was possibly related to a right hand/forearm contact, however, there was no abrasion or injury documented to the upper extremity that was consistent with this transfer. A second possible scenario for this transfer was a nasal expulsion as the

air bag contacted the chest, anterior neck, and chin of the child passenger. The transfer did not resemble a spray-type deposit, but a contact with a body area.

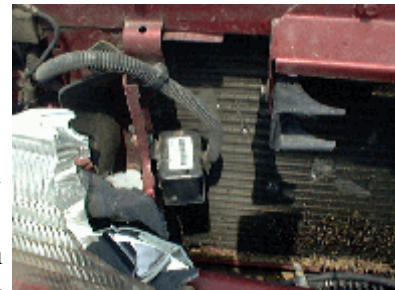
bracket. This contact, in combination with probable deer contact, rotated the sensor and mounting bracket approximately 5 degrees in a counterclockwise direction.

The crash sensors were mounted on brackets that were bolted to the forward aspect of the upper radiator support panel, located at the inboard edge of the headlamp assembly. The left crash sensor was identified by Ford part no. F5SB-14B005-AB with a bar coded identification number of \*8W32240230\*. This sensor was not damaged or displaced as a result of the deer impact. The right crash sensor was identified by part no. F5SB-14B004-AA. The bar coded identification number was \*8X33943101\*. The right crash sensor was contacted by displacement and fracturing of the plastic grille assembly that resulted from the impact with the deer. A wipe mark (area where road film was removed) was noted to the leading edge of the sensor and mounting bracket. As a result of the contact, the mounting bracket was rotated approximately 5 degrees in a counterclockwise direction (**Figure 9**). There was no residual damage to the crash sensor.

**Figure 9. Rotated right crash sensor.**

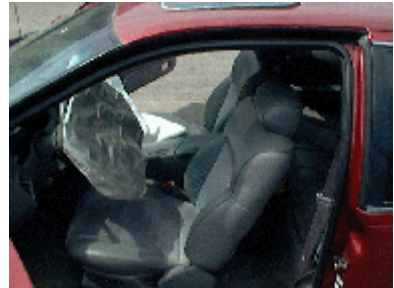
The front driver air bag (**Figure 10**) deployed as designed with no tears or perforations noted to the woven nylon-type fabric. The bag was constructed of two panels that were sewn with an internal peripheral seam. The overall width of the driver air bag in its deflated state was 64.8 cm (25.5"). The bag was tethered by four internal straps that were sewn to the face of the bag with a 17.1 cm (6.75") tether reinforcement. The tether straps were positioned at the 12 and 6 and 3 and 9 o'clock positions. Maximum rearward excursion of the driver bag was 27.9 cm (11.0") at the tether locations and 31.8 cm (12.5") at the center of the tether reinforcement. The driver bag was vented by two 1.3 cm (0.5") diameter ports that were located at the 11 and 1 o'clock sectors. The ports were centered 7.3 cm (2.875") inboard of the peripheral seam. There was no damage or occupant contact evidence on the driver bag.

**Figure 10. Profile view of the deployed front driver air bag.**

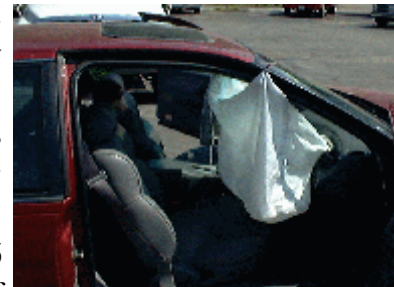
The front right passenger air bag (**Figure 11**) was mounted to the right instrument panel in a mid mount configuration. The module assembly consisted of two external cover flaps that were recessed 10.8 cm (4.25") forward of the protruding lower instrument panel. The upper flap was rigid by design which probably directed the deployment path of the air bag in an outward and downward direction. The horizontal width of the flap at the tear seam was 36.8 cm (14.5") with an overall height of 6.6 cm (2.6"). The acronym SRS was molded into the lower right corner of the upper flap. The lower front right air bag cover flap had a overall height of 8.3 cm (3.25") and was hinged at the bottom edge with a hinge width of 32.4 cm (12.75"). The flap tapered outward to the maximum width at the tear seam of 36.8 cm (14.5"). The thickness of the vinyl flap was approximately 4.8 mm (3/16"). The outer edges of the flap were bowed in an outward direction which deflected the center area inboard. There was no damage or contact evidence to the passenger cover flaps.

**Figure 11. Deployed front passenger air bag.**

The front right passenger air bag was constructed of a typical nylon-type fabric. The top panel of the bag was approximately 30.2 cm (11.875") in width at the inflator manifold and flared out to a maximum width of 86.4 cm (34.0") over a depth of 50.8 cm (20.0"). The face of the passenger air bag was 86.4 cm (34.0") in width and approximately 61.0 cm (24.0") in height in its deflated state. The bag was not tethered by internal straps and/or bands and was vented by a single port located on the inboard side of the bag at the 9 o'clock sector. The vent port was 7.0 cm (2.75") in diameter and was centered 25.4 cm (10.0") outboard of the module cover flaps. Maximum rearward excursion of the passenger bag was 82.6 cm (32.5") from the mid aspect of the cover flaps at the mid aspect of the bag and 57.2 cm (22.5") and the junction of the top panel and face of the bag. Both measurements were recorded with the bag in its fully deflated state. There was occupant contact evidence of the surface of the passenger air bag.
