CALSPAN ON-SITE AIR BAG NON-DEPLOYMENT INVESTIGATION

CALSPAN CASE NO. CA98-037

VEHICLE - 1995 FORD E350 CARGO VAN

CRASH DATE - JUNE, 1998

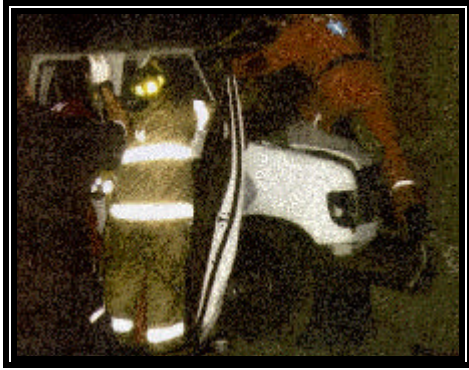
Figure 1: Right view of the Ford's final rest position.

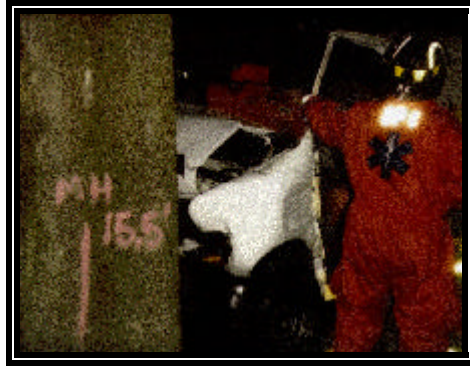
Figure 2: Left view of the Ford's final rest position.

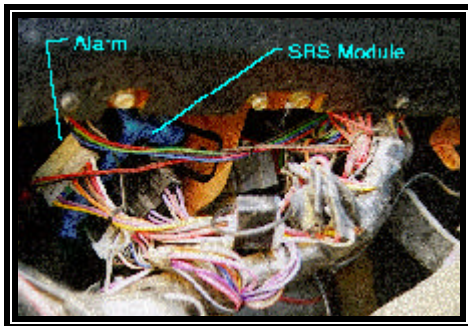
It was noted during the inspection that two after-market toggle switches and an alarm had been incorporated into the vehicle's electrical wiring. This necessitated a modification to the vehicle's interior electrical wiring, **Figure 3**. The function of the toggle switches was unknown. The alarm was mounted by double-sided tape to the enclosure of the SRS diagnostic module, **Figure 4**. Inspection of the (visible) wiring harness leading to and from the SRS control module was unremarkable. The SRS wiring appeared to be isolated and intact. The alarm and accessory wiring appeared to have been spliced into an adjacent wiring harness. The police investigator indicated a cellular phone was also in the vehicle at the time of the crash. It could not be determined if these modifications had any effect on the SRS performance.

Figure 3: View of the modified electrical wiring.

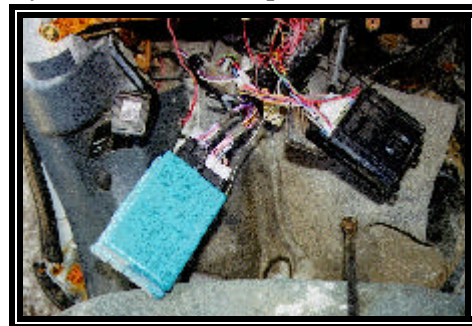
Figure 4: View of the SRS module and after-market alarm.

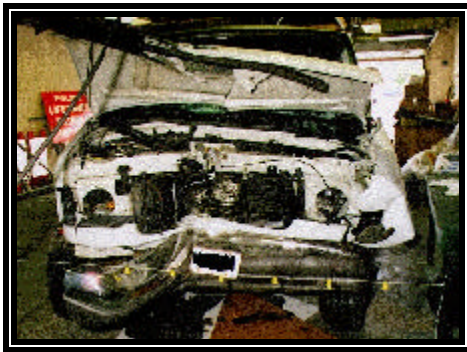
Figures 5 and 6 are the front and left lateral views of the Ford. The van sustained 100.3 cm (39.5 in) of direct contact damage to the center and left portions of the vehicle's front plane. The direct damage began 10 cm (4 in) right of center and extended to the left corner of the front bumper. The Field L used in the measurement of the crush profile was 114.3 cm (45.0 in). The crush profile of the front bumper was as follows: C1=50.2 cm (19.75 in), C2=55.9 cm (22.0 in), C3=58.4 cm (23.0 in), C4=58.4 cm (23.0 in), C5=57.8 cm (22.75 in), C6=0. The left and right front fenders buckled in the crash and restricted the operation of the front doors respectively. The left front door and right second door were removed during the extrication of the occupants. The Collision Deformation Classification (CDC) of the vehicle was 12-FYEW-4. The barrier equivalent delta V of the van calculated by the barrier model of the WINSMASH model was approximately 45 km/h (28 mph). The delta V of the vehicle was above the SRS deployment threshold.

Figure 5: Front view of the 1995 Ford E350 cargo van.

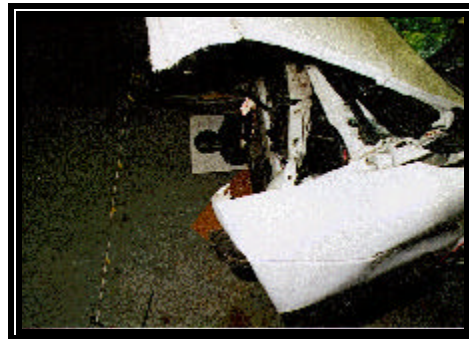
Figure 6: Left lateral view across the damaged frontal plane.

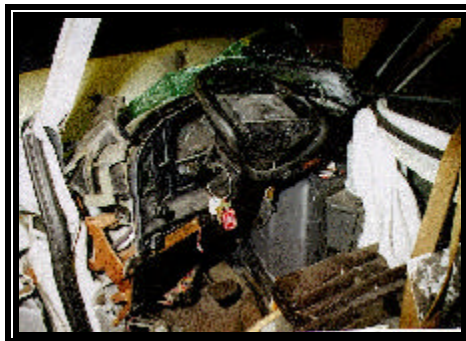
At inspection, the steering wheel was rotated 180 degrees and the upper rim was deformed forward and in contact with the steering column, **Figure 7**. The rim deformation was a result of loading from the driver's abdomen.

Figure 7: View of the steering wheel rim deformation.
