**CALSPAN ON-SITE VEHICLE ROLLOVER INVESTIGATION  
CALSPAN CASE NO. CA98-041  
VEHICLE: 1998 MERCEDES-BENZ ML 320  
LOCATION: ALABAMA  
CRASH DATE: JULY, 1998**

Contract No.  
DTNH22-94-D-07058

| 4. <i>Title and Subtitle</i><br>Calspan On-Site Rollover Investigation<br>Vehicle: 1998 Mercedes-Benz ML 320<br>Location: Alabama | | 5. <i>Report Date:</i><br>September, 1999 | |

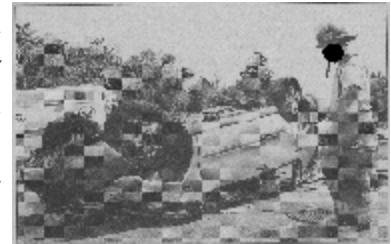
**Figure 1.** On-scene photograph of the Mercedes-Benz at final rest

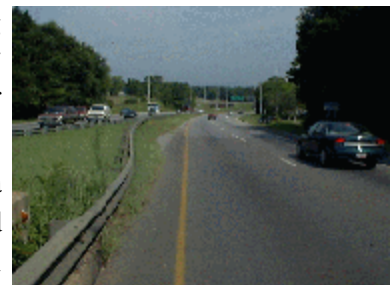
The crash occurred on an urban four lane divided arterial (**Figure 2**) during daylight hours in a posted 80 km/h (50 mph) speed zone. In the vicinity of the rollover, the asphalt travel lanes curved to the right with a radius of curvature of 762 m (2500') and a 3 percent negative grade relative to the ML320's direction of travel. The inboard travel lane was bordered by a 0.8 (2'8") asphalt shoulder with a mountable curb bordering the inboard edge of the shoulder. The grass median was 6.3 m (20'8") in width with a W-beam guardrail median barrier. The outboard shoulder was 2.5 m (8'3") in width. The conditions were police reported as overcast and dry.

**Figure 2.** Overall view of the crash site.

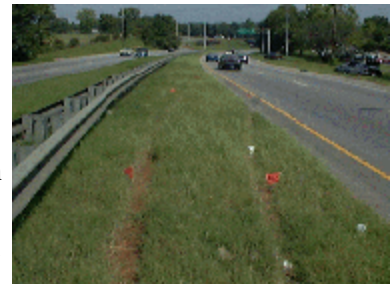
**Figure 3. Left side yaw marks on the grass median.**

The left side tire marks of the Mercedes-Benz ML320 identified the trajectory of the vehicle. The left rear tire mark was 29.3 m (96.0') in length which terminated at the mid point of the grass median at the on-set of the lateral rollover. The left front tire mark was 26.8 m (88.0') in length which arced back onto the asphalt surface of the roadway. The left front tire of the vehicle traversed the top surface of the mountable curb and contacted the asphalt shoulder surface (**Figure 4**). The high coefficient of friction surface acting on the laterally skidding tire surface resulted in the

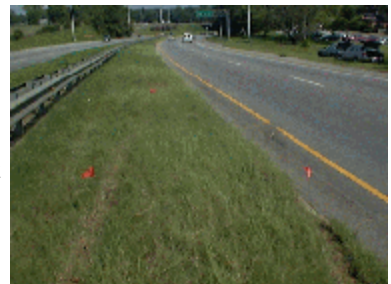
**Figure 4. Left front tire traverses curb and re-enters paved surface.**

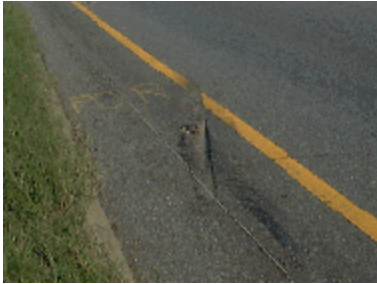
sidewall of the tire partially folding under the alloy wheel. The outer aspect of the alloy wheel tire bead contacted and gouged the asphalt surface. The gouge from the left front wheel was 0.8 m (2'9") in length and 12.7 cm (5.0") in width with a maximum depth of approximately 2.5 cm (1.0"). Refer to **Figures 5 and 6**. Fragments of the removed asphalt compound were embedded into the outer aspect of the wheel (**Figure 7**). It should be noted, however, that the left front tire did not air out and remained inflated to a post-crash measured pressure of 30 psi.

**Figure 5. Left front wheel gouge in the asphalt shoulder.**

As a result of the wheel gouging the asphalt shoulder surface, the ML320 was tripped into a lateral side-over-side rollover, leading with its left side. At the on-set of the rollover, the ML320 had rotated approximately 40 degrees in a clockwise direction over the longitudinal distance of 29.3 m (96.0'). As the vehicle initiated the lateral rollover, the left front wheel continued to mark on the asphalt surface. An aluminum transfer extended 0.3 m (1.0') beyond the gouge created by the left front wheel (**Figure 6**). The left rear quarter panel area of the vehicle gouged the grass median on the first quarter roll. The large gouge mark (area where the grass had been removed by the vehicle) on the median was located 2.4-5.5.m (8.0-18.0') past the termination point of the left rear tire mark. The overall width of the median gouge was approximately 1.1 m (3'6").

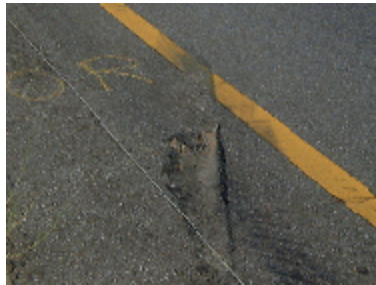
**Figure 6.. Close-up view of the wheel gouge.**

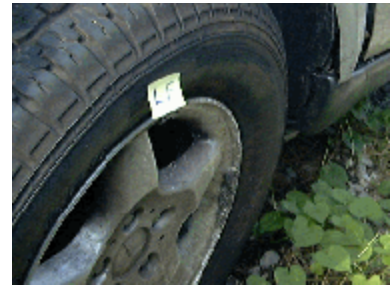
**Figure 7. Asphalt embedded into the bead of the left front alloy wheel**

over a 340 degree area. A 10.8 cm (4.25") length by 2.5 cm (1.0") width of asphalt was embedded into the outer bead area of the alloy wheel. This resulted from the lateral skidding of the vehicle on the asphalt at the trip point of the rollover. The CDC for this wheel contact was 11-RFWN-2. It should be noted that the left front tire was not aired out and the pressure was recorded at 30 psi. There was no damage to the right front tire or the alloy wheel.

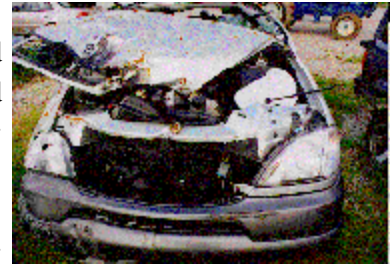
rubber transfers were noted at the leading edge of the bumper fascia. The outboard transfer was located 66-74.3 cm (26-29.25") left and center while the more prominent inboard transfer was located 21.3-49.5 cm (8.4-19.5") left of center. An additional transfer was located on the inboard aspect of the left headlamp lens.

The black transfer extended onto the hood face of the Mercedes-Benz (**Figure 8**). The transfer began 6.4 cm (2.5") right of center and extended 41.3 cm (16.25") left of center. At the mid point of the transfer, it extended 29.2 cm (11.5") vertically onto the apex of the hood face. The transfer bordered the sheetmetal at the left surround for the plastic grille assembly which was fractured during the crash. An additional yellow paint transfer was noted to the vertical aspect of the right hood face. The transfer probably resulted from contact with a marking on the rear of the struck semi-trailer. The Collision Deformation Classification (CDC) was for this initial impact was 12FYEW-1.

**Figure 8. Frontal damage**

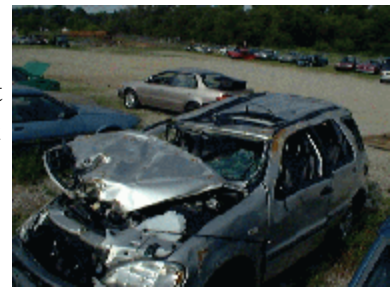
The subsequent rollover resulted in severe damage to the roof area of the vehicle with direct contact and residual crush resulting to all body panels with the exception of the rear liftgate door (**Figure 9**). The initial contact (first quarter roll) involved the left side of the vehicle against the grass/dirt median and the asphalt road surface. The left rear quarter panel was dented with dirt embedded into the trim panel at the rear quarter window from the median contact. The fuel filler door was separated, however, the fuel cap remained intact and there was no fuel leakage. The left rear door was crushed to a depth of 2.5 cm (1.0") at the mid forward third area of the panel. Faint abrasions were present on the door surface, rub strip, and the window frame was crushed and abraded. The left rear door handle was fractured from the door and found on the median at the crash scene. The left front door was abraded superficially on the rub strip with several abrasions located on the door panel below the rub strip. The rear view mirror was fractured and compressed into the door panel which crushed the mid aspect of the door to a depth of 2.5 cm (1.0"). The left front door window frame was heavily abraded and crushed in a downward direction. Vertically oriented abrasions were noted to the left front fender at the forward aspect and at the wheel opening. The left side surface of the front bumper fascia was abraded from contact against the asphalt road surface.

**Figure 9. Left front three-quarter view of the rollover damage.**

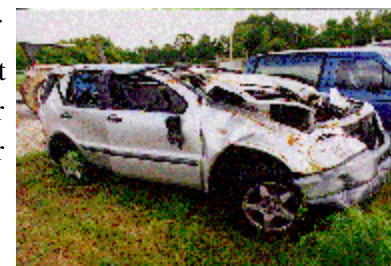
The right side of the ML320 sustained minor damage that consisted of isolated dents to the doors and quarter panel. There was no direct contact damage to the right rear quarter panel. The right side rear view mirror mounting bracket fractured from ground contact during the rollover sequence.

**Figure 10. Right side view of the rollover damage.**

The top surface of the roof and hood sustained severe damage during the rollover (**Figure 10**). The direct contact damage on the roof extended

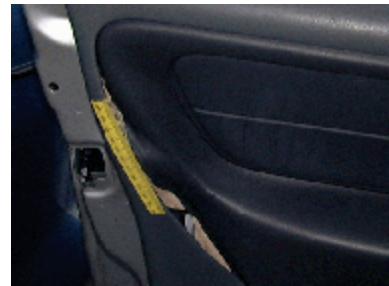
The driver's left hip area contacted the left door panel/armrest during the rollover sequence that resulted in a 3.2 cm (1.25") separation of the panels of the interior door surface (**Figure 11**). Although no scuff was noted to the panel, the separation was in an outward direction indicative of occupant loading. Several stands of hair were noted to the headliner over the driver's seated position. The hair strands were adhered to the fabric headliner between the sunroof and the siderail. The driver loaded the manual seat belt system during the rollover. There was no damage to the system components. Several fabric fibers were observed embedded into the shoulder belt webbing in the area of the driver's thoracic region. Numerous blood stains from the driver's right hand laceration were noted to the headliner of the vehicle that resulted post-crash as she exited the Mercedes-Benz through the rear liftgate area..

**Figure 11. Driver's left hip contact to the left front door panel.**

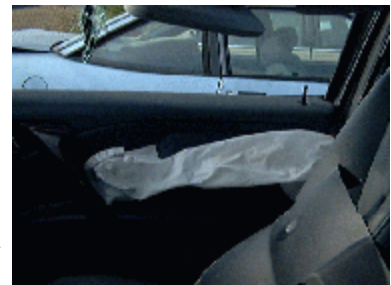
The door mounted side impact air bag (**Figure 12**) was concealed within two nearly symmetrical module cover flaps in the upper rear aspect of the front door panels. The units were identified by SRS AIRBAG molded into the lower right aspect of the upper module cover flap. The flaps were 24.1 cm (9.5") in width at the horizontal tear seam and 7.0 cm (2.75") in height. The bag membrane was constructed of a typical nylon-type fabric that was 50.9 cm (20.0") in length and 25.4 cm (10.0") in height. The bag was not vented into the passenger compartment. An internal tether limited the inward (lateral) excursion of the bag. The tether was sewn to the face of the bag with a 21.1 cm (4.75") horizontal stitch pattern located at the mid point of the bag.

**Figure 12. Deployed right side impact air bag.**

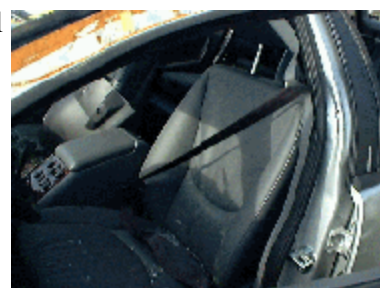
The driver of the 1998 Mercedes-Benz ML320 was seated in a normal driving posture with the power seat track adjusted to a rear track position. The track position was 1.3 cm (0.5") forward of the full rear position and 16.5 cm (6.5") rearward of the full forward position. The seat back was slightly reclined from the vertical position. The driver was properly restrained by the manual belt system (**Figure 13**). Belt usage was confirmed by clothing fabric fibers that were embedded into the shoulder belt webbing, the lack of driver contact points within the vehicle, and driver statements. In addition, the driver would have probably been ejected from the vehicle, if unrestrained, during the multiple rollover event.

**Figure 13. View of the driver’s seat position and the manual belt system.**

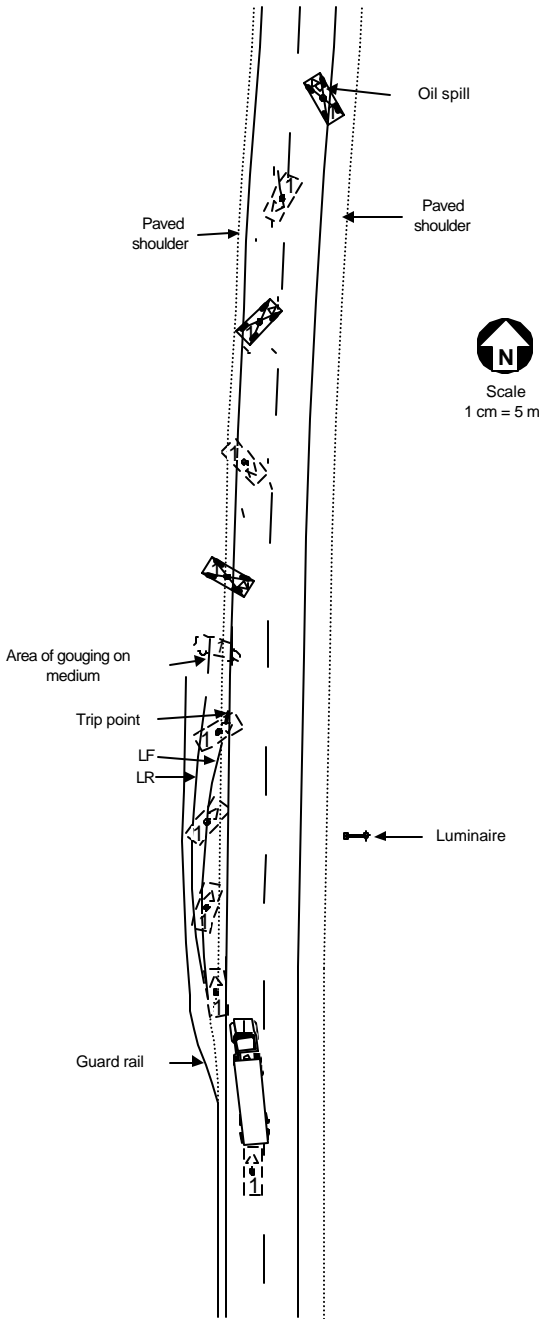
**Figure 14. Crash Schematic**

The first gouge on the asphalt road surface from left side contact was located 4.8 m (15'9") north of the trip point adjacent to the inboard yellow edge line. The Mercedes-Benz continued to roll on a lateral trajectory, completing 10 quarter rolls before coming to rest on its roof approximately 61 m (200') north of the trip point. The quarter turns were identified by fifteen (15) gouge marks in the asphalt road surface over the longitudinal trajectory of the vehicle. Final rest was identified by a oil fluid spill in the outboard northbound travel lane. At rest, the vehicle was on its roof facing in a northerly direction diagonal to the travel lanes. The Crash Schematic is attached as **Figure 14**.
