**VERIDIAN ON-SITE AIR BAG RELATED
CHILD DRIVER FATALITY INVESTIGATION
VERIDIAN CASE NO. CA98-042
VEHICLE: 1994 MERCURY SABLE STATION WAGON
LOCATION: PENNSYLVANIA
CRASH DATE: JULY 1998**

<p>14. <i>Sponsoring Agency Code</i></p>	
<p>15. <i>Supplementary Notes</i> On-site investigation of an air bag deployment crash that resulted in the death of a 7 year old male child driver.</p>			
<p>16. <i>Abstract</i> This on-site crash investigation focused on the injuries and injury mechanisms that resulted in the death of a 7 year old male who entered the family's 1994 Mercury Sable station wagon and deliberately drove the vehicle from the residence. The Sable was equipped with frontal air bags for the driver and right passenger positions. The child driver drove the vehicle approximately 150 m (500') from a parked position at roadside and negotiated a left curve with a downgrade. As he approached a 3-leg T intersection, the Sable drifted to the left and impacted a tree with the front right area of the vehicle. The moderate severity crash deployed the vehicle's frontal driver and right passenger air bag systems. The child driver was positioned within a close proximity to the steering assembly

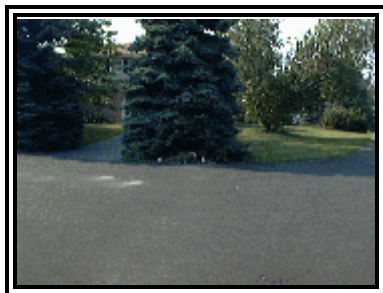
Figure 1. Stuck spruce tree.

The Mercury Sable departed the northwest corner of the intersection and penetrated the lower branches of a spruce tree which shielded the trunk of the tree from view. The front right area of the vehicle subsequently impacted the trunk of the tree that was 25 cm (10") in diameter. The trajectory algorithm of the WinSMASH program computed an impact speed of 19.7 km/h (12.2 mph) for the Mercury Sable. The 12 o'clock direction of force impact crushed the front bumper to a maximum depth of 15.9 cm (6.25") (**Figure 4**) which resulted in a WinSMASH generated velocity change of 17.9 km/h (11.1 mph) with a longitudinal component of -17.9 km/h (-11.1 mph). The impact induced deceleration was sufficient to deploy the Sable's frontal air bag system. The vehicle came to rest engaged against the struck tree with the ignition in the on-position and the engine stalled. The investigating officer noted during a post-crash inspection of the vehicle that the emergency fuel cut-off switch was not tripped.

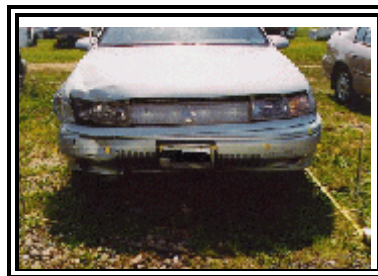
Figure 2. Front right damage resulting from the tree impact.

Components damaged by the crash included the front bumper fascia and reinforcement beam, right headlamp assembly, grille, hood face, and the right front fender. Superficial sideswipe-type damage extended the full length of the right side of the vehicle, however, the damage was not associated with this event.

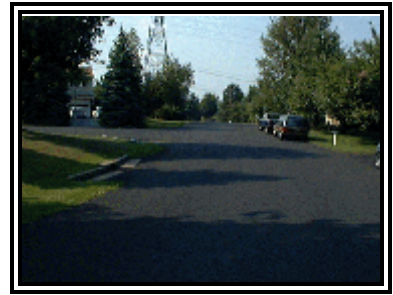
Figure 3. Trajectory of the Mercury Sable.

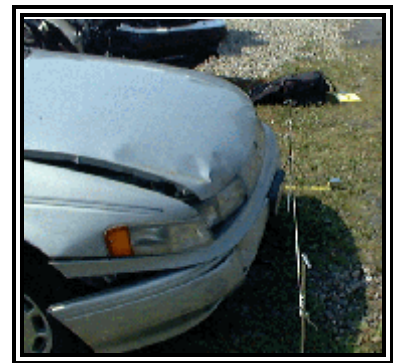
Figure 4. Profile view documenting the crush profile.

bumper corner. Direct damage on the hood face and grille began 21.6 cm (8 . 5 ") right of center and extended 69.9 cm (27.5") to the right corner. The specific damage that resulted from the trunk of the tree began 41.9 cm (16.5") right of center and extended 24.8 cm (9.75") to the right. The combined induced and direct contact damage was 142.2 cm (56.0") which involved the full width of the bumper system. The crush profile was documented at bumper level and was as follows: C1= 0 cm, C2 = 1.9 cm (0.75"), C3 = 5.6 cm (2.2"), C4 = 9.5 cm (3.75"), C5 = 14.2 cm (5.6"), C6 = 15.2 cm (6.0"). The Collision Deformation Classification (CDC) for the tree trunk impact sequence was 12-FREN-1.

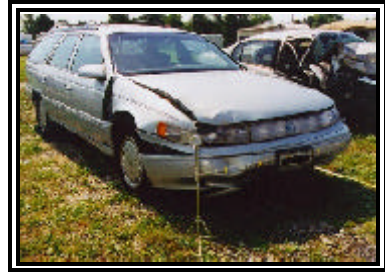
The 1994 Mercury Sable station wagon sustained moderate frontal damage as a result of the impact sequence with the tree. Maximum crush was 15.9 cm (6.25") located on the front bumper fascia 51.4 cm (20.25") right of center (**Figure 5**). The direct contact damage consisted of abrasions and transfers from both the trunk of the struck tree and the lower branches which extended to the ground. The direct contact damage on the fascia began 13.3 cm (5.25") right of center and extended 69.9 cm (27.5") to the right

Figure 5. Damage to the front right area of the Sable.

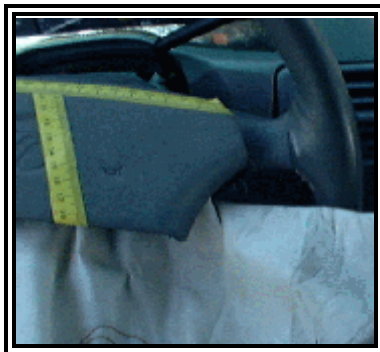
The child driver was positioned within a close proximity to the steering assembly as the vehicle impacted the tree. The upper cover flap of the front left (driver) air bag module contacted the child's anterior neck and chin areas which resulted in a large tissue transfer to the cover flap (**Figure 6**). The transfer was located on the lower right corner of the cover flap. His forward position impeded the deployment path of the expanding air bag membrane. As a result, the bag expanded against the interior surfaces of the module assembly which produced black/gray vinyl transfers to the top, right

Figure 6. Tissue transfer on the upper cover flap.

At impact, the child's face was positioned within a close proximity to the steering wheel mounted driver air bag module cover. As the frontal air bag system deployed, the asymmetrical module cover flaps opened at the designated seams. The right aspect of the upper module cover flap contacted the child driver under the chin area which resulted in a large tissue transfer on the flap. The investigating officer noted the child

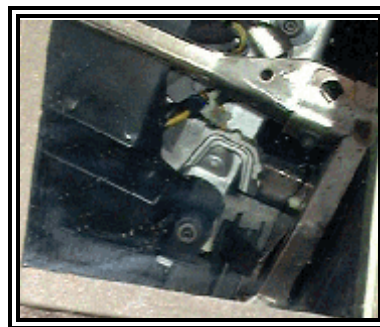
Figure 7. Shear capsule separation.

The child driver's forward trajectory in response to the frontal impact force in combination with air bag expansion against his body resulted in compression of the energy absorbing steering column. The shear capsules were completely separated with 4.1 cm (1.625") of left separation and 4.4 cm (1.75") of right bracket displacement (**Figure 7**). There was no deformation to the steering wheel.

The forward position of the child driver, in combination with the deployment of the driver air bag against his body and his response to the 12 o'clock impact force, resulted in compression of the energy absorbing steering column. The shear capsule brackets were separated from the stationary blocks 4.1 cm (1.625") on the left and 4.4 cm (1.75") on the right. This compression resulted in complete separation of the shear bracket assemblies.

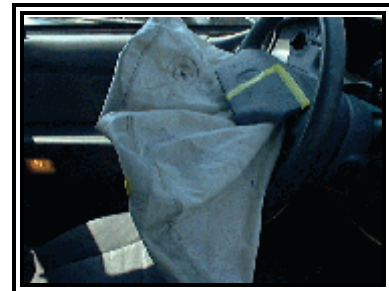
The expanding air bag within the module assembly resulted in a large area of black/gray vinyl transfers to the right side area of the bag (**Figure 8**). The transfer pattern was approximately 40.6 cm (16.0") vertically and 24.1 cm (9.5") horizontally. A second area of less pronounced vinyl transfers were located on the left side of the forward panel of the driver air bag. This transfer pattern measured 22.9 cm (9.0") vertically and 17.8 cm (7.0") horizontally. A third area of vinyl transfers was located on the upper right quadrant of the face of the bag. The transfers began 2.5 cm (1.0") right of the vertical center line and extended 17.8 cm (7.0") to the right. The pattern began 1.3 cm (0.5") above the horizontal center line and extended upward 19.1 cm (7.5").

Figure 8. Vinyl transfers on the right side of the front left air bag.

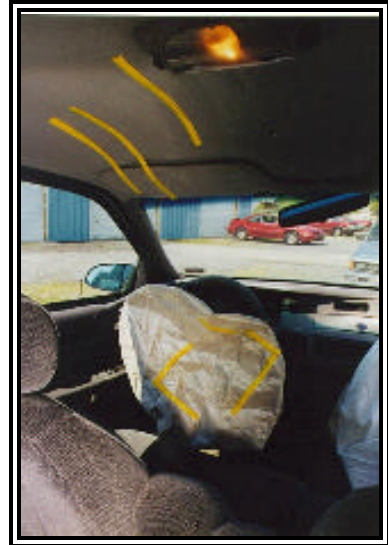
The continued expansion of the driver air bag membrane displaced the child driver in an upward and rearward direction (**Figure 9**) into the headliner. Scuff marks on the headliner evidence his displacement by the expanding driver's air bag. He came to rest in a slumped seated position in the driver's seat with his back resting against the seat back.

Figure 9. Vertical and rearward displacement of the child driver.

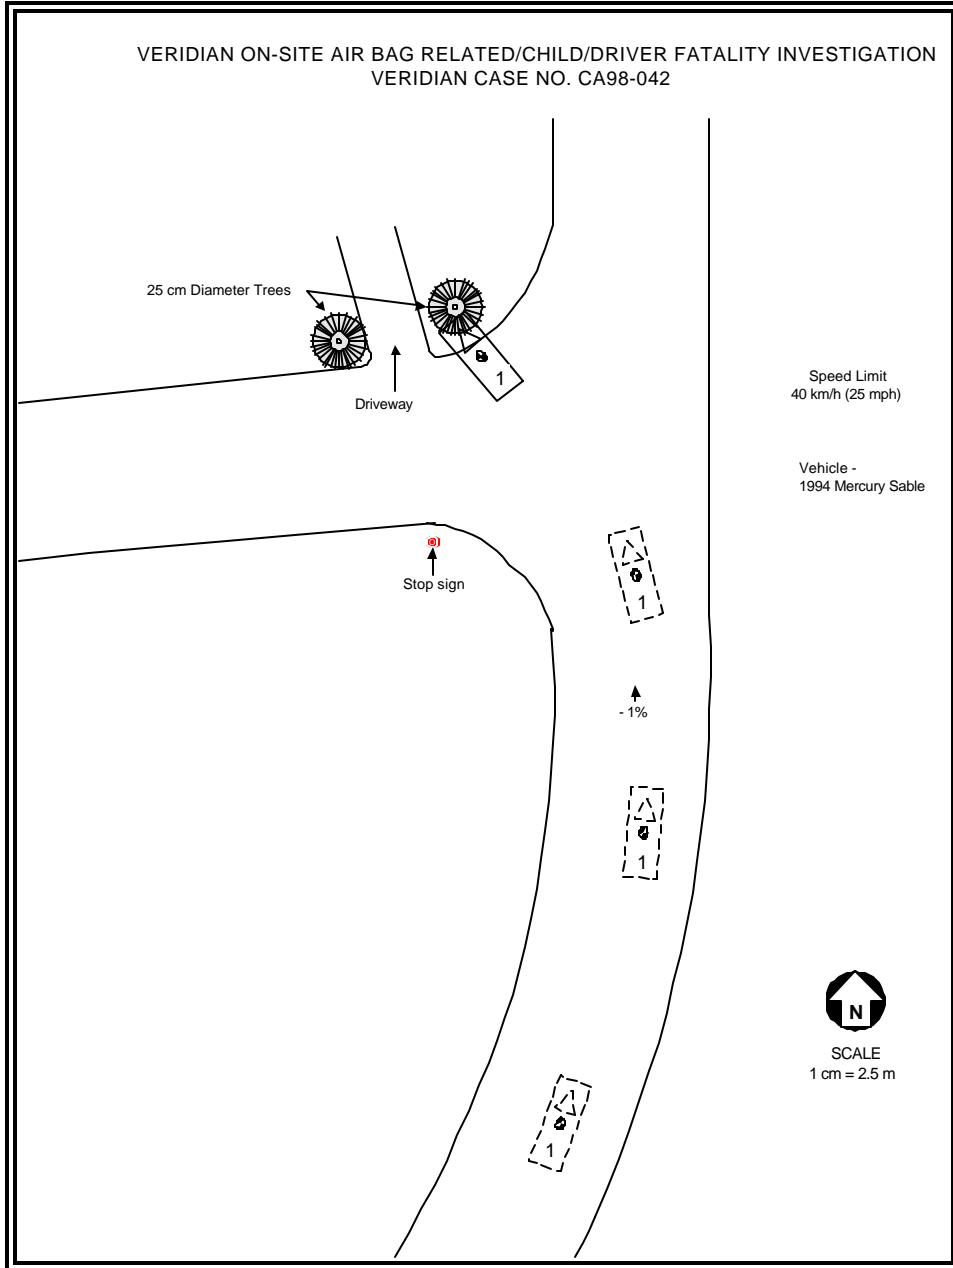
Figure 10. Crash Schematic

The child driver maneuvered the Mercury Sable onto the travel lanes of the local residential street. **Figure 10** is the schematic of the crash scene. He successfully negotiated a moderate left curve as the vehicle was accelerated by the one percent negative grade. The child drove the vehicle approximately 150 m (500') narrowly avoiding several parked vehicles on the sides of the street (**Figure 3**). As he approached the 3-leg T intersection, his intentions were unknown as to turning left at the intersection or proceeding straight ahead. The vehicle subsequently drifted across the mouth of the intersection and departed the northwest corner of the intersection. It should be noted that the 16 year old sister and her friend observed the Mercury Sable pass them as they walked along the edge of the road in a northerly direction. They attempted to run after the vehicle, however, were unsuccessful in catching up to it.
