**VERIDIAN REMOTE AIR BAG RELATED
DRIVER FATALITY INVESTIGATION
VERIDIAN CASE NO. CA98-051
VEHICLE: 1992 LINCOLN CONTINENTAL
LOCATION: VIRGINIA
CRASH DATE: FEBRUARY 1996**

<p>1. <i>Report No.</i> CA98-051</p>	<p>2. <i>Government Accession No.</i></p>	<p>3. <i>Recipient's Catalog No.</i></p>	
<p>4. <i>Title and Subtitle</i> Veridian Remote Air Bag Related Driver Fatality Investigation Vehicle: 1992 Lincoln Continental Location: Virginia</p>		<p>5. <i>Report Date:</i> March 2001</p>	
		<p>6. <i>Performing Organization Code</i></p>	
<p>7. <i>Author(s)</i> Crash Data Research Center</p>		<p>8. <i>Performing Organization Report No.</i></p>	
<p>9. <i>Performing Organization Name and Address</i> Transportation Sciences Crash Data Research Center Veridian Engineering P.O. Box 400 Buffalo, New York 14225</p>		<p>10. <i>Work Unit No.</i> C01115.0000.(8770-8779)</p>	
		<p>11. <i>Contract or Grant No.</i> DTNH22-94-D-07058</p>	
<p>12. <i>Sponsoring Agency Name and Address</i> U.S. Department of Transportation National Highway Traffic Safety Administration Washington, D.C. 20590</p>		<p>13. <i>Type of Report and Period Covered</i> Technical Report Crash Date: February 1996</p>

VERIDIAN REMOTE

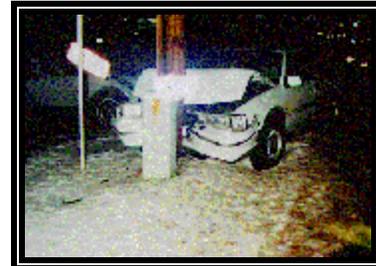
This remote investigation focused on the death of a 86 year old male driver of a 1992 Lincoln Continental that was involved in an off-road, center frontal impact with a utility pole (**Figure 1**). The Lincoln was equipped with frontal air bags for the driver and right passenger positions that deployed as a result of the crash. The driver of the Lincoln sustained a laceration of the upper lip, a contusion of the right upper chest, an abrasion of the left lateral neck, bilateral rib fractures 3-6 with a bilateral hemothorax, a rupture of the superior vena cava, and lacerations of the liver. The first EMT responding to this call arrived on-scene within minutes of the time of the crash. He noted that the Lincoln driver was discolored and appeared to be dead at the time of his arrival. The driver was transported to a local hospital where he was pronounced dead approximately 50 minutes after the crash.

Figure 1. Final rest position of Lincoln Continental.

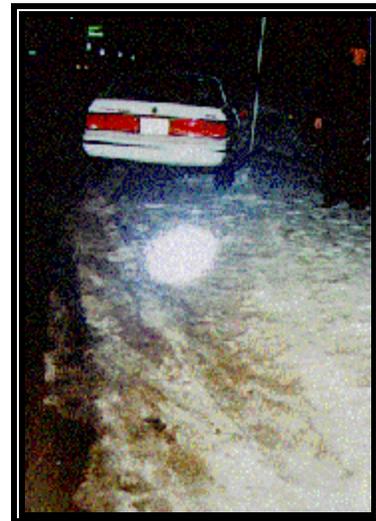
the outboard travel lane. After entering the outboard lane, the driver did not initiate corrective steering input to remain in the outboard travel lane. The Lincoln continued in a south southwesterly direction and exited the right (west) edge of the roadway. Free rolling tire prints (**Figure 2**) in the snow on the west shoulder of the roadway indicated that the Lincoln driver did not initiate steering or braking inputs between the point of roadway departure and the point of impact. (NOTE: The autopsy report indicated that the driver had coronary arteriosclerosis and arterial nephrosclerosis. After completing the autopsy, the Medical Examiner informed the investigating officer that the driver could have experienced a pre-crash heart related episode which caused him to relinquish steering control.)

Figure 2. Off-road trajectory of Lincoln.

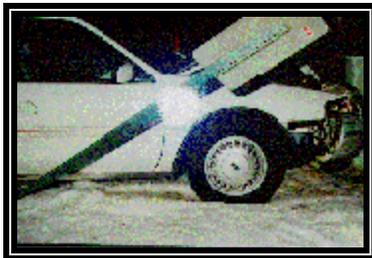
After departing the roadway, the Lincoln traveled approximately 18.6 m (61') to impact. The right side of the Lincoln initially struck a bus stop sign. This impact bent the sign post in a southwesterly direction (**Figure 3**). The center frontal area of the Lincoln then struck a wooden utility pole that was located a short distance outboard of the west shoulder (**Figure 4**). The resultant direction of force for this impact was 12 o'clock and the velocity change experienced by the Lincoln was visually estimated to be in the 22-29 km/h (14-18 mph) range. As a result of the center frontal impact sequence, the frontal air bag system deployed. The Lincoln came to rest engaged against the utility pole facing in a south southwesterly direction.

Figure 3. Sign post struck by Lincoln.

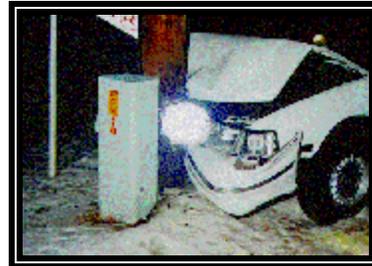
Figure 4. Frontal damage sustained by Lincoln.

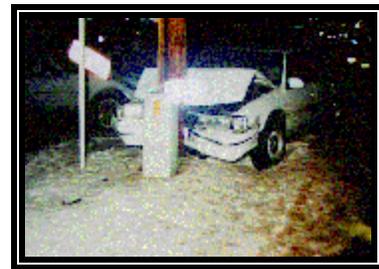
Exterior damage to the Lincoln was moderate in severity and was associated primarily with the center frontal impact with the utility pole (**Figure 5**). Damaged components included the front bumper, grille, both headlight assemblies, the radiator and radiator support panel, the hood, and the forward portion of both front fenders. The direction of force for this impact was 12 o'clock with a Collision Deformation Classification (CDC) of 12-FCEN-2. A maximum frontal crush value was estimated to be 30-36 cm (12-14") in the vicinity of the vehicle's centerline. The change in velocity resulting from this damage was estimated to be in the 23-29 km/h (14-18 mph) range. Green paint transfers were noted to the right side of the front bumper and the right front fender. These paint transfers were associated with the initial impact with the bus stop sign post. The estimated CDC for this initial impact event was 12-RYES-1.

Figure 5. Frontal damage sustained by Lincoln.

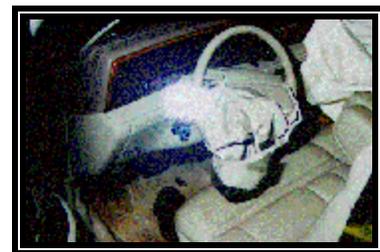
When the Lincoln was inspected by the investigating officer after the crash, the driver's seat was found to be in a forward seat track position. In this position, the Lincoln driver would have been located in a close proximity to the steering wheel and driver air bag module. On-scene photographs (**Figure 6**), verified that the driver was contacted by the upper flap of the driver's air module, as that module deployed. The contact produced a vertically oriented abrasion of the lower right portion of the flap. (NOTE: The full width of the flap was

Figure 6. Deployed driver's air bag module.

not visible in available photographs. It is possible that the noted contact could have extended further to the left across the flap.) In addition, damage was noted to the lower peripheral seam of the driver's bag (seam appeared to be torn), indicating that the bag was heavily loaded as it expanded. Again, available photographs were not sufficiently clear to determine if the steering wheel rim was back-loaded and deformed, as a result of the air bag attempting to inflate against a closely positioned driver.

The driver air bag module was mounted in a 2-spoke steering wheel rim. This installation utilized asymmetrical module cover flaps with the upper flap being much larger than the lower flap. A vertically oriented abrasion pattern was visible on the lower right portion of the upper flap. This pattern indicated that the module flap struck the driver's chest as it swung upward during the deployment sequence.

The driver was also contacted by the expanding air bag. Damage was noted to the lower peripheral seam of the air bag. Specifically, the seam appeared to have torn and partially separated. It is believed that this damage is an indicator that the close proximity of the driver to the steering wheel interfered with normal bag inflation. The quality and range of on-scene photographs was insufficient to determine if back-loading of the steering wheel rim during the inflation sequence resulted in deformation of the rim. Virtually all of the driver's reported injuries were associated with being contacted by either the air bag module flap or the expanding air bag.

It appeared that the air bag's inflation pattern may have been impeded due to the driver's relatively close proximity to the steering wheel. Specifically, the bottom portion of the peripheral seam was partially ruptured during the inflation sequence. Available photographs were insufficient to determine if the steering wheel rim was deformed by back-loading from the air bag during the deployment.
