**VERIDIAN ON-SITE FAIL-TO-DEPLOY INVESTIGATION
VERIDIAN CASE NO. CA98-60
VEHICLE: 1998 HONDA CIVIC EX
LOCATION: PENNSYLVANIA
CRASH DATE: OCTOBER, 1998**

1. <i>Report No.</i> CA98-60	2. <i>Government Accession No.</i>	3. <i>Recipient's Catalog No.</i>	
4. <i>Title and Subtitle</i> Veridian On-Site Fail-To-Deploy Investigation Vehicle: 1998 Honda Civic EX Location: Pennsylvania		5. <i>Report Date:</i> July, 1999

14. <i>Sponsoring Agency Code</i>	
15. <i>Supplementary Notes</i> On-site investigation of a severe run-off-road crash with tree that failed to deploy the frontal air bag system in a 1998 Honda Civic EX.

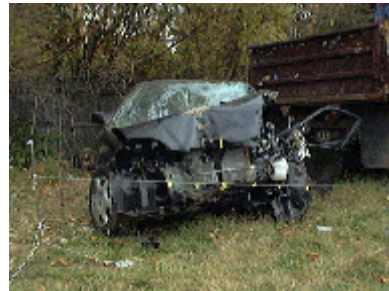
Figure 2. Frontal view of the impact damage to the 1998 Honda Civic.

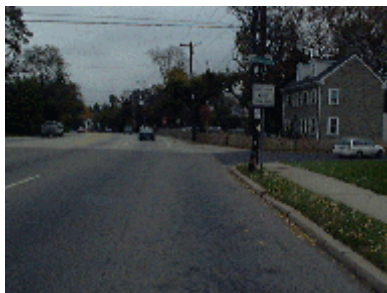
The front of the Honda struck and penetrated a wooden picket fence located 0.6 m (2.0') outboard of the west edge of the turning apron (**Figure 4**). The direction of force for this impact was 12 o'clock. While penetrating through the fence, the Honda sheared off two 10x10 cm (4x4") support posts which anchored the fence. After penetrating through the fence, the center frontal area of the vehicle struck and sheared a utility pole guy wire (**Figure 5**) that was anchored into the ground 1 m (3.3') inside of the fenced area.

Figure 4. Overall view of the crash site.

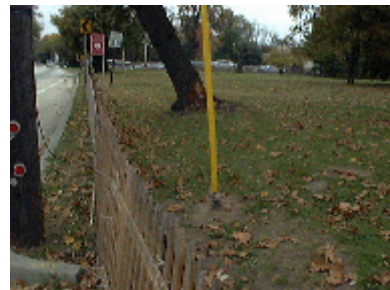
Figure 5. Struck guy wire and tree.

Following the second impact, the Honda continued in a northerly direction in a tracking altitude for a distance of approximately 7 m (23') where its left frontal area impacted a large tree (**Figure 5**) that was 68.6 cm (27.0") in diameter. The direction of force for this third impact was, again, 12 o'clock. The vehicle's impact speed was computed at 67.8 km/h (42.1 mph). The associated total and longitudinal delta V was computed at 60.0 km/h (37.3 mph). These values were derived using the damage and

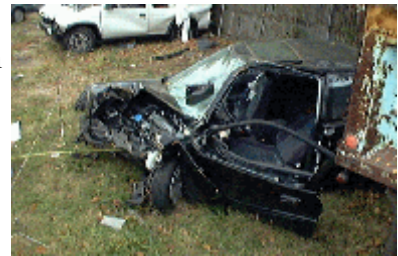
The exterior damage sustained by the Honda Civic in the crash sequence was severe in nature (**Figure 6**). Maximum frontal crush was 83.3 cm (32.8") located at the left corner position. Direct contact damage sustained as a result of striking the tree initiated 29.2 cm (11.5") to the left of the vehicle's centerline and extended 44.4 cm (17.5") to the left corner of the vehicle. The field L dimension for the crush envelope was 83.8 cm (33.0") as measured from the left corner to the right. The impact with the tree separated the bumper fascia and the reinforcement bar from the vehicle, therefore the crush profile was documented at the lower radiator support panel. The crush profile for the full crush envelope were measured as follows:

Figure 6. Overhead view of the crush profile.

In addition to the crush dimensions noted above, the left wheelbase dimension was reduced 33 cm (13") and the right wheel base dimension was elongated 2.3 cm (0.9"). The Collision Deformation Classification (CDC) assigned to the tree impact was 12-FLEW-4 and the delta V for this impact was computed by the SMASH program at 60.0 km/h (37.3 mph).

Clearly, the severity level of the left frontal tree impact exceeded the threshold level of air bag deployment and the system should have deployed during the crash sequence. During the vehicle inspection conducted for this effort, Honda representatives were unable to successfully download stored data from the single point diagnostic control unit for the air bag system.

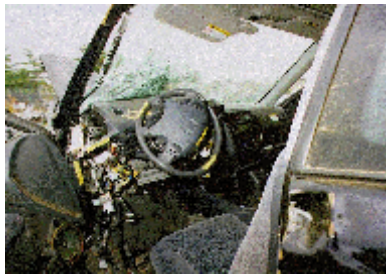
Interior damage to the Honda Civic was rated as moderately severe and was associated with a combination of impact induced deformation and occupant contact. The passenger compartment was reduced in size by intrusion of frontal components which included the windshield, the left upper A-pillar, the instrument panel, the steering assembly, and the toe pan (**Figure 7**). The A dimension (as measured from the steering wheel hub to the backlight header) was reduced 16.3 cm (6.4"). Other intrusion extents were measured

Figure 7. Interior damage/driver loading of the steering wheel.

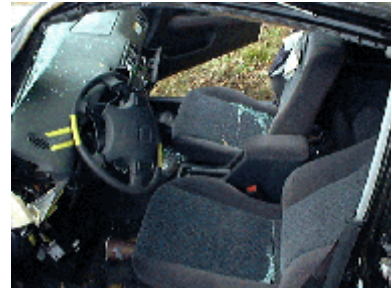
Figure 8. Non-deployed air bag and driver loading of the steering assembly.

Driver contact was noted to the steering assembly and the instrument panel (**Figure 8**). The driver loaded all aspects of the steering assembly including the rim, spokes, and the air bag module assembly (NOTE: At the time the driver initiated loaded the steering wheel, it was positioned in a straight 12/06 o'clock position, however, due to engagement against the tree, the wheel rotated approximately 260 degrees counterclockwise). The lower rim at the left spokes was deformed 17.8 cm (7.0") forward and the upper rim was deformed 7.6 cm (3.0") forward. The steering column shear capsules were completely separated with 1.8 cm (0.7") of separation noted for the left capsule and 2.8 cm (1.1") of separation noted for the right capsule.

When power was supplied to the vehicle during the inspection, the ignition key was turned to the on-position and the SRS indicator lamp came on and stayed on. Normally, this indicator lamp should light for seven seconds and then go out as the diagnostic cycle is completed. The Honda representative connected the diagnostic scan tool (Honda PGM Tester) to the SRS control unit to test for stored fault or trouble codes. He was unsuccessful in his attempts to download data from the control unit. The test unit used to interrogate the control unit repeatedly showed 16 lines of 0 codes indicating that the test unit was not communicating properly with the control unit.

A second test procedure was initiated which involved plugging a jumper wire into the service check connector for the SRS. With the wire in place, a flash code of 2-1 was displayed through the SRS indicator light. The code indicated the front passenger air bag circuit was open. No additional data could be extracted from the system.

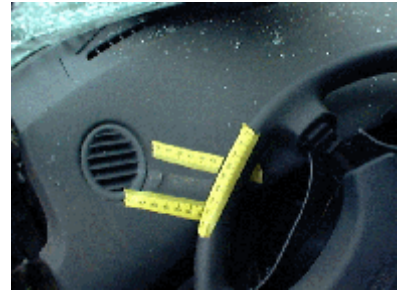
In addition, two contacts were noted to the upper surface of the instrument panel. The first contact was located behind the deformed upper steering wheel rim and consisted of a tissue transfer imbedded in a gouge on the upper surface of the instrument panel (**Figure 9**). The contact extended from 49.0-55.9 cm (19.3-22.0") to the left of the vehicle's centerline. The contact point was associated with the driver's left wrist. The second contact to the upper panel surface was located to the right of the steering wheel at the leading edge of the instrument cowl. This contact extended from 8.9-17.3 cm (3.5-6.8") to the left of the vehicle's centerline and consisted of a deformation (compression) of the padded surface. The contact was assigned to the driver's right hand.

Figure 9. Tissue transfer to the upper instrument panel.

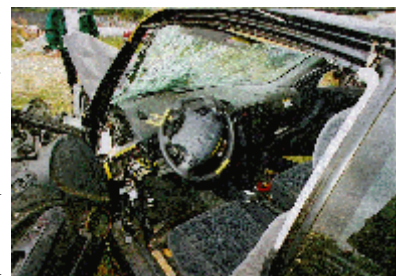
It is likely that the Honda driver began moving forward as a result of the two initial impacts with the fence and the guy wire. It is also likely that these two closely spaced impacts woke the driver. Following the left frontal impact with the tree, he moved directly forward (**Figure 10**). His knees and lower legs impacted and penetrated the mid-instrument panel and knee bolster to the left and right of the steering column. These contacts resulted in a laceration with abrasion over the left knee and an abrasion to the left thigh.

Figure 10. Overall view of the driver's trajectory and contact points.
