CALSPAN REMOTE PASSENGER AIR BAG/INJURY INVESTIGATION

CALSPAN CASE NO. CA98-068

VEHICLE - 1994 PLYMOUTH VOYAGER

LOCATION - DELAWARE

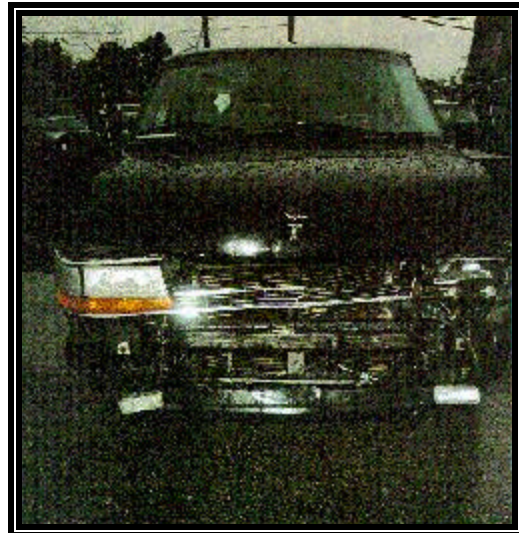
Figures 1 through 3 are views of the frontal damage sustained by the Plymouth Voyager. The photographs were taken a short time after the crash by persons representing the legal interests of the vehicle's occupants. The photographs indicated the Voyager sustained approximately 13 to 18 cm (5 to 7 inches) of longitudinal deformation across the full 157 cm (62 in) front end width

Figure 1: Front view of the 1994 Plymouth Voyager.

of the vehicle. The damage was confined to the frontal structure of the vehicle forward of the radiator support plane. The damaged components included: the bumper cover, bumper reinforcement, grille, hood left headlamp structure and left front fender. The Barrier Model of the WINSMASH model calculated a damage-based delta V of approximately 24 km/h (15 mph). The Collision Deformation Classification of the vehicle was 12-FDEW-01.

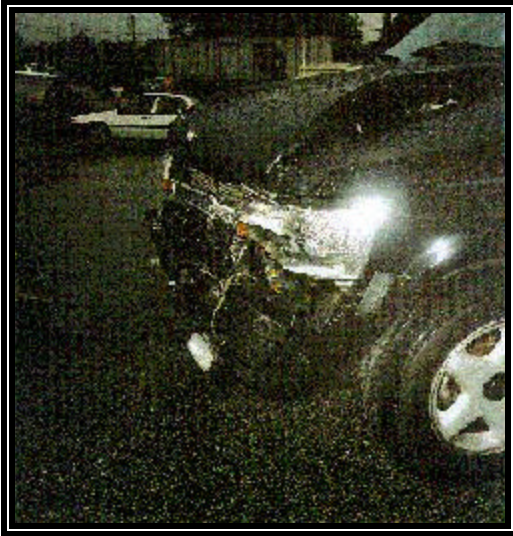
Figure 2: Left lateral view across the frontal -plane.

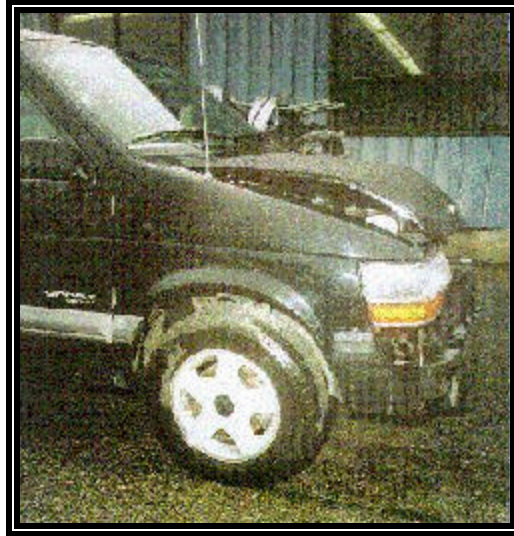
Figure 3: Right side view of the frontal damage.

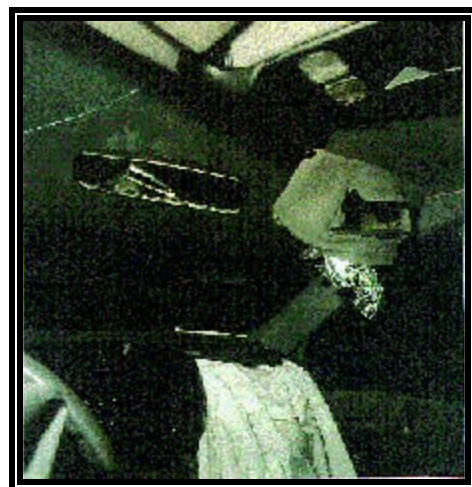
Two scuff marks were identified on the driver's knee bolster and were attributed to contact with the driver's lower extremities. These contacts reportedly did not produce any injury. The glass of the center rear view mirror was fractured, **Figure 4**. Additionally, the upper left center aspect of the windshield was fractured immediately forward of the center mirror. These fractures probably occurred as a result contact from the expanding right front passenger air bag.

The photograph also reveals the right sunvisor was down at the time of the crash. The deformation of the sunvisor and mirror fracture were also caused by contact from the expanding right front passenger air bag. The fractured mirror was displaced from its mounting.

Figure 4: Left view of the front center interior.

The altered path of the air bag caused the bag to contact the center mirror and right sunvisor. The air bag contacted the back side of the center mirror and rotated the mirror to the left about its pedestal mount. The upper left corner of the mirror contacted and fractured the left center aspect of the windshield. The mirror's surface was also fractured due to the contact. The air bag also deformed the right sunvisor and caused the fracture of the courtesy mirror, **Figure 4**.

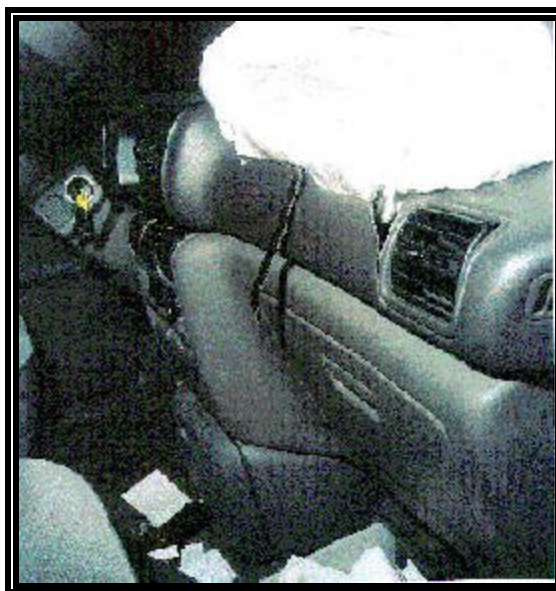
The Supplemental Restraint System in the 1994 Plymouth Voyager consisted of a driver and right front passenger air bags. The vehicle's SRS detected an above threshold crash severity and had deployed the air bags subsequent to the impact. The driver air bag was designed in the typical manner and was located in the center hub of the steering wheel. The right front passenger air bag was a top mount design located in the right aspect of the instrument panel. **Figure 5** is a view of the right front passenger air bag module. The mid aspect of the instrument panel, aft of the module, was partially ruptured during the deployment sequence. This partial rupture was indicative of an altered deployment sequence. The forward position of the right front occupant probably impeded the normal deployment of the air bag sufficiently to cause a pressure to build within the module. The panel then partially ruptured due to the continued expansion of the air bag within the module.

Figure 5: Right view of the passenger air bag module.

Upon impact, the vehicle's Supplemental Restraint System deployed. The 12 o'clock direction of the impact caused the right front passenger to initiate a forward trajectory and move into contact with the expanding air bag. The partially expanded air bag contacted the passenger's anterior chest, face, and head. The expansion of the air bag caused abrasions to the forehead, nose and anterior chest. During the expansion, the air bag fabric removed the contact lens from the passenger's right eye and caused the hyphema. The contact lens of the left eye was also damaged. The passenger was rendered unconscious due to the contact with the expanding air bag and was amnesic to the events of the crash. The passenger's forward position and interaction with the expanding air bag altered the normal deployment path of the air bag resulting in the pressurization of the module and the partial rupture of the instrument panel, **Figure 5**.
