**TRANSPORTATION SCIENCES
Crash Data Research Center**

Veridian Engineering
Buffalo, New York 14225

**VERIDIAN REMOTE AIR BAG RELATED
ADULT DRIVER FATALITY INVESTIGATION
VERIDIAN CASE NO. CA98-071
VEHICLE: 1994 TOYOTA CAMRY
LOCATION: FLORIDA
CRASH DATE: APRIL 1998**

U.S. Department of Transportation
National Highway Traffic Safety Administration
Washington, D.C. 20590

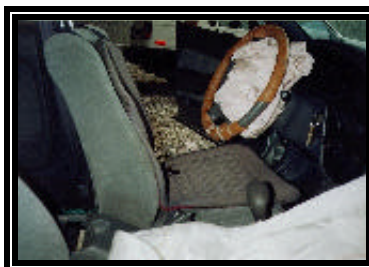
Figure 1. Forward seated position of the short stature female driver.

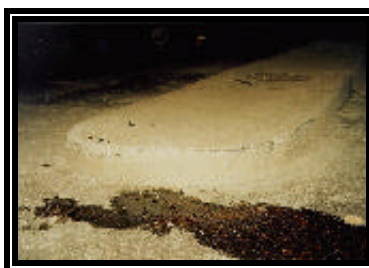
The crash occurred in the northbound lanes of a divided state route at the junction of a designated right turn lane. The turn lane was separated from the northbound through lanes by a curbed concrete median (**Figure 2**). The investigating officer reported the height of the curbing at 15.2 cm (6.0") and the width of the median at 1.2 m (4.0'). In the vicinity of the crash site, a construction work zone was established, however, the work zone was not active during this nighttime crash. The asphalt road surface was dry and the temperature was reported at 21 degrees C (70 degrees F). The posted speed limit was 64 mph (40 mph).

Figure 2. Struck curbed median.

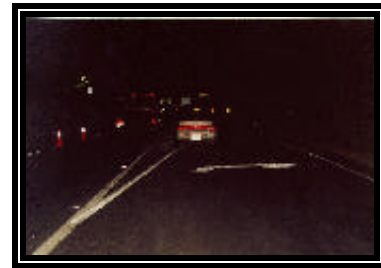
This witness further reported that the driver of the Camry was traveling at approximately 32-40 km/h (20-25 mph) on the outboard travel lane. This witness noted that the Camry began to drift to the right toward the designated right turn lane (**Figure 3**). She stated to

Figure 3. Pre-crash trajectory of the Toyota Camry.

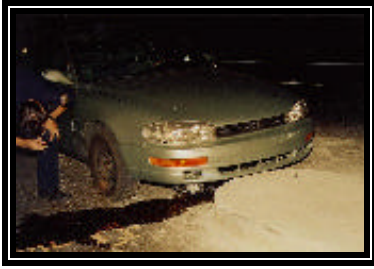
The lower aspect of the front bumper fascia initially contacted and overrode the curbed median as evidence by abrasions to the fascia (**Figures 4 and 5**). The contact displaced the front bumper fascia in an upward direction as the vehicle continued forward, thus exposing the lower radiator support to impact the face of the curbed median. The lower radiator support was displaced rearward and vertically upward which exposed the crossmember to the face of the barrier curb. The crossmember was crushed approximately 7.6 cm (3.0") rearward from this engagement (**Figure 6**).

Figure 4. Lower front bumper fascia alignment with struck curbed median.

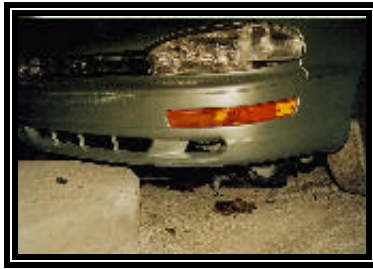
Figure 5. Additional view of the initial contact with the curbed median.

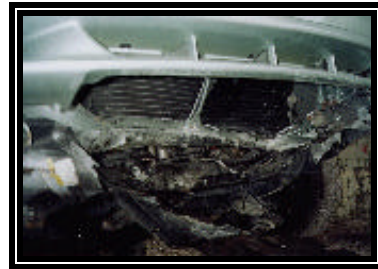
Figure 6. Radiator and crossmember damage from the curbed median.

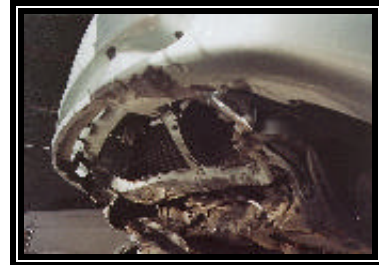
The lower aspect of the front bumper fascia of the Toyota Camry initially contacted the curbed median which abraded the fascia. The impact displaced the fascia up and rearward which exposed the lower radiator support. The radiator support impacted the curbed median as the vehicle continued forward. As a result, the lower support was displaced an estimated 15.2 cm (6.0") at the left corner area. The engine cradle/crossmember subsequently impacted the face of the curbed median which crushed the member approximately 7.6 cm (3.0") rearward. The vehicle damage is identified in **Figure 7**. The damage was rated as moderately severe with a Collision Deformation Classification (CDC) of 12-FDLW-1. During the engagement, the front right tire and wheel impacted the curbed median that resulted in minor deflection of the outer aspect of the right wheel rim. There was abrasion damage noted to the mid face of the front bumper fascia. Due to the height of this damage, it did not appear to be related to this event.

Figure 7. Profile view of the undercarriage damage deformation.

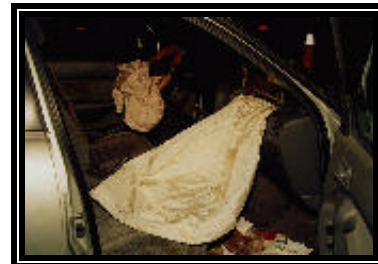
The front right passenger air bag deployed from a mid mounted module in the right instrument panel (**Figure 8**). The single cover flap was formed into the top and mid aspect of the instrument panel and hinge at the upper aspect, which allowed the flap to open in an upward direction. The vinyl exterior of the cover flap was reinforced with a sheet metal liner that also acted as a hinge. Post-deployment, the cover flap was in a near vertical position.

Figure 8. Deployed front right passenger air abg.

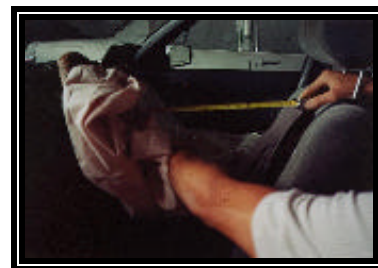
The driver of the Toyota Camry was a short stature female seated in a presumed upright driving attitude with the seat track adjusted to a forward position. She was seated on a one-piece aftermarket cushion that provided additional padding to the seat cushion and seat back surfaces. This cushion was approximately 2.5 cm (1.0") in thickness. The investigating officers measured the horizontal distances between the steering assembly and the aftermarket seat cushion. At the lower aspect (6 o'clock sector) of the steering wheel rim, a horizontal distance of 20.3 cm (8.0") was documented while a distance of 40.6 cm (16.0") was measured at the mid point of the air bag module cover (**Figure 9**).

Figure 9. Police measurement of horizontal distance between the driver air bag module and the seat back.

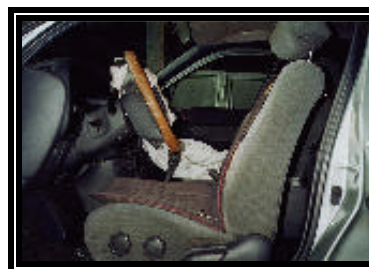
At deployment, the front driver air bag membrane deployed from the H-configuration module cover flaps and expanded against the chest of the forward positioned driver (**Figure 10**). She sustained bilateral rib fractures 2-8 that began at the lateral aspects and extended anteriorly with bilateral hemothoraces and a complete collapse of the left lung and a partial collapse of the right lung, a midline fracture of the sternum, a laceration of the left main pulmonary artery, and small focal contusions over the anterior surface of the heart. As the air bag membrane continued to expand, the upper aspect of the bag contacted the chin of the driver that resulted in a 5x4 cm (1.9x1.5") abrasion. There was no injury of the head or neck documented in the autopsy report.

Figure 10. Forward seated position of the driver.
