**REDESIGNED AIR BAG SPECIAL STUDY (RABSS)
SCI TECHNICAL SUMMARY REPORT**

NASS CDS CASE NO. 1999-04-057J

RABSS VEHICLE - 1998 CHEVROLET S-10 PICKUP TRUCK

LOCATION - STATE OF NEW JERSEY

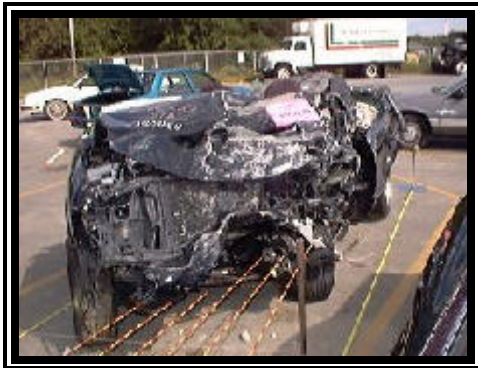
The 1998 Chevrolet S-10 pickup truck sustained severe frontal damage as a result of the impact with the Isuzu Trooper sport utility vehicle (**Figures 3 & 4**). The direct contact damage encompassed the entire front end width resulting in a combined direct and induced damage length (Field L) of 72.0 cm (28.3 in). Six crush measurements were documented at the level of the bumper: C1= 151.0 cm (59.4 in), C2= 129.0 cm (50.8 in), C3= 118.0 cm (46.5 in), C4= 76.0 cm (29.9 in), C5= 51.0 cm (20.1 in), C6= 32.0 cm (12.6 in). The Collision Deformation Classification (CDC) for this impact to the Chevrolet was 12-FDEW-6 with a principal direction of force of (+)10 degrees. *The crush seemed overstated, however, inadequate researcher field documentation prohibited further SCI analysis for correctional purposes.* The hood was deformed rearward from the impact force. The left fender was displaced rearward which restricted/deflated the left front wheel/tire and jammed the left door. Extensive (left and right side) bed to cab contact was noted which also jammed the right door. The right front wheel/tire was deflated (not restricted). The windshield was fractured from exterior impact forces. Reduction in the left side wheelbase measured 90.0 cm (35.4 in) while elongation in the right side wheelbase measured 3.0 cm (1.2 in). The pillars were cut as the roof and doors were removed by rescue personnel during occupant extrication activities post-crash.

Figure 3. Frontal damage to the 1998 Chevrolet S-10 pickup truck.

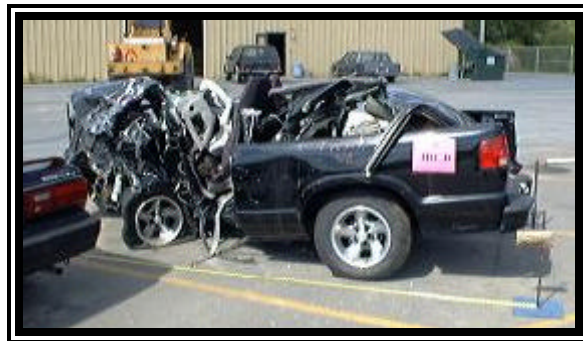
Figure 4. Left side view.

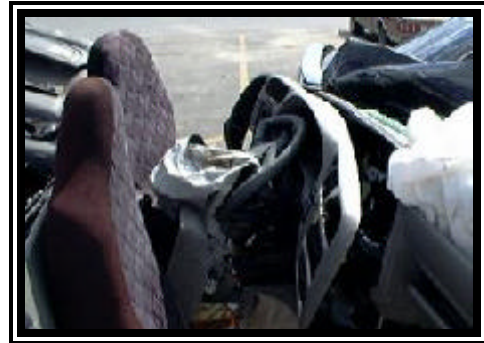
Interior damage to the Chevrolet pickup truck identified through the vehicle inspection was severe and was attributed to occupant contact and component intrusion (**Figure 5**). Scuff marks and indentations were documented on the left knee bolster, center instrument panel (at the junction with the right knee bolster), and glove compartment door. The left and right instrument panel were fractured and out-of-place. The upper portion of the steering wheel rim was deformed forward 14.0 cm (5.5 in). Deformation to the lower portion of the steering wheel rim was not identified as the

Figure 5. Interior view.

hub/spokes were also deformed. Tissue transfers and blood pooling were noted to the left toepan area. Vertical floor buckling (*intrusion*) deformed the seat cushions upward while bed to cab contact produced extensive longitudinal (forward) buckling of the rear cab panel, which deformed the seat backs to an upright position. *SCI revised* longitudinal intrusions into the driver space involved 50.0 cm (19.7 in) of toepan, 39.0 cm (15.4 in) of instrument panel, and 37.0 cm (14.6 in) of steering wheel/column intrusion. 26.0 cm (10.2 in) of lateral sill intrusion was also documented to the driver space. Additional longitudinal intrusions into the front occupant space involved 25.0 cm (9.8 in) center instrument panel, 13.0 cm (5.1 in) of right instrument panel, 14.0 cm (5.5 in) of right toepan, 16.0 cm (6.3 in) of rear panel (left), 11.0 cm (4.3 in) of rear panel (center), and 13.0 cm (5.1 in) of rear panel (right) intrusion. Vertical intrusions into the front passenger space involved 4.0 cm (1.6 in) of left floor and 6.0 cm (2.4 in) of right floor intrusions. The rear panel intrusions (buckling) produced longitudinal seat back intrusions of 5.0 cm (2.0 in) to the left and 8.0 cm (3.1 in) to the right seat back.

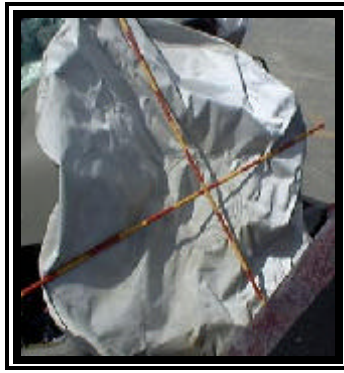
The 1998 Chevrolet S-10 pickup truck was equipped with redesigned frontal air bags for the driver and front right passenger positions. The air bags deployed as a result of the crash. The driver air bag was housed in the center of the steering wheel with a vertically oriented flap tear seam (I-configuration). The flaps were symmetrical in shape and measured 7.0 cm (2.8 in) in width and 10.0 cm (3.9 in) in height. Although no contact evidence was identified on the exterior surface of the module cover flaps, blood spattering was noted on the lower (centered) portion of the air bag face. The NASS researcher measured the diameter of the driver air bag at 68.0 cm (26.8 in) in its deflated state (**Figure 6**). The bag was tethered by four internal straps and vented by two ports located at the 11 o'clock and 1 o'clock sectors on the rear aspect of the air bag.

Figure 6. 1998 Chevrolet S-10 deployed redesigned driver air bag.

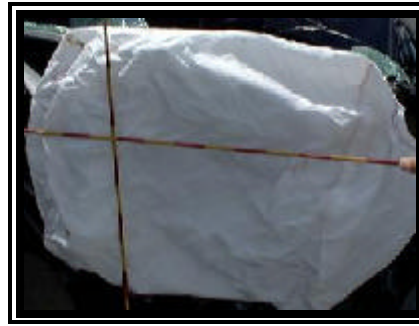
The front right passenger air bag deployed from the right mid-instrument panel area with a single cover flap design hinged at the top aspect. The cover flap was rectangular in shape and measured 32.0 cm (12.6 in) in width and 12.0 cm (4.7 in) in height. No contact evidence was identified on the exterior surface of the module cover flaps. The NASS researcher measured the passenger air bag at 50.0 cm (19.7 in) square in its deflated state (**Figure 7**). Blood spattering was noted on the upper left quadrant of the air bag face. No internal tether straps were present. The bag was vented by two ports located at the 9 o'clock and 3 o'clock sectors on the side aspect of the air bag. The vehicle was equipped with a passenger air bag cutoff switch which was set to the "on" position.

Figure 7. 1998 Chevrolet S-10 deployed redesigned passenger air bag.
