**TRANSPORTATION SCIENCES  
CRASH DATA RESEARCH CENTER**

**REMOTE CRASH INVESTIGATION OF AN ADAPTIVE CONTROL VEHICLE**

**VERIDIAN CASE NO. 1999-08-136F**

**VEHICLE - 1996 CHRYSLER TOWN AND COUNTRY/IMS CONVERSION**

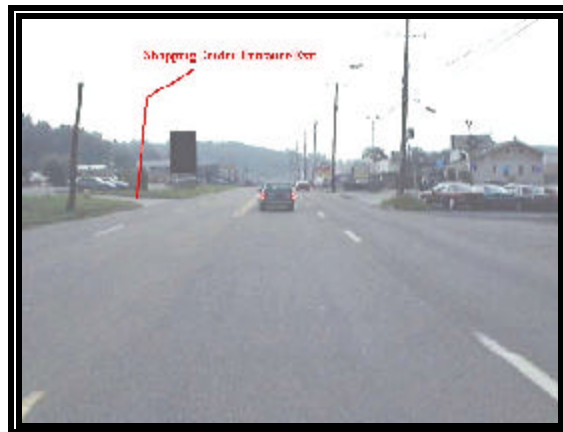
This two-vehicle crash occurred during the afternoon hours of August, 1999. At the time of the crash, it was daylight and the weather was not a factor. The road surfaces were dry. The crash occurred at the non-signalized junction of a 4-lane north/south road and 2-lane east/west private roadway. The private road served as the entrance/exit lanes of a shopping center. The shopping center was located on the east side of the primary roadway. The junction was controlled by a stop sign for traffic exiting the shopping center. The speed limit of the primary road was 64 km/h (40 mph). **Figure 1** is a southward view of the crash scene. The subject vehicle was entering the roadway from the left.

**Figure 1:** Southward view of the crash scene.

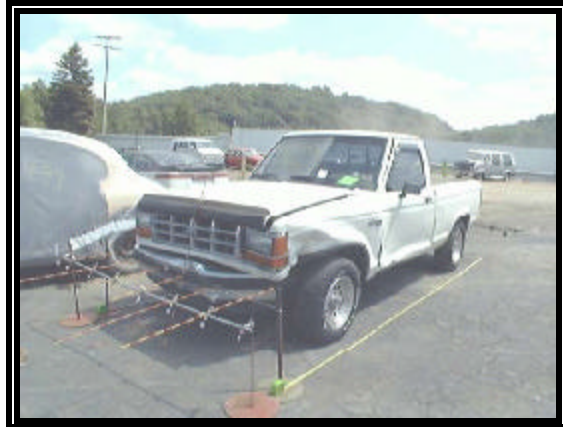
**Figure 4** is the left front view of the 1990 Ford Ranger. The vehicle was identified by a Vehicle Identification Number (VIN): 1FTCR10ALUB (production sequence deleted). The front bumper system sustained 60 cm (24 in) of direct contact damage that began 20 cm (8 in) left of center and extended to

the left corner. The maximum crush was located at C1 and measured 17 cm (7 in). The energy of the frontal impact was managed by the structures of the front bumper and its mounting. There was no damage to the left front suspension nor change in the wheelbase dimension. The CDC of the damage was 12-FDEW-01. The Barrier Equivalent delta V calculated by the WINSMASH model was 15 km/h (10 mph).

The left side damage consisted of 64 cm (25 in) of sideswiping direct contact. The direct damage began 58 cm (23 in) rearward of the left front axle and extended to approximately the midline of the door. The combined direct and induced damage measured 120 cm (47 in) and began 40 cm (16 in) rearward of the front axle. The maximum crush measured 5 cm (2 in) at the mid-door. The CDC was coded 11-LPEW-01. The Barrier Equivalent delta V was 8 km/h (5 mph).

**Figure 2:** Left front view of the Ford.

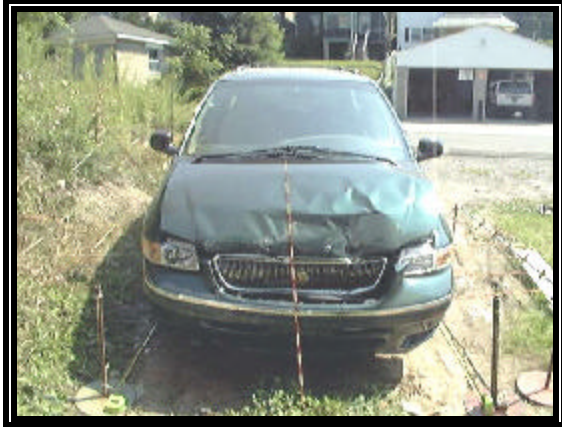
**Figures 3 and 4** are the front and left side views of the IMS, respectively. The vehicle's front plane sustained direct contact damage across the entire frontal width of the vehicle. The maximum crush of 8 cm (3 in) was measured at C6. Due to the relative bumper height mis-match the van sustained additional damage to the radiator and center grille area during the impact. Vehicular damage was confined to the structures forward of the radiator support plane indicative of the minor nature of this impact. The wheelbase dimensions were unchanged. The Collision Deformation Classification (CDC) of the impact was 12-FDEW-01. The Barrier Equivalent Delta V calculated by WINSMASH program was 12 km/h (7 mph).

**Figure 3:** Front view of the Chrysler.

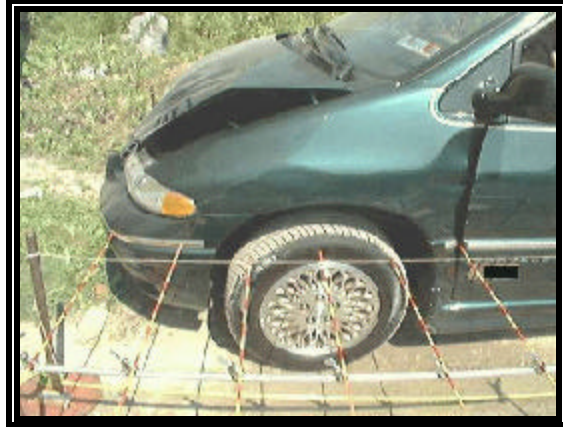
The forward aspect of the vehicle's left side sustained 75 cm (30 in) of direct contact damage that began at the front bumper's left corner, **Figure 4**. The maximum crush of 9 cm (4 in) was measured at C6. The CDC of the impact was 12-FLEW-01. The delta V of this contact was determined to be 6 km/h (3 mph).

**Figure 4:** View of the left side damage.

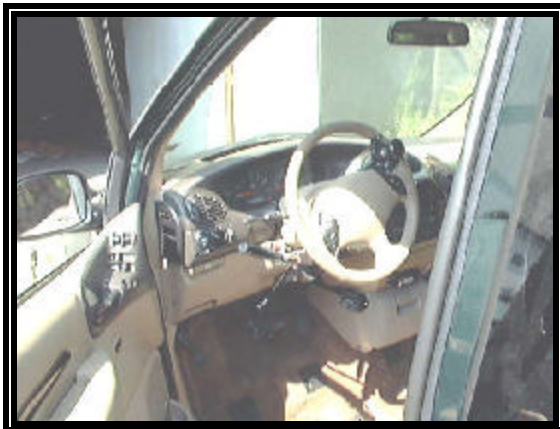
**Figure 5** is an interior view of the driver's position depicting the location of the adaptive controls installation. The steering wheel spinner knob was located in the 2 to 3 o'clock sector of the rim. The driver indicated that the reduced effort steering was very responsive and took some experience getting used to.

**Figure 5:** Interior view of the driver's position.

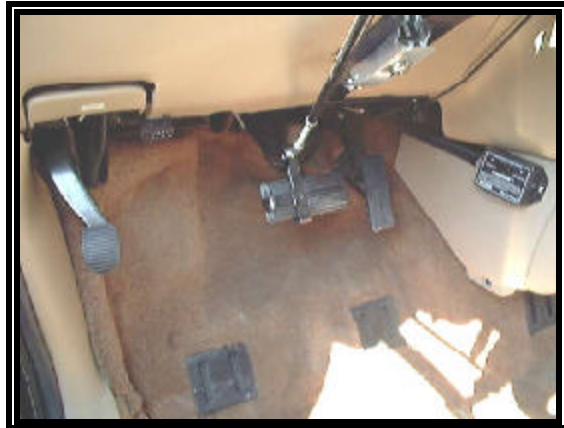
The accelerator/brake hand control electro-mechanically controlled the vehicle's operation. It was located on the left side of the steering column, directly below the turn signal stalk. A downward motion of the control electronically controlled the accelerator, increasing engine rpm. The brakes were actuated mechanically by a forward motion. Forward movement of the lever directly depressed the brake pedal, **Figure 6**. Both accelerator and brake could be foot operated, without the use of the adaptive control hand lever.

**Figure 6:** Close-up view of the mechanical brake actuation rod.

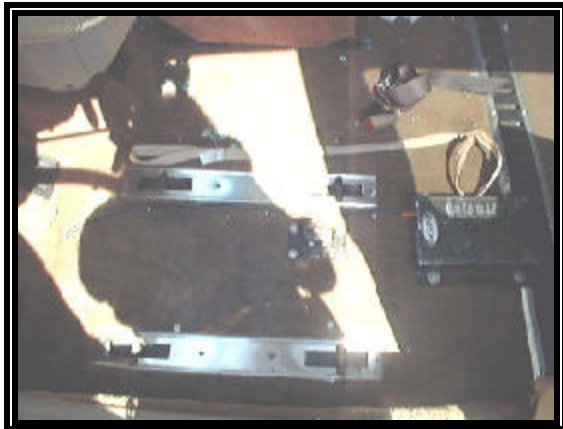
**Figure 7:** View of the driver's floor area.

The wheel chair was held stationary in the driver's position by an EZ Lock device, model unknown, **Figure 7**. The lock was electronically released via a remote switch mounted on the center console. A manual/emergency release was located on the forward aspect of the lock. The lock was fastened to the floor by 4-3/8 in diameter grade 5 bolts. The lock latched about a 1/2 in diameter pin attached to the rear aspect of the wheelchair. The left front seating position was also equipped with floor anchors for the attachment of a OEM seat mounted on a special base. The anchors were arranged in a rectangular pattern that accommodated the dimensions of the base attachments.

The manual restraint system consisted of the OEM 3-point lap and shoulder belt with a modified inboard anchor. The buckle assembly was fixed to a webbing section attached to the floor of the van via a modified floor anchor, refer to Figure 7. The anchor consisted of a formed steel section that was spot-welded to the floor. The section extended across the width of the vehicle to allow for the adjustment of the inboard anchor.
