SCI/NASS COMBINATION CASE REPORT

CASE NUMBER - NASS-1999-08-167C

VEHICLE - 1998 JAGUAR XJ8L

CRASH DATE - September, 1999

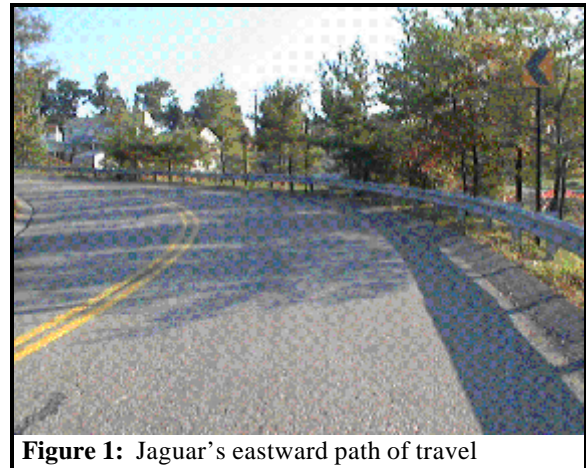
The Jaguar was traveling east in the eastbound lane negotiating a curve left on a two-lane, two-way, undivided county roadway (**Figure 1**). The Nissan was traveling west in the westbound lane negotiating a right curve on the same roadway. The bituminous roadway had a positive slope of over 2% for eastbound traffic at the point of the crash. It was daylight with rain at the time of the crash and the road surface was wet. The posted speed limit was 32 km.p.h. [20 m.p.h.]. The roadway was divided by a double yellow line and bordered by a solid white fog line with a W-beam guardrail along the south edge. According to the Police Crash Report, the Jaguar driver lost control on the wet surface and went into a counterclockwise yaw and crossed over the centerline into the westbound lane. It is not known if the Jaguar's driver attempted any avoidance actions. The driver of the Nissan braked (unknown if lock-up) in an attempt to avoid the crash with the Jaguar.

Figure 1: Jaguar's eastward path of travel

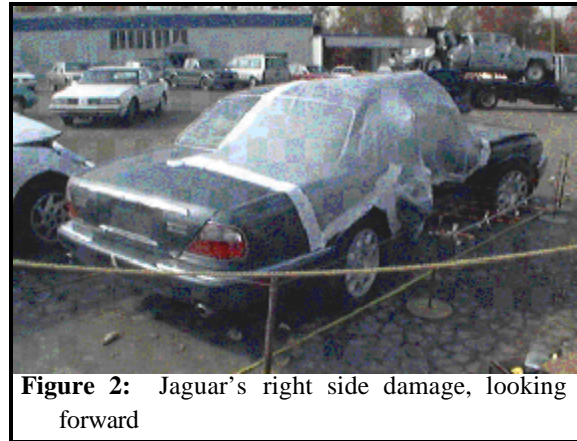
The Jaguar's contact with the Nissan involved the right side from just behind the right front axle to the rear wheel well (**Figure 2**). The maximum crush to the Jaguar's right side was 63 centimeters [24.8 inches] and was located between C3 and C4 (**Figure 3**). The wheelbase on the right side was shortened 25 centimeters [9.8 inches] with the left side being lengthened 9 centimeters [3.5 inches]. The glazing in the Jaguar's front and rear right side doors disintegrated. The two right doors and the right B-pillar intruded, causing deformation to the front right seat cushion and seat back.

Figure 2: Jaguar's right side damage, looking forward

The CDC for the Jaguar's single impact was determined to be: **02-RYEW-4 (70)**. The WinSMASH reconstruction program, damage-only algorithm with crush profiles from both vehicles, was used. The Total, Longitudinal, and Lateral Delta Vs for the Jaguar are, respectively: 34 km.p.h. [21 m.p.h.], -12 km.p.h. [-7.5 m.p.h.], and -32 km.p.h. [-20 m.p.h.]. The crash severity for the Jaguar was moderate.

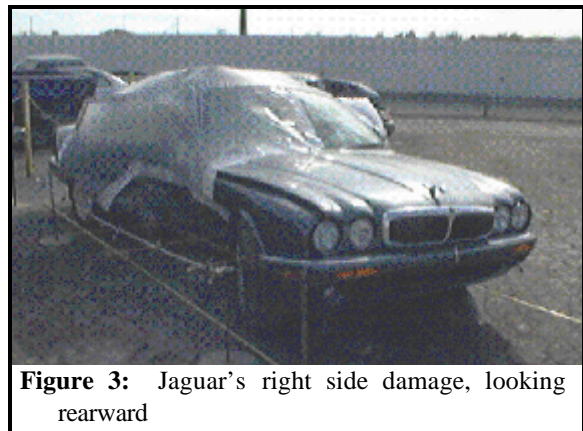
Figure 3: Jaguar's right side damage, looking rearward

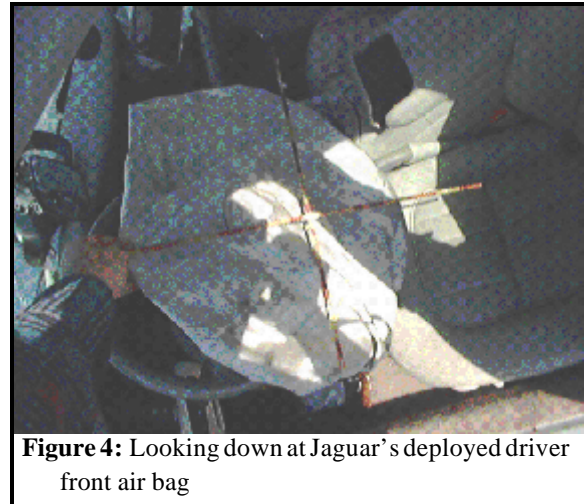
The Jaguar's driver front air bag deployed from the steering wheel hub where it was mounted (**Figure 4**). The driver's front air bag had a single module cover which opened upwards. Its overall dimensions were 24 centimeters [9.5 inches] at the top and 15 centimeters [5.9 inches] at the bottom and 17 centimeters [6.7 inches] vertically. The flap appear to be made of thick vinyl/leather type material. The driver's air bag was 50 centimeters [19.7 inches] in diameter and had two tethers. The driver's air bag had two vent ports located at the 11 and 1 o'clock positions. The driver's front air bag and cover flap revealed no visible evidence of direct contact. It should be noted that the driver air bag's front and back surfaces were covered with mud at the time of the inspection.

Figure 4: Looking down at Jaguar's deployed driver front air bag

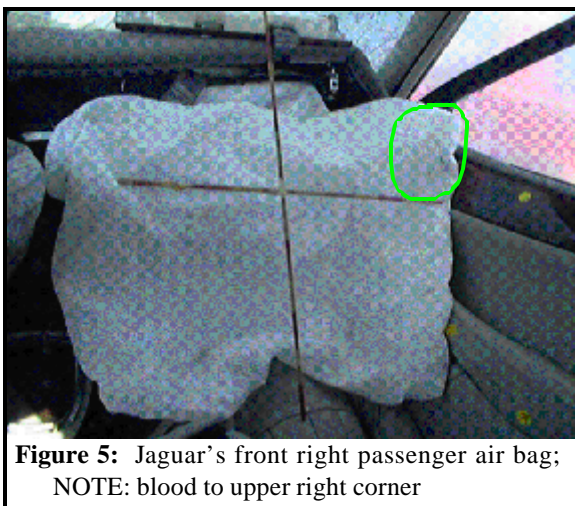
Figure 5: Jaguar's front right passenger air bag;
NOTE: blood to upper right corner

An inspection of the Jaguar's front right passenger air bag revealed blood on the front upper right corner (**Figure 5**). The NASS investigator indicated that the front right air bag's cover flap had been damaged, but was not specific. It appears that there was damage to the bottom right corner due to intrusion by the right side door panel (**Figure 6**).

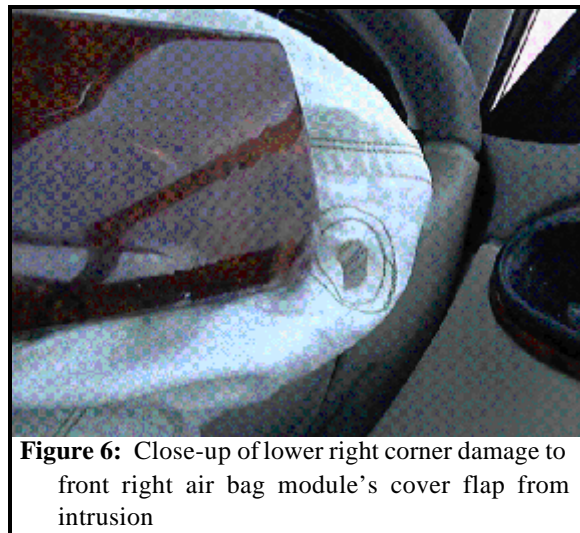
Figure 6: Close-up of lower right corner damage to front right air bag module's cover flap from intrusion

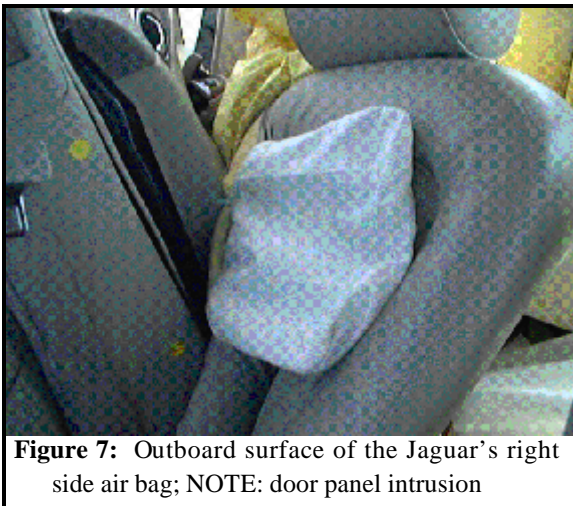
The Jaguar's front right side air bag deployed from along outside seam of the front right bucket seat back where it was mounted (**Figures 7, 8**). The side air bag's dimensions were 30 centimeters [11.8 inches] horizontally and 28 centimeters [11 inches] vertically and it was not tethered and had no vent ports. An inspection of the Jaguar's front right side air bag revealed no visible evidence of direct contact from the front right passenger.

Figure 7: Outboard surface of the Jaguar's right side air bag; NOTE: door panel intrusion

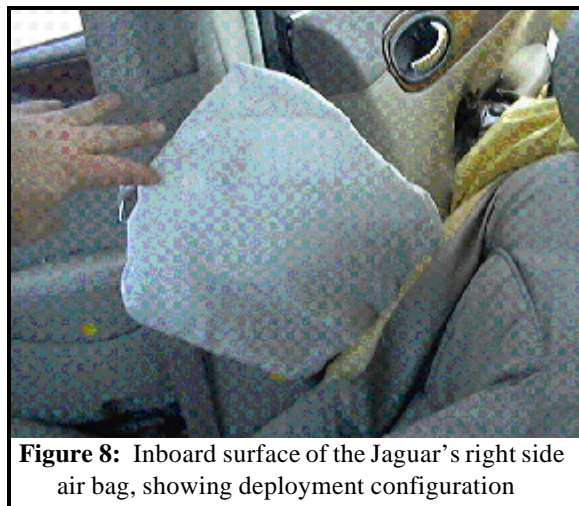
Figure 8: Inboard surface of the Jaguar's right side air bag, showing deployment configuration

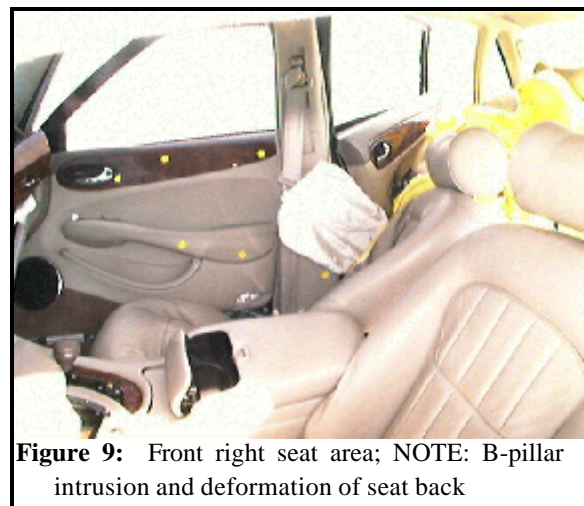
Figure 9: Front right seat area; NOTE: B-pillar intrusion and deformation of seat back

blood spots at the air bag’s upper right corner. He probably encountered the deployed side air bag with the right side of his thorax. The combination of his rightward momentum and the intruding right side components deflated the side air bag. The intruding door panel and B-pillar caused his seat cushion to be bent downward and his seat back to be bent inward and rearward (**Figure 9**). He was struck by the intruding door panel, causing contusions and abrasions on his right side, and he sustained a fracture of the right transverse process of the L2 vertebra, probably due to contact with the intruding B-pillar. There is no knowledge of his position at final rest.

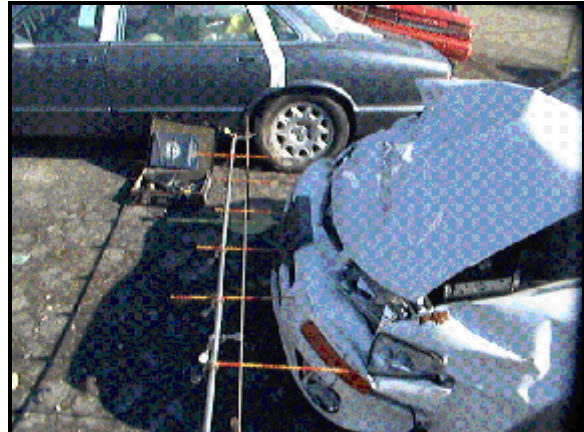
Damage to the Nissan from impacting the Jaguar involved the entire front (Figures 10, 11). The CDC was determined to be 12-FDEW-1 (10). The WinSMASH reconstruction program, damage-only algorithm with crush profiles from both vehicles, was used. The Total, Longitudinal, and Lateral Delta Vs for the Nissan are, respectively: 49 km.p.h. [30 m.p.h.], -48 km.p.h. [-29 m.p.h.], and -9 km.p.h. [-6 m.p.h.].

Figure 10: Reference line view of Nissan's front end deformation viewed from left

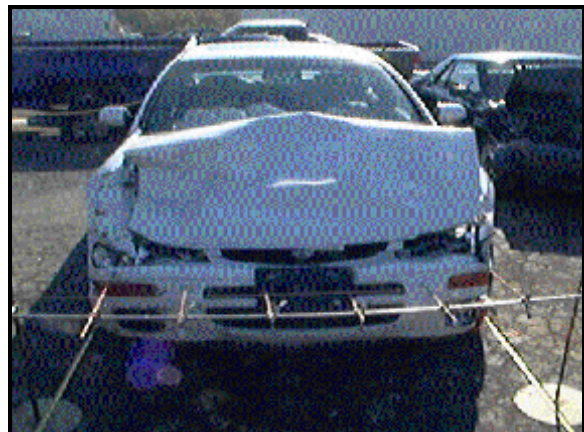
Figure 11: Frontal view of damage to the Nissan's front end from impacting Jaguar's right side
