**REDESIGNED AIR BAG SPECIAL STUDY (RABSS)  
SCI TECHNICAL SUMMARY REPORT**

**NASS RABSS CASE NO. 1999-08-801E**

**RABSS VEHICLE - 1999 FORD ESCORT SE**

**CRASH DATE - JULY, 1999**

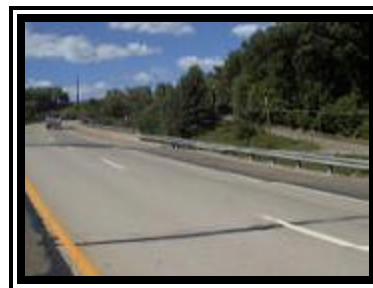
**Figure 1. Northeast approach into the second guardrail impact.**

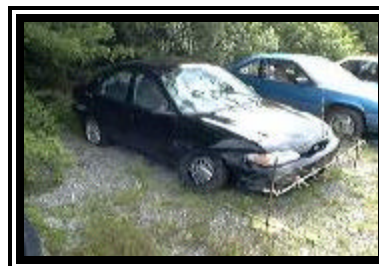
The Ford Escort sustained minor frontal damage as a result of the impact with the second guardrail (**Figure 2**). The direct contact

**Figure 2. Front and right side damage to the 1999 Ford Escort SE.**

damage began at the front right bumper corner and extended 36.0 cm (14.2 in) inboard. The impact resulted in a combined direct and induced damage length (Field L) of 139.0 cm (54.7 in). Six crush measurements were documented at the level of the bumper: C1= 0 cm, C2= 0 cm, C3= 0 cm, C4= 0 cm, C5= 2.0 cm (0.8 in), C6= 4.0 cm (1.6 in). The direct contact damage extended rearward to the right front wheel which restricted and deflated the tire. Separation in the contact damage was noted between the right A and C-pillars. This damage to the right rear area was attributed to the third guardrail impact which began 30.0 cm (11.8 in) forward of the right rear axle and extended 87.0 cm (34.3 in) rearward. Superficial scratching was identified on the left side of the vehicle attributed to the first guardrail impact. The direct contact damage began 62.0 cm (24.4 in) forward of the left front axle and extended 310.0 cm (122.0 in) rearward. The windshield was fractured from exterior forces and the (interior) front right air bag module cover flap.

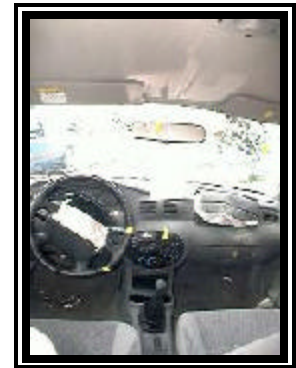
Interior damage to the Ford Escort identified through the NASS vehicle inspection was moderate and was attributed to occupant contact (**Figure 3**). Blood spattering was noted to the (right) upper and lower sections of the driver air bag. The upper portion of the steering wheel rim was deformed forward 2.0 cm (0.8 in) with the tilt column set to the full down position. A scuff mark was documented on the left knee bolster (padded type) and glove compartment door. The rear view mirror was displaced and fractured. Spider-web type fractures were identified to the right mid/lower windshield area from passenger contact and the air bag module cover flap. A large indentation was documented on the passenger air bag module cover flap which was attributed to the passenger's mandible fracture. Blood spattering was also noted to the (rear) upper section of the passenger air bag. No loading evidence was found on the webbing of the front manual lap and shoulder belt systems.

**Figure 3. Interior view of the 1999 Ford Escort SE.**

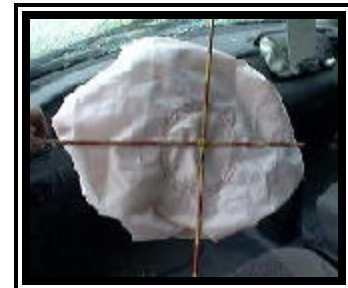
The 1999 Ford Escort SE was equipped with redesigned frontal air bags for the driver and front right passenger positions. The air bags had deployed as a result of the crash. The driver air bag was housed in the center of the steering wheel with a horizontally oriented flap tear seam (H-configuration). The flaps were asymmetrical in shape as the upper flap measured 21.0 cm (8.3 in) in width and 11.0 cm (4.3 in) in height while the lower flap measured 21.0 cm (8.3 in) in width and 10.0 cm (3.9 in) in height. Although no contact evidence was identified on the exterior surface of the module cover flaps, blood spattering was found on the (right) upper and lower sections of the air bag.

**Figure 4. 1999 Ford Escort SE redesigned driver air bag.**

The NASS researcher measured the diameter of the driver air bag at 50.0 cm (19.7 in) in its deflated state (**Figure 4**). The bag was tethered by two internal straps and vented by two ports located at the 11 o'clock and 1 o'clock sectors on the rear aspect of the air bag.

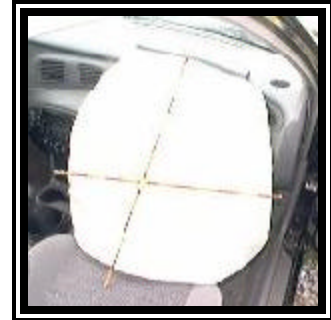
The front right passenger air bag deployed from a mid-mount module in the right instrument panel with a single cover flap design hinged at the top aspect. The cover flap was rectangular in shape which opened in an upward direction toward the windshield and measured 31.0 cm (12.2 in) in width and 19.0 cm (7.5 in) in height. A large indentation was identified to the center portion of the module cover flap which was attributed

to the passenger's mandible fracture. The lower right portion of the cover flap was also deformed from contact to the windshield (fractured). Blood spattering was documented to the back of the air bag (upper section) which was attributed to the passenger's facial injury. The NASS researcher measured the passenger air bag at 40.0 cm (15.7 in) in width and 50.0 cm (19.7 in) in height in its deflated state (**Figure 5**). No tether straps were present. The bag was vented by two ports located at the 3 o'clock and 9 o'clock sectors on the side aspect of the air bag. No cutoff switch was reported for the front right air bag.

**Figure 5. 1999 Ford Escort SE redesigned passenger air bag.**

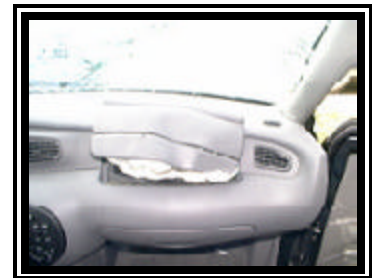
The front right passenger was unrestrained (3-point lap and shoulder belt available) and presumed to be seated out of position forward due to pre-crash braking actions by the driver prior to the second guardrail impact. His face was positioned against or within a close proximity to the mid-mount front right air bag module cover flap. Lack of belt usage was confirmed by the nature of the injuries sustained and contact points within the vehicle. At impact with the second guardrail, the flap struck the passenger in the chin area which resulted in bilateral fractures of the mandible, evidenced by the indentation documented to this component (**Figure 6**). It should be noted that the redesigned air bag system deployed with less force, therefore, preventing this out-of-position occupant from serious injury or death. He was accelerated into the windshield resulting in multiple abrasions/lacerations to the facial area as evidenced

**Figure 6. Passenger contact to the air bag module cover flap.**

by the spider-web type fracture identified on the right mid-windshield. In addition, the medical report stated that glass was embedded into the hair and face. He also sustained an abrasion to the left posterior forearm from contact to the rear-view mirror/windshield, evidenced by the displacement and fracture of this component. The front right passenger was transported to a local hospital for treatment and admitted for two days.

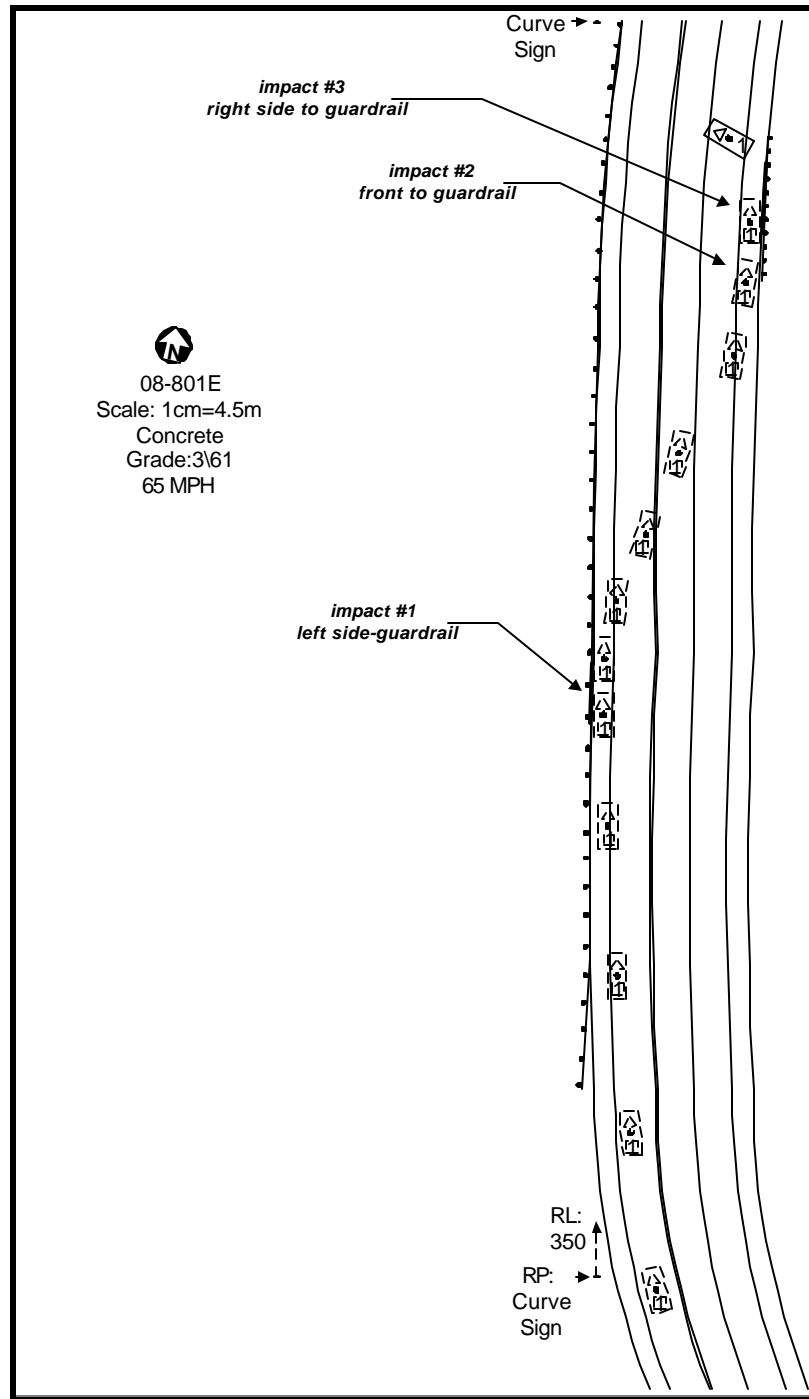
Figure 7. NASS Scene Diagram

This single vehicle crash occurred during the early morning hours of July, 1999. At the time of the crash, it was dark (street lighted) with no adverse conditions as the roads were dry. The crash occurred off the northbound lanes of a 4-lane north/south asphalt roadway (see **Figure 7 - page 6**) which was divided by a grass median and curved right for northbound traffic. No traffic controls were present at the scene which had a posted speed limit of 105 km/h (65 mph).
