SCI/NASS COMBINATION CASE REPORT

CASE NUMBER - NASS-99-11-082E

VEHICLE - 1997 BMW 740iL

CRASH DATE - May, 1999

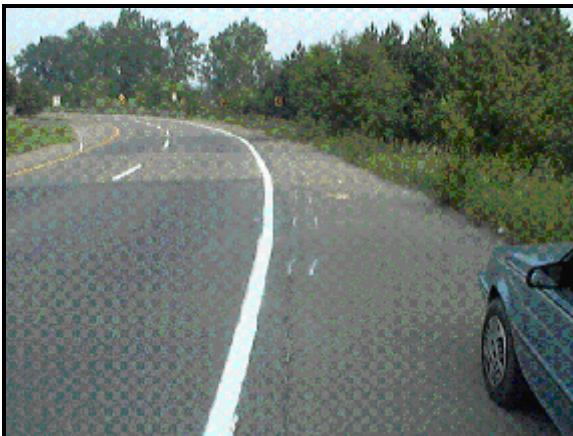
The case vehicle was traveling in a westerly direction at high speed in the westbound lane of a two-lane, two-way undivided city roadway and was about to enter a left curve. The case vehicle had just passed another westbound vehicle when its right rear tire lost traction on some loose gravel. The case vehicle went into a counterclockwise yaw and departed the right side of the roadway (**Figure 1**). The case vehicle's driver braked and steered to his left trying to regain control. The crash occurred off the right side of the roadway.

Figure 1: Westerly view of case vehicle's path of travel path while in CCW yaw leaving roadway with right rear tire mark highlighted

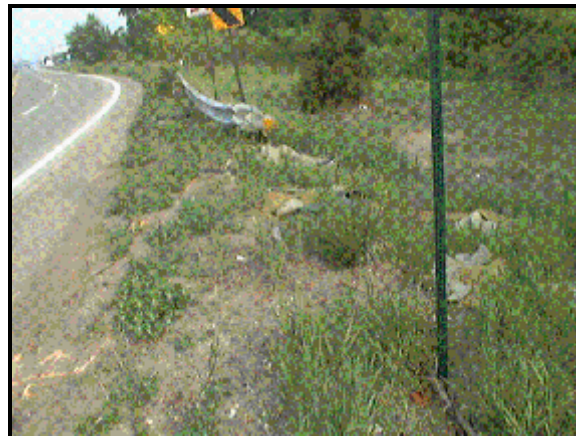
Figure 2: Case vehicle's path of travel leading into second struck sign post and guardrail

The right side of the case vehicle impacted a small tree (diameter of trunk 3 centimeters [1.2 inches]), continued its westerly counterclockwise yaw, struck a green road sign post, another 4 centimeter (1.5 inch) road sign post with its right rear prior to striking the end of a guardrail, causing the case vehicle's front right passenger door-mounted side air bag to deploy (**Figure 2**). The case vehicle's impact with the guardrail also resulted in the front right passenger door coming open. The case vehicle continued in a westerly direction, rolling over six quarter turns and coming to rest on its roof with the trunk lid atop a chain link fence. At final rest the case vehicle was heading in a southerly direction. The case vehicle was towed from the scene due to damage.

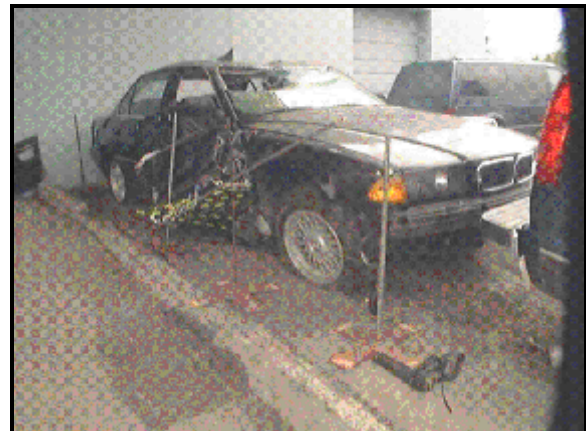
Figure 3: Front right angle view of deformation to case vehicle; NOTE: front right door open

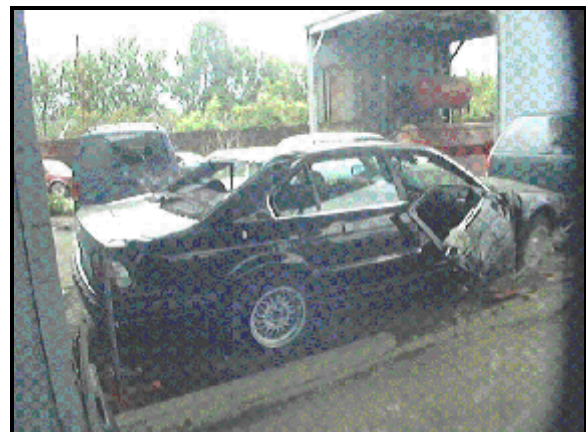
Figure 4: Angled view from right rear of right side damage and rollover damage; NOTE: C-pillar damage and back light

There was several areas of integrity loss to the case vehicle. The case vehicle's front right door came open due to latch/striker failure. The front right window, back light and moon roof were disintegrated from impact forces. The windshield was cracked but remained in place.

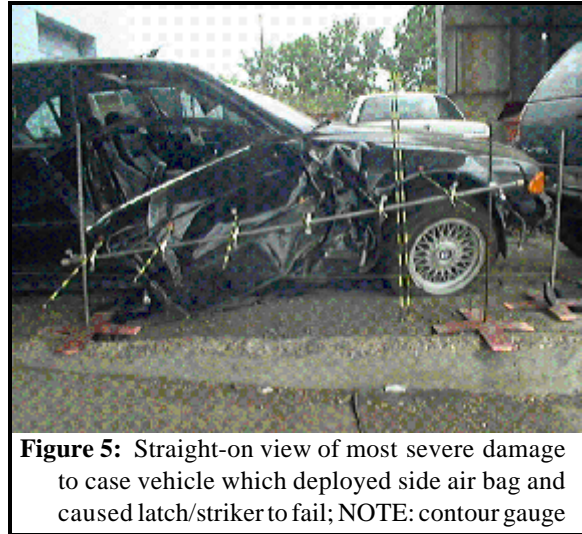
Figure 5: Straight-on view of most severe damage to case vehicle which deployed side air bag and caused latch/striker to fail; NOTE: contour gauge

Because of the case vehicle's multiple impacts with resulting overlap damage, CDCs could be determined only for events 4 (guardrail impact) and 5 (rollover). The CDCs were determined to be: **03-RYEW-3 (80)** and **00-TYDO-3** for the case vehicle (maximum crush was 13 centimeters [5.1 inches] on the right side). No reconstruction program was used on the case vehicle's left side impact due to the collision conditions (i.e., yielding objects and overlapping damage) being beyond the scope of the WinSMASH reconstruction program; however, this contractor's visually estimated Delta V for the right side impact with the guardrail is between 13 km.p.h. (8 m.p.h.) and 21 km.p.h. (13 m.p.h.).

The case vehicle's most severe impact occurred when the right side struck the end portion of a W-beam guardrail which caused the case vehicle's right door-mounted side air bag to deploy. This impact also resulted in the failure of the latch/striker of case vehicle's right front passenger door, allowing it to open. The case vehicle's guardrail impact precipitated the case vehicle's rollover event.

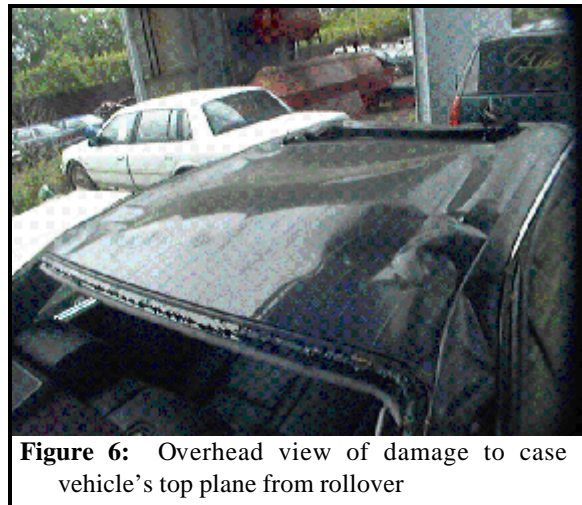
Figure 6: Overhead view of damage to case vehicle's top plane from rollover

An examination of the case vehicle's interior showed no visible evidence of contact by the vehicle's occupants primarily because of the crusted over mud strewn throughout the interior. The energy absorbing steering column was not measured for compression. The case vehicle driver and front right passenger's knee bolsters showed no evidence of scuffing or deformation. There was evidence of intrusion by the case vehicle's windshield, windshield header and roof. The most significant being 48 centimeters (18.9 inches) by the windshield into front right passenger seat position. The roof above the front right seat position was intruded 10 centimeters (3.9 inches).

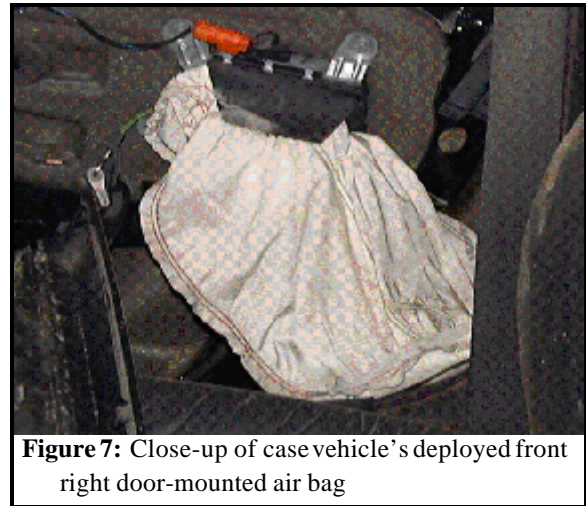
The case vehicle was equipped with a SRS that consisted of front air bags and door-mounted side air bags at the driver and front right passenger seat positions. The only air bag that deployed was the front right passenger's side air bag (**Figure 7**). The right side air bag deployed as a result of the case vehicle's right side impact with the guardrail. The front right passenger's side air bag deployed from the door panel where it was mounted. The module cover consisted of two trapezoidal cover flaps with overall dimensions of 13 centimeters (5.1 inches) at the top and bottom horizontal creases, 9 centimeters (3.5 inches) at the center horizontal seam and 7 centimeters (2.8 inches) angled horizontal seams. The flap material is an unknown vinyl/rubber material. The side air bag was 43 centimeters (16.9 inches) longitudinally and 28 centimeters (11 inches) vertically and had one tether along the air bag seam. The front right passenger's side air bag had no vent ports.

Figure 7: Close-up of case vehicle's deployed front right door-mounted air bag

An inspection of the front right passenger's side air bag and cover flap revealed no visible evidence of direct contact (i.e., fibers or skin) or damage from the front right passenger.

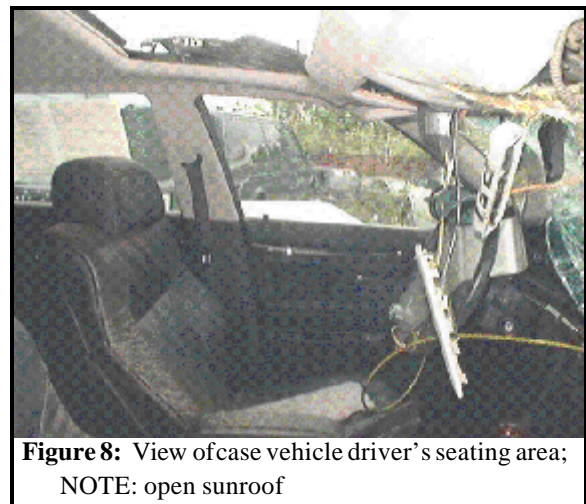
Figure 8: View of case vehicle driver's seating area; NOTE: open sunroof

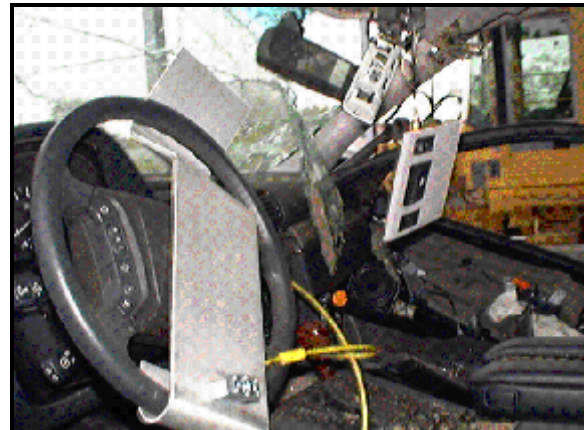
Figure 9: Interior view of case vehicle; NOTE: anti theft device on SW hub and overhead console hanging down

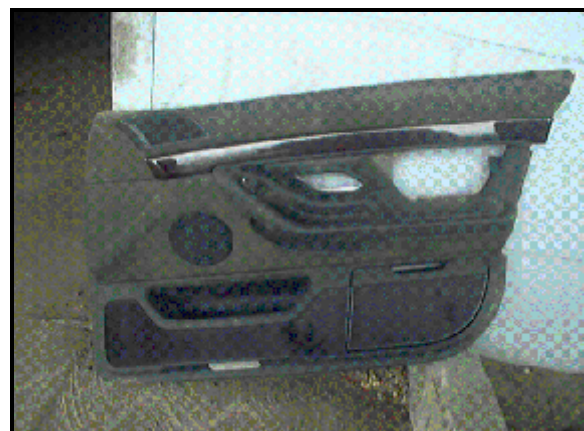
Figure 10: Close-up of case vehicle's front right door panel showing no evidence of contact

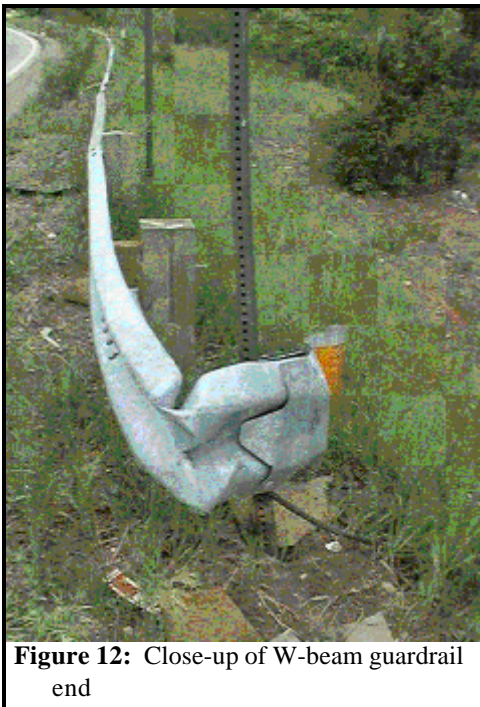
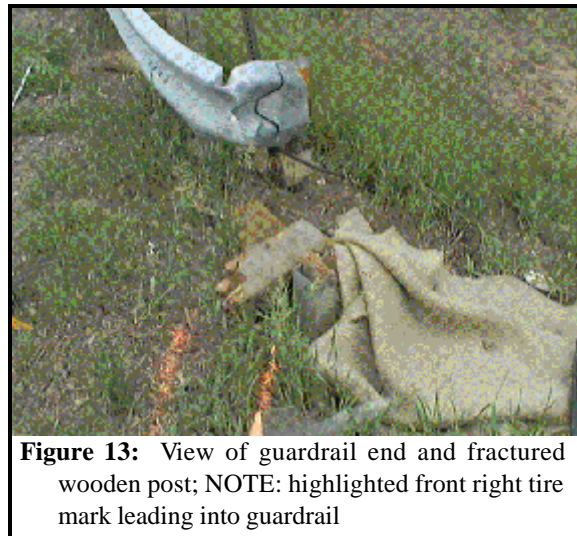
The impact to the end portion of the W-beam guardrail fractured the wooden 4 X 4 post to which it was anchored and caused the guardrail to fold back accordion style (**Figures 12-13**).
