**REDESIGNED AIR BAG SPECIAL STUDY (RABSS)  
SCI TECHNICAL SUMMARY REPORT**

**NASS CDS CASE NO. 1999-11-089J**

**RABSS VEHICLE - 1998 DODGE CARAVAN SE**

**CRASH DATE - MAY, 1999**

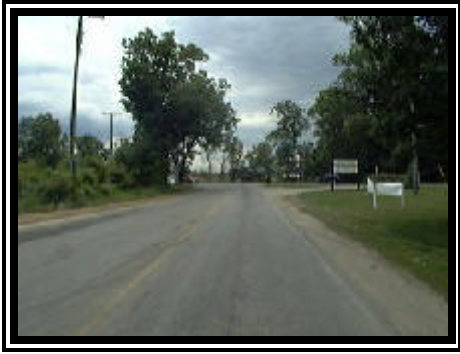
Figure 1. Southeasterly approach for the 1998 Dodge Caravan SE.

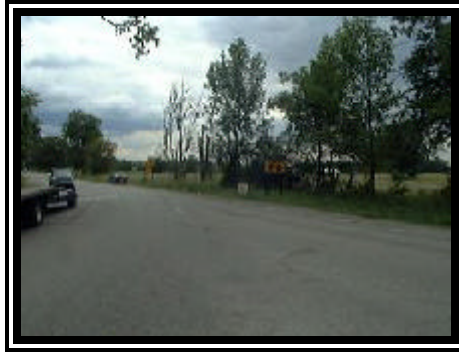
Figure 2. Southeasterly approach for the 1998 Dodge Caravan SE.

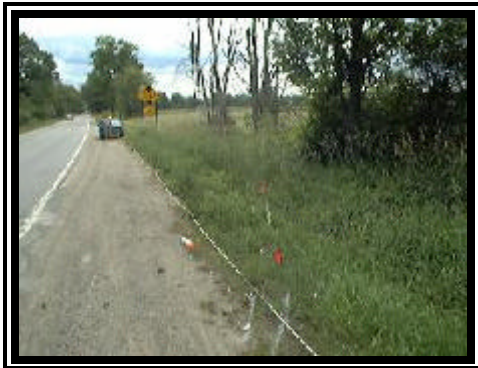
Figure 3. Pre-crash road departure (east view).

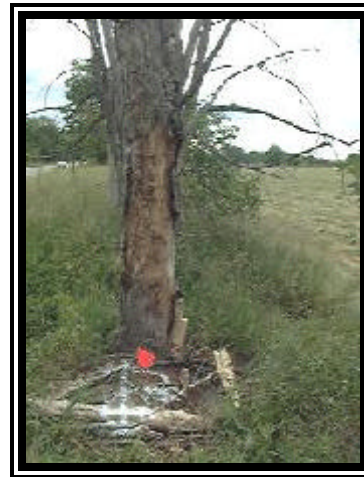
Figure 4. Impacted tree (east view).

As the Dodge Caravan departed the south pavement edge of the 3-leg intersection, the front left area impacted a large diameter tree (**Figure 4**) resulting in moderate damage. The WinSMASH reconstruction program computed a velocity change of 32.8 km/h (20.4 mph) with a matching negative longitudinal component. The impact induced deceleration was sufficient to deploy the Dodge's redesigned frontal air bag system. At this point, the vehicle rotated approximately 25 degrees counterclockwise and came to rest in close proximity to the point of impact facing east.

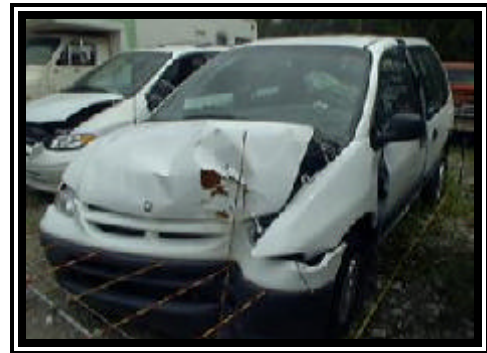
The 1998 Dodge Caravan SE sustained moderate frontal damage as a result of the impact with the tree (**Figure 5**). The direct contact damage began 18.0 cm (7.5 in) to the right of the front left bumper corner and extended 32.0 cm (12.6 in) inboard. The impact deformed the entire front end width resulting in a combined direct and induced damage length (Field L) of 140.0 cm (55.1 in). Six crush measurements were documented at the level of the bumper: C1= 18.0 cm (7.1 in), C2= 48.0 cm (18.9 in), C3= 30.0 cm (11.8 in), C4= 12.0 cm (4.7 in), C5= 0 cm, C6= 0 cm.

**Figure 5. Front left damage to the 1998 Dodge Caravan SE.**

The Collision Deformation Classification (CDC) for this impact to the Dodge was 12-FLEN-3 with a principal direction of force of 0 degrees. The hood was deformed up and rearward from engagement against the tree. The windshield was fractured from exterior impact forces (only). Reduction in the left side wheelbase measured 16.0 cm (6.3 in).

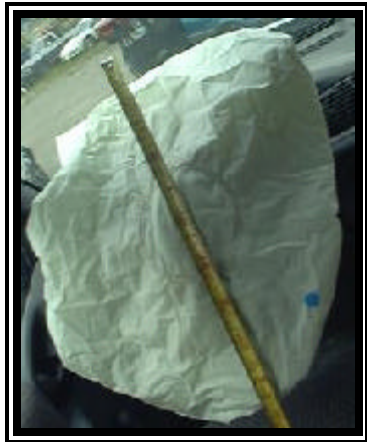
flaps were asymmetrical in shape as the upper flap measured 18.0 cm (7.1 in) in width and 1.0 cm (0.4 in) in height while the lower flap measured 18.0 cm (7.1 in) in width and 9.0 cm (3.5 in) in height. Although no contact evidence was identified on the exterior surface of the module cover flaps, blood spattering was noted at the lower right quadrant of the air bag face. The NASS researcher measured the diameter of the driver air bag at 60.0 cm (23.6 in) in its deflated state (**Figure 6**). The bag was tethered by two internal straps. No vent ports were present.

**Figure 6. 1998 Dodge Caravan SE deployed redesigned driver air bag.**

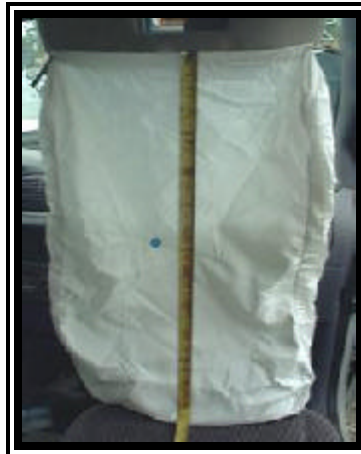
The front right passenger air bag deployed from the right mid-instrument panel area with a horizontally oriented flap tear seam (H-configuration). No contact evidence was identified on the exterior surface of the module cover flaps. The cover flaps were rectangular and symmetrical in shape and measured 31.0 cm (12.2 in) in width and 7.0 cm (2.8 in) in height. The NASS researcher measured the passenger air bag at 44.0 cm (17.3 in) in width and 75.0 cm (29.5 in) in height in its deflated state (**Figure 7**). A fabric transfer that measured 6.0 cm (2.4 in) in width and 16.0 cm (6.3 in) in height was identified at the left (centered) quadrant of the air bag face. No internal tether straps or vent ports were present.

**Figure 7. 1998 Dodge Caravan SE deployed redesigned passenger air bag.**

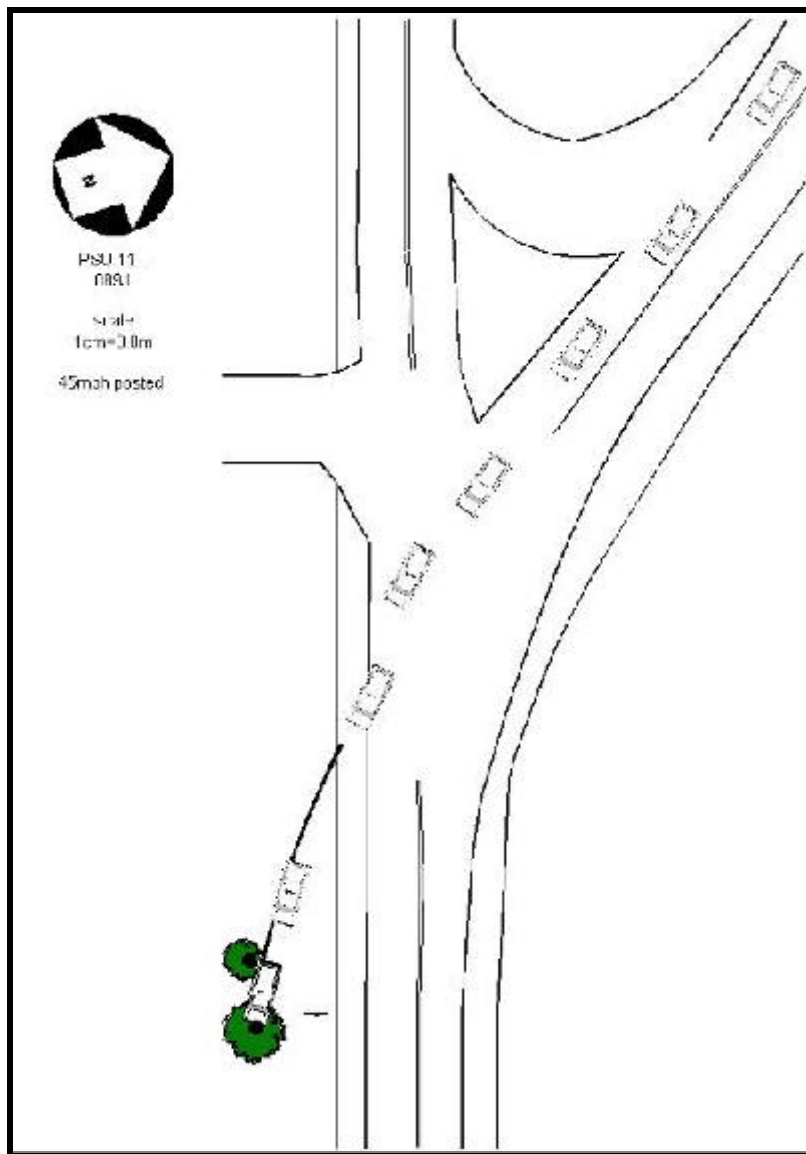
Figure 8. NASS Scene Diagram.

This single vehicle crash occurred during the evening hours of May, 1999. At the time of the crash, it was dark (street not lighted) with no adverse conditions as the roads were dry. The crash occurred off the south pavement edge of a level 3-leg “Y” intersection (see **Figure 8 - page 7**). The asphalt roadway was bordered by narrow paved shoulders with tree clusters just off the south pavement edge. Traffic control through the intersection was controlled by an overhead signal system in green phase for southbound traffic. The posted speed limit at the crash site was 72 km/h (45 mph).
