**REMOTE SIDE IMPACT AIR BAG DEPLOYMENT INVESTIGATION
SCI TECHNICAL SUMMARY REPORT**

NASS CDS CASE NO. 1999-11-117C

VEHICLE - 1998 MERCEDES-BENZ ML320 SPORT UTILITY

CRASH DATE - JULY, 1999

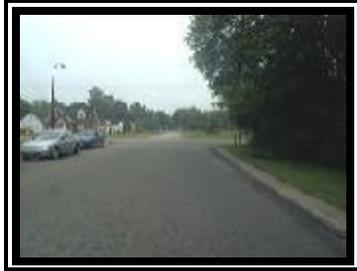
The 30 year old female driver of the 1998 Mercedes-Benz ML320 was operating the vehicle eastbound (**Figure 1**) on approach to a rural 4-leg intersection. Although intending to turn left, she was unfamiliar with the area and failed to detect the stop sign as she proceeded straight through the intersection. The

Figure 1. Eastbound approach for the 1998 Mercedes-Benz ML320 sport utility vehicle.

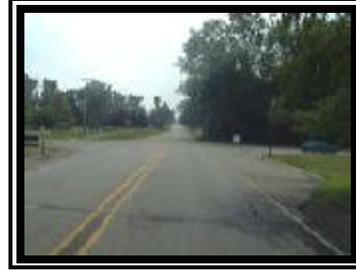
NASS scene inspection revealed that the stop sign was obstructed by tree limbs. The 1992 GMC Sierra pickup truck was driven by a 46 year old male who was operating the vehicle southbound (**Figure 2**) when he observed the Mercedes cross his path of travel. Upon recognition of the impending harmful event, he steered left and braked in avoidance remaining in the southbound travel lane prior to the collision.

Figure 2. Southbound approach for the 1992 GMC Sierra pickup truck.

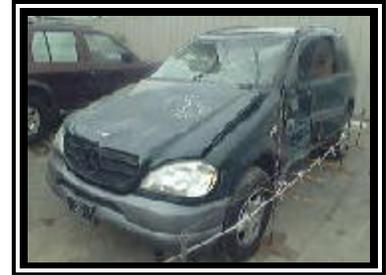
The Mercedes sustained moderate left side damage as a result of the impact with the Sierra pickup truck (**Figure 3**). The direct contact began 102.0 cm (40.2 in) forward of the left rear axle and extended forward 135.0 cm (53.1 in). The combined direct and induced damage length (Field L) began 55.0 cm (21.7 in) forward of the left rear axle and extended forward 228.0 cm (89.8 in). Six crush measurements were documented at the level of the lower door: C1= 4.0 cm (1.6 in), C2= 17.0 cm (6.7 in), C3= 32.0 cm (12.6 in), C4= 27.0 cm (10.6 in), C5= 8.0 cm (3.1 in), C6= 4.0 cm (1.6 in). The direct contact damage restricted the left front door opening. Induced damage was noted to the left front/rear glazing (disintegrated), left fender and quarter panel. The right front wheel/tire was deflated (not restricted). Rollover damage was documented to the top and right side surface of the vehicle with a maximum crush value of 6.0 cm (2.4 in) identified at the right A-pillar area. The windshield was fractured from exterior forces (only).

Figure 3. Left side and top damage to the 1998 Mercedes-Benz ML320 sport utility.

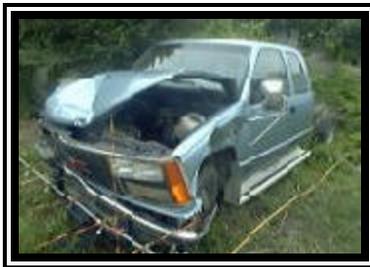
Figure 4. Frontal damage to the 1992 GMC Sierra pickup truck.

The 1992 GMC Sierra pickup truck sustained moderate frontal damage as a result of the impact with the Mercedes (**Figure 4**). The direct contact damage began at the front right bumper corner and extended 110.0 cm (43.3 in) inboard. The impact deformed the full frontal width resulting in a combined direct and induced damage length (Field L) of 175.0 cm (68.9 in). The end structure was displaced to the left approximately 25.0 cm (9.8 in). The hood was displaced up and to the left from engagement against the side surface of the Mercedes. Induced damage was identified at the left and right fenders which restricted the front wheels/tires (not deflated). The windshield was undamaged.

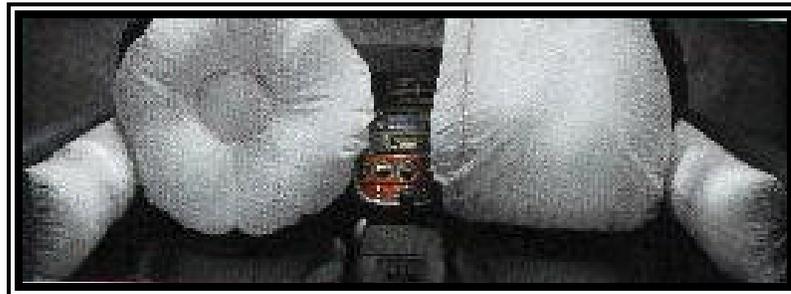
The 1998 Mercedes-Benz ML320 was equipped with frontal air bags for the driver and front right passenger positions (**Figure 6**). The air bags did not deploy as a result of the crash. The driver air bag was housed in the center of the steering wheel with a dual cover flap design. The front right passenger air bag was housed in a mid-mount module in the right instrument panel with a single cover flap design hinged at the top aspect. No cutoff switch was reported for the front right air bag. The vehicle was also equipped with restraint pretensioners which did not actuate as a result of the impacts.

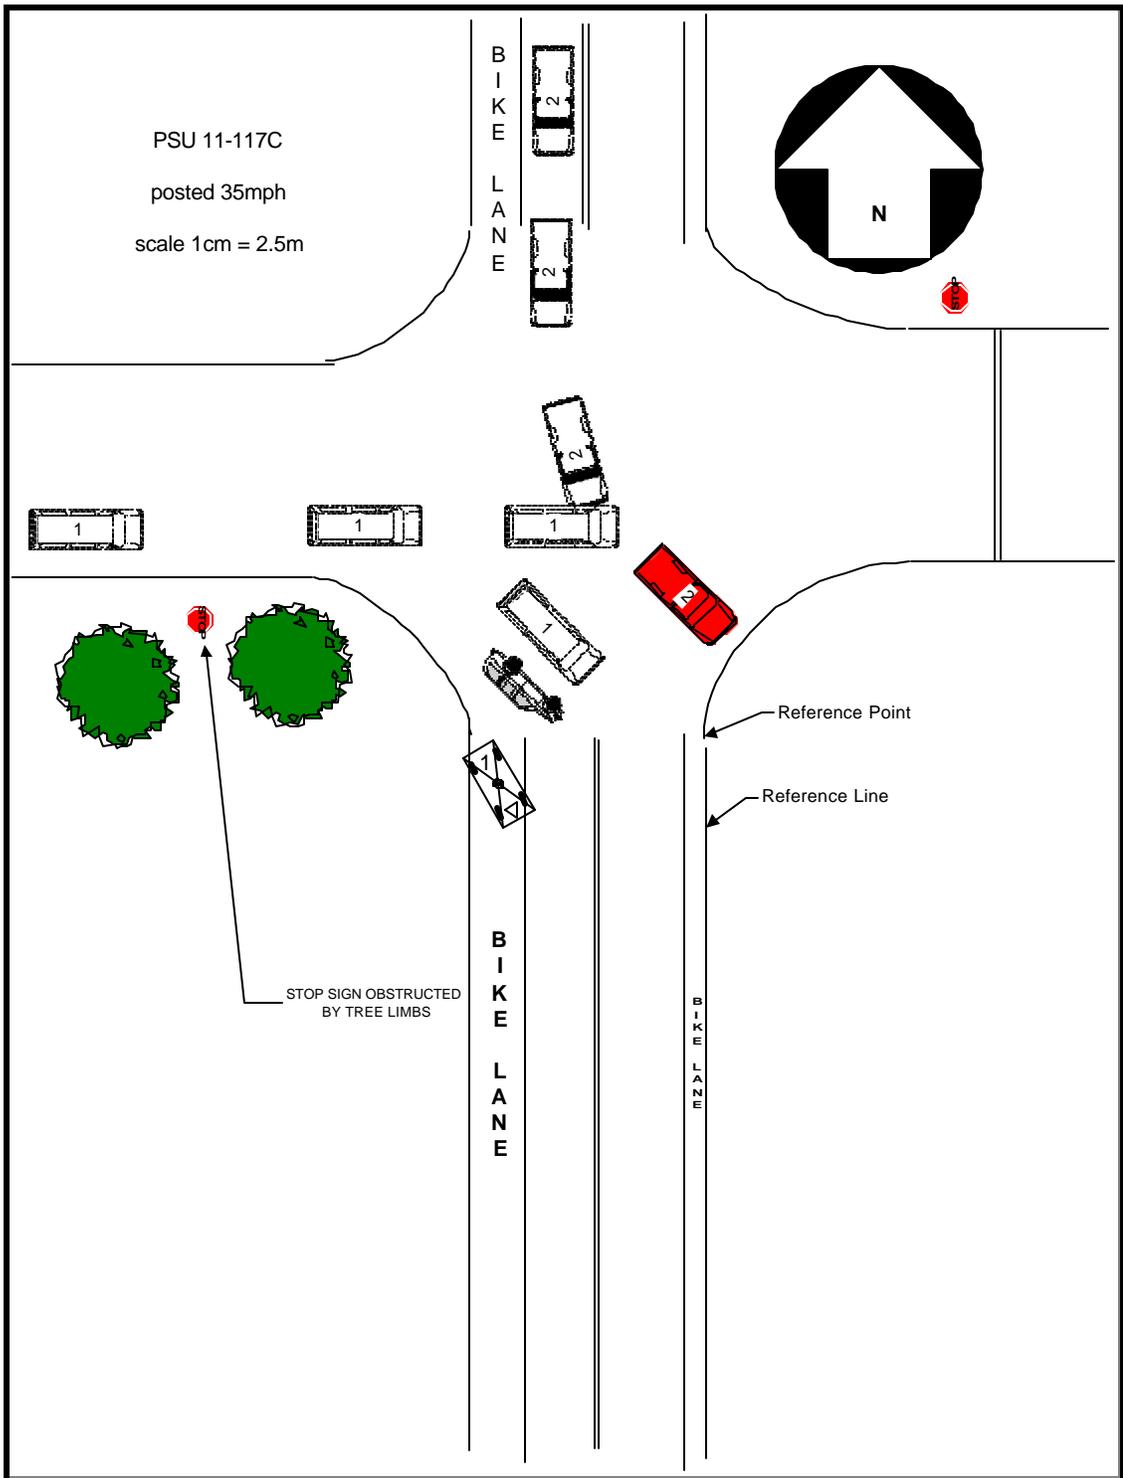
Figure 9. NASS Scene Diagram

This two-vehicle crash occurred during the afternoon hours of July, 1999. At the time of the crash, it was daylight with no adverse conditions as the roads were dry. The crash occurred in the southbound lane of a straight/level 4-leg intersection (**see Figure 9 - page 7**) which was controlled by stop signs for east/westbound traffic. The speed limit at the crash scene was 56 km/h (35 mph).
