**REDESIGNED AIR BAG SPECIAL STUDY (RABSS)
SCI TECHNICAL SUMMARY REPORT**

NASS CDS CASE NO. 1999-11-196J

RABSS VEHICLE - 1999 DODGE STRATUS ES

CRASH DATE - DECEMBER, 1999

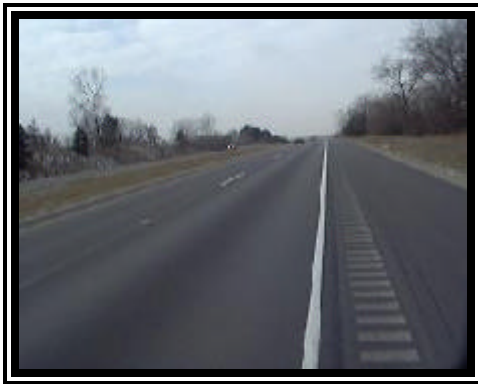
The 45 year old female driver of the 1999 Dodge Stratus ES was operating the vehicle westbound (**Figure 1**) in the outboard lane at a (driver reported) speed of 121 km/h (75 mph) when she changed lanes to the left to pass a westbound (non-contact) slow moving vehicle traveling ahead. She completed

Figure 1. Westbound approach for the 1999 Dodge Stratus ES.

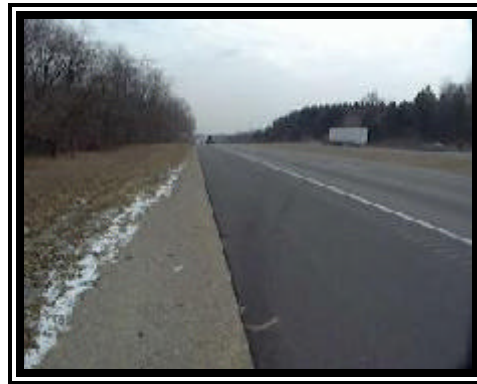
As the Dodge Stratus re-entered the outboard (westbound) lane, the frontal area impacted the rear left area of the Peterbilt resulting in moderate damage. Although the impact was classified as out-of-scope, the WinSMASH reconstruction program computed a barrier equivalent velocity change of 44.9 km/h (27.9 mph) with a longitudinal component of -44.2 km/h (-27.5 mph). The impact induced deceleration was sufficient to deploy the Dodge's redesigned frontal air bag system. At this point, the Dodge traveled approximately 28.0 meters (91.9 feet) onto the north shoulder and came to rest facing northwest (**Figure 2**) as the Peterbilt was driven to final rest along the north shoulder facing west.

Figure 2. Look back view (east) from vehicle final rest showing post-impact yaw marks onto north shoulder.

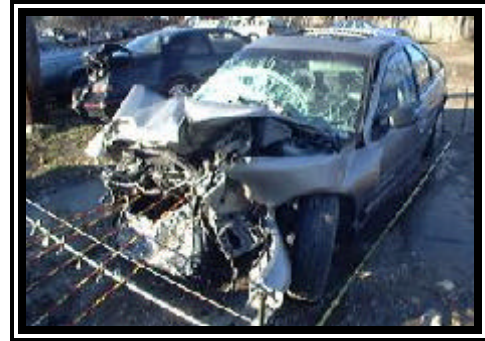
The 1999 Dodge Stratus ES sustained moderate frontal damage as a result of the impact with the Peterbilt (**Figure 3**). The direct contact damage encompassed the entire end width resulting in a combined direct and induced damage length (Field L) of 81.0 cm (31.9 in). Six crush measurements were documented at the level of the lower radiator (*bumper reinforcement bar and fascia separation*): C1= 28.0 cm (11.0 in), C2= 49.0 cm (19.3 in), C3= 51.0 cm (20.1 in), C4= 53.0 cm (20.9 in), C5= 46.0 cm (18.1 in), C6= 37.0 cm (14.6 in). The Collision Deformation Classification (CDC) for this impact to the Dodge was 12-FDEW-3 with a principal direction of force of (-)10 degrees. The hood was deformed up and rearward from engagement against the rear surface of the Peterbilt. The windshield was fractured from exterior impact forces and the interior front right passenger air bag deployment. A 15.2 cm (6.0 in) slit was identified along the right lower windshield from possible penetration of the opposing vehicle. The right fender was deformed rearward which jammed the front door. The left fender was deformed laterally which restricted the left front wheel/tire (not deflated). Induced contact damage also produced buckling of both A-pillars, front roof side rails, and roof. Reduction in the right side wheelbase measured 4.0 cm (1.2 in).

Figure 3. Frontal damage to the 1999 Dodge Stratus ES.

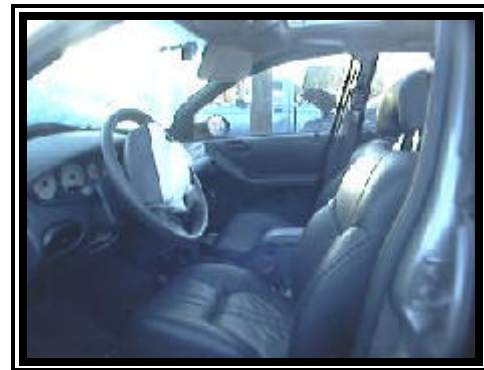
Interior damage to the Dodge Stratus identified through the vehicle inspection was minimal and was attributed to occupant contact and component intrusion (**Figure 4**). Scuff marks were documented on the left knee bolster (rigid plastic type), sunvisor, and roof panel. The instrument cluster located on the center instrument panel was slightly pushed inward with the surrounding trim panel displaced. The rearview mirror was displaced to the right (undamaged). The roof glazing was disintegrated. Longitudinal intrusions into the front occupant space involved 7.0 cm (2.8 in) of right toepan, 5.0 cm (2.0 in) of left toepan, 5.0 cm (2.0 in) of left instrument panel, 4.0 cm (1.6 in) of center instrument panel, and 6.0 cm (2.4 in) of right instrument panel intrusion. Vertical intrusions into the driver space involved 3.0 cm (1.2 in) of roof intrusion.

Figure 4. Interior view.

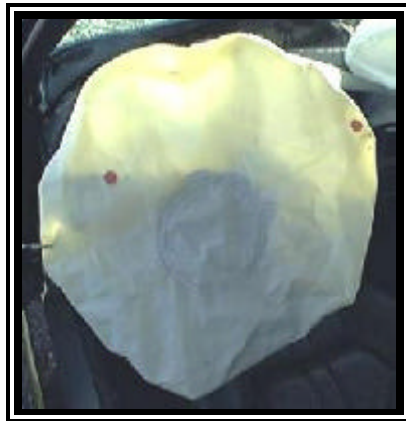
The 1999 Dodge Stratus was equipped with redesigned frontal air bags for the driver and front right passenger positions. The air bags deployed as a result of the crash. The driver air bag was housed in the center of the steering wheel with a horizontally oriented flap tear seam (H-configuration). The flaps

were symmetrical in shape and measured 21.0 cm (8.3 in) in width and 7.0 cm (2.8 in) in height. Although no contact evidence was identified on the exterior surface of the module cover flaps, blood spattering was noted on the right portion of the air bag face. The NASS researcher measured the diameter of the driver air bag at 55.0 cm (21.7 in) in its deflated state (**Figure 5**). The bag was tethered by two internal straps and vented by one port located at the 12 o'clock sector on the rear aspect of the air bag.

Figure 5. 1999 Dodge Stratus ES deployed redesigned driver air bag.

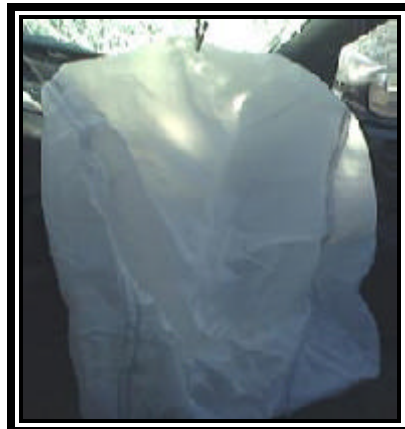
The front right passenger air bag deployed from the right top instrument panel area with a single cover flap design hinged at the forward aspect. The cover flap was rectangular in shape and measured 37.0 cm (14.6 in) in width and 21.0 cm (8.3 in) in height. Although no contact evidence was identified on the exterior surface of the module cover flap, blood spattering was also noted along the lower left quadrant of the air bag face. The NASS researcher measured the passenger air bag at 66.0 cm (26.0 in) in width and 68.0 cm (26.8 in) in height in its deflated state (**Figure 6**). No internal tether straps or vent ports were present.

Figure 6. 1999 Dodge Stratus ES deployed redesigned passenger air bag.
