SCI/NASS COMBINATION CASE REPORT

CASE NUMBER - NASS-99-12-081G

VEHICLE - 1998 OLDSMOBILE SILHOUETTE

CRASH DATE - May, 1999

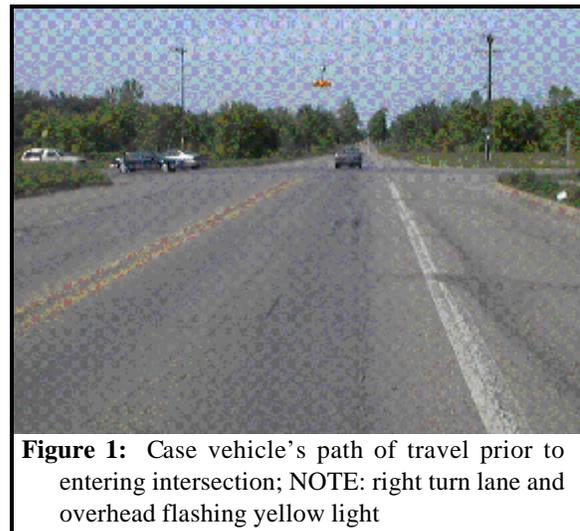
The case vehicle was traveling north in the inside northbound lane of a three-lane, two-way, undivided county roadway and was approaching a four-leg, partially controlled intersection intending to continue traveling north (**Figure 1**). Vehicle #1 was traveling east in the eastbound lane of the intersecting, three-lane, two-way, undivided county roadway and entered into the intersection. The case vehicle's driver was unable to attempt any avoidance maneuvers and was struck by vehicle #1. The crash occurred in the intersection of the two roadways.

Figure 1: Case vehicle's path of travel prior to entering intersection; NOTE: right turn lane and overhead flashing yellow light

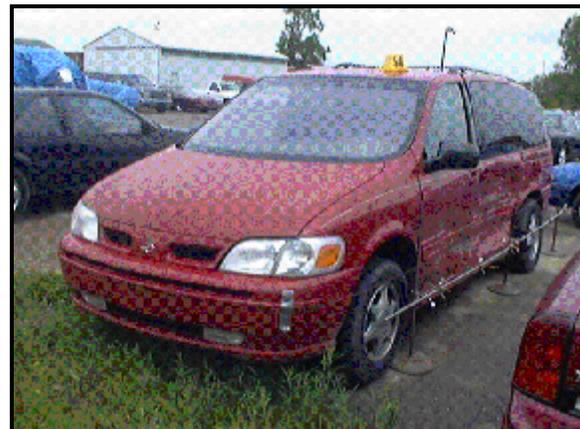
The case vehicle's initial contact with vehicle #1 involved the left side from just behind the left rear axle forward (**Figure 2**). The case vehicle's right rear tire impact with the curb involved the tire only. Direct damage from the case vehicle's initial impact extended from 6 centimeters (2.4 inches) behind the left rear axle forward 202 centimeters (79.5 inches). The maximum crush to the case vehicle's left side was a measured 16 centimeters (6.3 inches) and was located between C3 and C4 (**Figure 3**). The wheel base on the left side was shortened 1 centimeter (0.4 inches) with the right side remaining unchanged. The right rear tire had been deflated during the curb impact and subsequently broke off from the rear axle. There was no glazing damage to the case vehicle.

The CDCs were determined to be: **11-LZEW-2 (-40)** and **03-RBWN-1 (+90)** for the case vehicle [maximum crush was 16 centimeters (6.3 inches) on the left side]. No reconstruction program was used on the case vehicle's left side impact due to one of the collision conditions (i.e., vehicle #1 was repaired) being beyond the scope of the WinSMASH reconstruction program; however, this contractor's visually estimated Delta V for the left side impact is

Figure 2: Front left oblique view of case vehicle

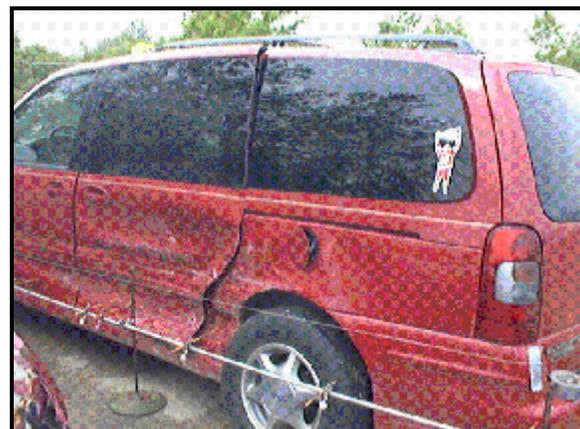
Figure 3: Case vehicle's left side damage

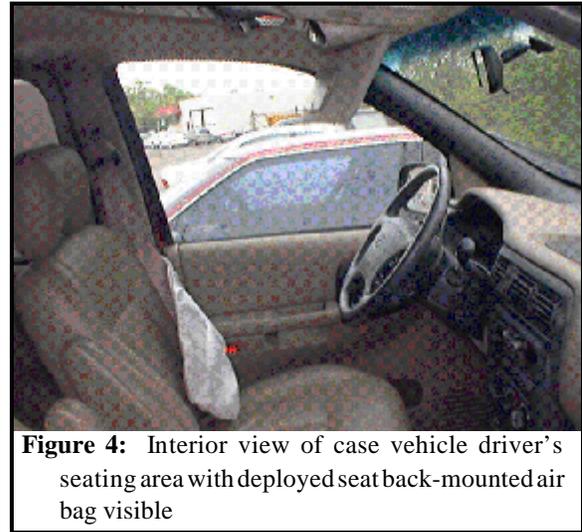
The case vehicle was equipped with a SRS that consisted of front air bags and seat back-mounted side air bags at the driver and front right passenger seat positions. The only air bag that deployed was the case vehicle driver's side air bag (**Figure 4**). The driver's side air bag deployed as a result of the case vehicle's left side impact with vehicle #1. The driver's side air bag deployed from the outside of the driver's seat back where it was mounted. The module cover consisted of a single symmetrical cover flap with overall dimensions of 18 centimeters (7.1 inches) at the vertical seam and 7 centimeters (2.8 inches) horizontally. The flap were made of thick vinyl- type material. The side air bag was 45 centimeters (17.7 inches) longitudinally and 27 centimeters (10.6 inches) vertically and was not tethered (**Figure 5**). The driver's side air bag had one vent port (unknown diameter) located at the 11 o'clock position.

Figure 4: Interior view of case vehicle driver's seating area with deployed seat back-mounted air bag visible

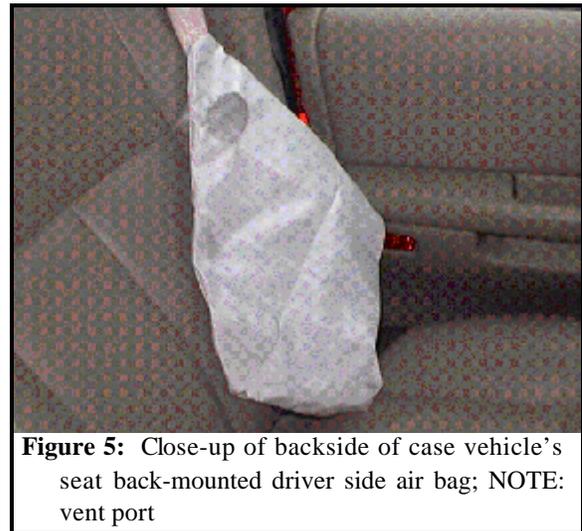
Figure 5: Close-up of backside of case vehicle's seat back-mounted driver side air bag; NOTE: vent port

An inspection of the case vehicle driver's side air bag and cover flap revealed no visible evidence of direct contact from the driver.

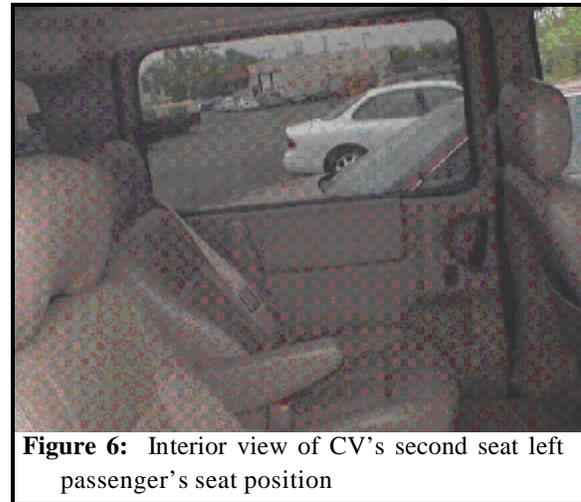
The case vehicle's driver made no avoidance maneuvers and the second seat left passenger’s pre-impact posture remained unchanged. The case vehicle's impact with vehicle #1 resulted in the case vehicle’s second seat left passenger continuing slightly forward and leftward contacting the left B-pillar with her head as the case vehicle rotated counterclockwise. The case vehicle’s subsequent impact with the curb resulted in this passenger moving back to the right. At final rest she was conscious and remained in her seat near her original seating position (**Figure 6**).

Figure 6: Interior view of CV’s second seat left passenger’s seat position

The second seat left passenger was not transported or treated by EMS personnel. The second seat left passenger sustained a contusion to the left side of her head and a seat belt abrasion to her left shoulder.

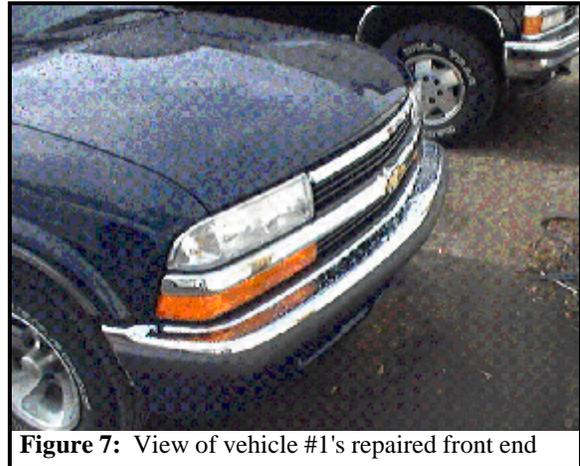
Vehicle #1 was equipped with front air bags for the driver and front right passenger seat positions and three-point lap-and-shoulder safety belts for the front outboard seating positions. There was a cut-off switch located in the center of the case vehicle's instrument panel for the front right passenger's front air bag which was turned to the off position. The interior was equipped with adjustable bucket seats with integral head restraints for the driver and front right passenger. Damage to vehicle #1 is unknown because it was repaired prior to the NASS researcher's inspection (**Figure 7**).
