**REDESIGNED AIR BAG SPECIAL STUDY (RABSS)  
SCI TECHNICAL SUMMARY REPORT**

**NASS CDS CASE NO. 1999-13-174J**

**RABSS VEHICLE - 1999 DODGE GRAND CARAVAN**

**CRASH DATE - OCTOBER, 1999**

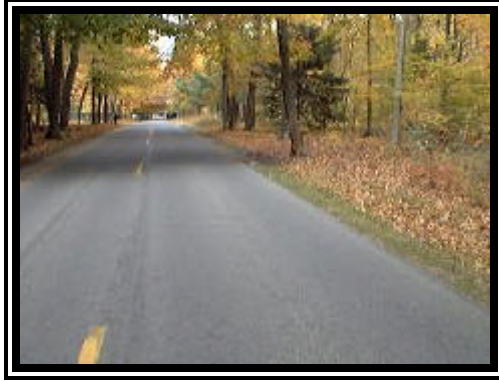
The 35 year old female driver of the 1999 Dodge Grand Caravan was operating the vehicle northbound (**Figure 1**) when she reportedly lost consciousness due to a pre-existing medical condition and allowed the vehicle to depart the east pavement edge in a forward tracking mode.

**Figure 1. Northbound approach for the 1999 Dodge Grand Caravan.**

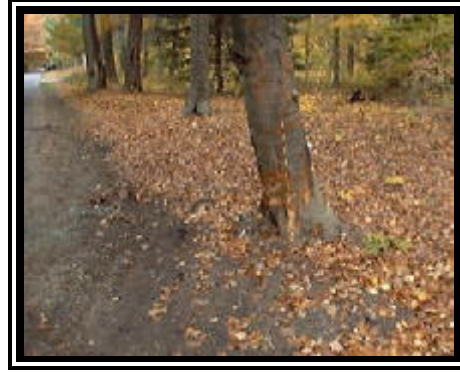
**Figure 2. Struck tree and vehicle final rest area.**

As the Dodge exited the right (east) pavement edge of the 2-lane roadway, the front right area impacted a large diameter tree (**Figure 2**) resulting in severe damage. The WinSMASH reconstruction program computed a (*SCI revised*) barrier equivalent velocity change of 43.9 km/h (27.3 mph) with a matching negative longitudinal component. The impact induced deceleration was sufficient to deploy the Dodge's redesigned frontal air bag system. At this point, the vehicle rotated approximately 25 degrees clockwise and came to rest partially in the roadway facing northeast.

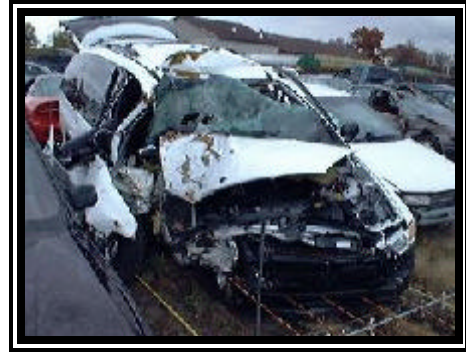
The 1999 Dodge Grand Caravan sustained severe frontal damage as a result of the impact with the tree (**Figure 3**). *Erroneous field documentation by the NASS researcher necessitated multiple SCI revisions to the crush profile.* The *revised* direct contact damage began at the front right bumper corner and extended approximately 35.0 cm (13.8 in) inboard. The impact deformed the entire front end width resulting in a combined direct and induced damage length (Field L) of 100.0 cm (39.4 in). Six crush measurements were documented at the level of the reinforcement bar (*bumper fascia separation*): C1= 6.0 cm (2.4 in), C2= 8.0 cm (3.1 in), C3= 24.0 cm (9.4 in), C4= 36.0 cm (14.2 in), C5= 46.0 cm (18.1 in), C6= 77.0 cm (30.3 in). *Contrary to the NASS case file*, the damage pattern exhibits a narrow end engagement with direct contact damage extending rearward to the A-pillar. Semi-circular buckling along the right windshield header area suggests possible tree penetration into the passenger compartment resulting in a *SCI revised* Collision Deformation Classification (CDC) of 12-FRAE-7. The hood was deformed up and rearward from engagement against the tree. The right fender was displaced rearward which restricted the right front wheel/tire (not deflated) and jammed the right side doors. Induced contact damage also produced outward buckling to the right front door (with integrity loss) and roof buckling aft of the B-pillar area. The windshield was fractured with a slit located along the right lower portion which measured 20.0 cm (7.9 in). Reduction in the right side wheelbase measured 80.0 cm (31.5 in).

**Figure 3. Front right damage to the 1999 Dodge Grand Caravan.**

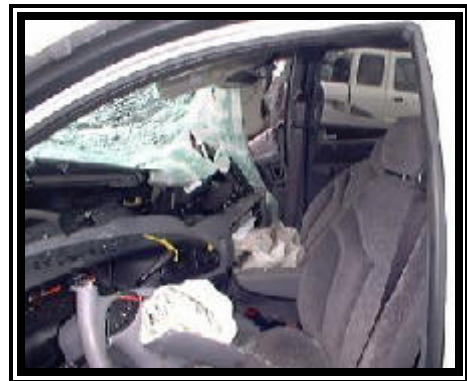
Interior damage to the Dodge identified through the vehicle inspection was severe and was attributed to occupant contact and component intrusion (**Figure 4**). Scuff marks and indentations were documented on the center instrument panel at the junction with the left knee bolster. Possible skin tissue was identified on the right lower windshield. The top portion of the steering wheel rim was cut by rescue personnel during driver extrication activities post-crash. The front right seat was deformed by multiple component intrusions. Longitudinal intrusions into the front right passenger space involved 80.0 cm (31.5 in) of instrument panel, 62.0 cm (24.4 in) of windshield, and 52.0 cm (20.5 in) of toepan intrusion. Longitudinal intrusions into the front center area involved 50.0 cm (19.7 in) of instrument panel, and 39.0 cm (15.4 in) of windshield intrusion. Longitudinal intrusions into the driver space involved 17.0 cm (6.7 in) of windshield intrusion. The NASS researcher failed to provide adequate (vertical) windshield header, roof and A-pillar intrusion measures.

**Figure 4. Interior view.**

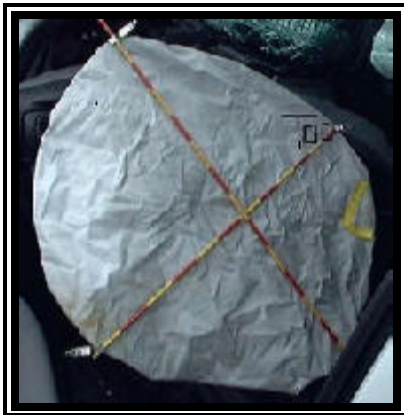
The 1999 Dodge Grand Caravan was equipped with redesigned frontal air bags for the driver and front right passenger positions. The air bags deployed as a result of the crash. The driver air bag was housed in the center of the steering wheel with a horizontally oriented flap tear seam (H-configuration). The flaps were symmetrical in shape and measured 17.0 cm (6.7 in) in width and 9.0 cm (3.5 in) in height. Although no contact evidence was identified on the exterior surface of the module cover flaps, makeup transfers and blood spattering were documented on the upper right quadrant of the air bag face. The NASS researcher measured the diameter of the driver air bag at 65.0 cm (25.6 in) in its deflated state (**Figure 5**). No internal tether straps or vent ports were present.

**Figure 5. 1999 Dodge Grand Caravan deployed redesigned driver air bag.**

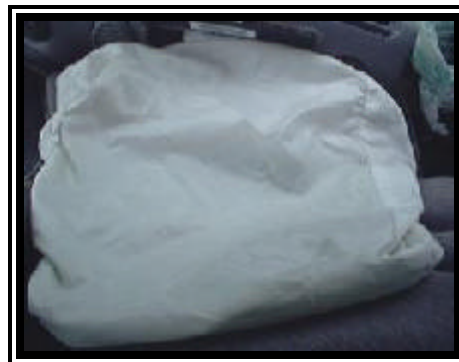
The front right passenger air bag deployed from the right mid-instrument panel area with a horizontally oriented flap-tear seam (H-configuration). The cover flaps were rectangular and symmetrical in shape and measured 29.0 cm (11.4 in) in width and 8.0 cm (3.1 in) in height. No contact evidence was identified on the exterior surface of the module cover flaps. The NASS researcher measured the passenger air bag at 60.0 cm (23.6 in) in width and 50.0 cm (19.7 in) in height in its deflated state (**Figure 6**). No internal tether straps or vent ports were present. Blood pooling was noted on the left mid-portion of the air bag face. Extensive longitudinal intrusion of the right instrument panel into the front right seating area re-directed the proper deployment path of the passenger air bag membrane upward and to the left.

**Figure 6. 1999 Dodge Grand Caravan deployed redesigned passenger air bag.**

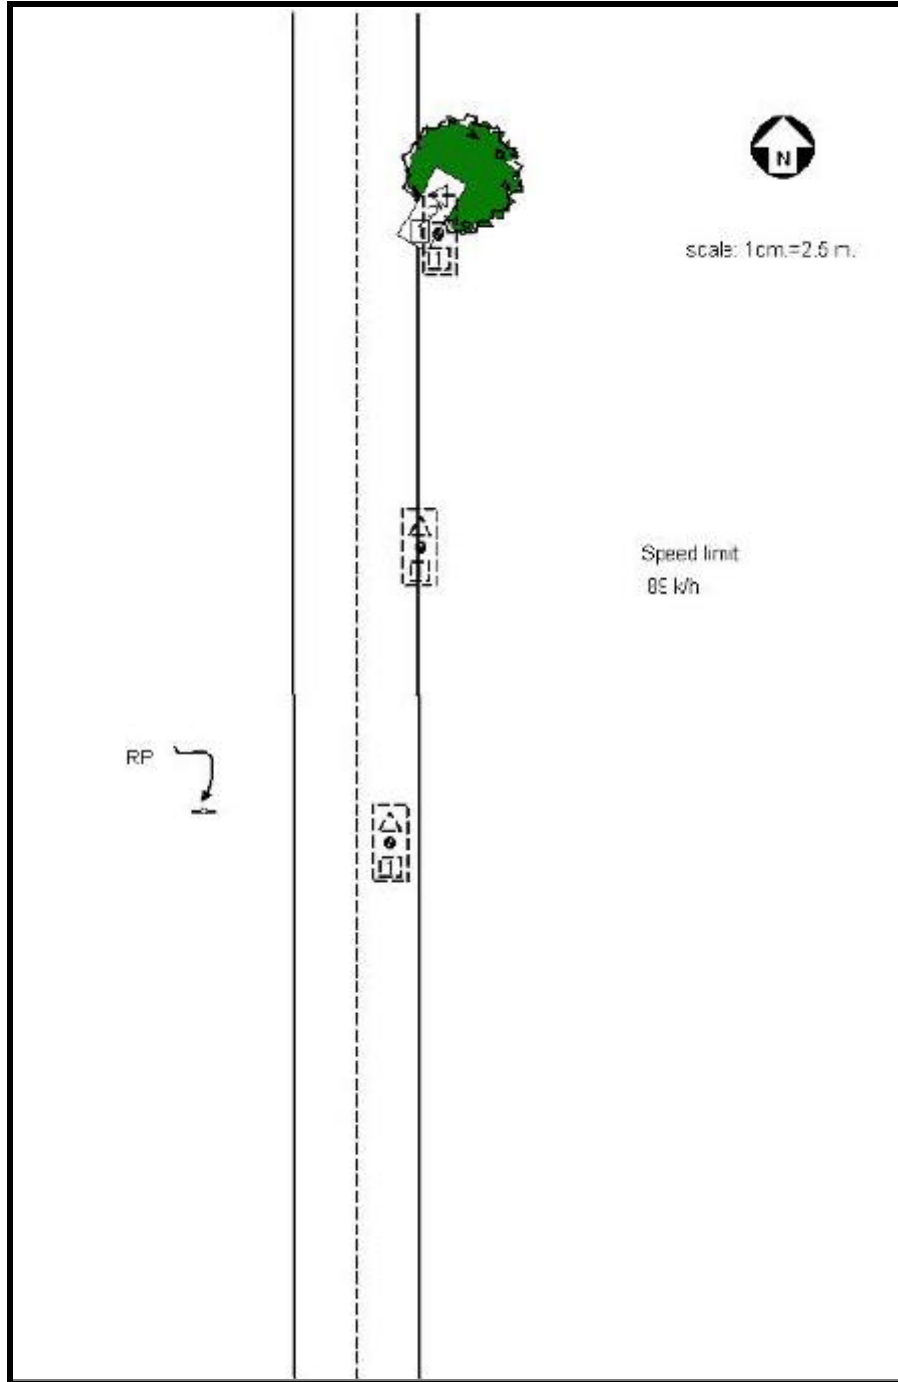
Figure 7. NASS Scene Diagram.

This single vehicle crash occurred during the afternoon hours of October, 1999. At the time of the crash, it was daylight with no adverse conditions as the road was dry. The crash occurred off the east pavement edge of a (straight/level) 2-lane north/south asphalt roadway (see **Figure 7 - page 6**) which was bordered by tree clusters. No traffic control was present at the scene which had a posted speed limit of 72 km/h (45 mph).
