**REDESIGNED AIR BAG SPECIAL STUDY (RABSS)  
SCI TECHNICAL SUMMARY REPORT**

**NASS RABSS CASE NO. 1999-13-801E**

**RABSS VEHICLE - 1999 FORD TAURUS SE**

**CRASH DATE - MAY, 1999**

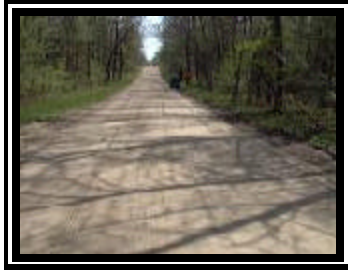
The 18 year old male driver of the 1999 Ford Taurus was operating the vehicle southbound (**Figure 1**) and proceeding straight when he observed a non-contact vehicle traveling northbound encroach into his lane of travel. Upon recognition of the impending harmful event, the driver initially steered right in avoidance, partially exiting the right (west) pavement edge. At this point, the driver steered left/braked and subsequently exited the left (east) pavement edge in a counterclockwise yaw.

**Figure 1. Southbound approach for the 1999 Ford Taurus.**

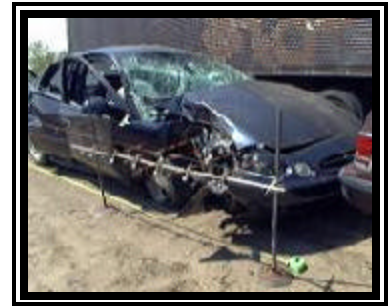
The Ford Taurus sustained severe right side damage as a result of the impact with the tree (**Figure 3**). The direct contact damage began 13.0 cm (5.1 in) aft of the front right bumper corner and extended 78.0 cm (30.7 in) rearward. The impact resulted in a combined direct and induced damage length (Field L) of 140.0 cm (55.1 in). Six crush measurements were documented at the level of the mid-door: C1= 0 cm, C2= 14.0 cm (5.5 in), C3= 44.0 cm (17.3 in), C4= 14.0 cm (5.5 in), C5= 24.0 cm (9.4 in), C6= 3.0 cm (1.2 in). Damage was noted to the hood which was displaced up and to the left from engagement against the tree. The right side wheelbase was displaced 49.0 cm (19.3 in). Induced damage was documented to the right A-pillar/side doors which shattered the side glazing and displaced the left front window frame outward 16.0 cm (6.3 in). Induced buckling was also noted to the roof area between the A and B-pillars. The windshield was fractured from exterior forces and the (interior) front right passenger air bag module cover flap.

**Figure 3. Right side damage to the 1999 Ford Taurus SE.**

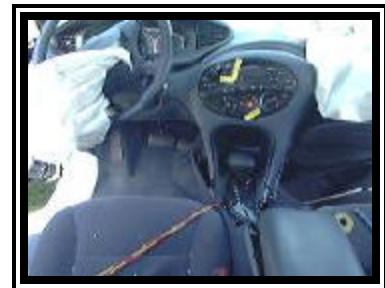
Interior damage to the Ford Taurus identified through the NASS vehicle inspection was moderate and was attributed to intrusions/occupant contact (**Figure 4**). A scuff mark was noted to the left knee bolster (rigid plastic type). No steering wheel rim deformation was noted (tilt column placed between the full up and center position), however, a scuff mark was noted to the steering column just above the knee bolster. Although no contact evidence was identified on the air bags or exterior surface of the module cover flaps, black vinyl transfers were noted to the face of the driver air bag from expansion within the module. The center instrument panel and rear view mirror were smudged and fractured. The right mid-windshield area was fractured from the passenger air bag module cover flap. Intrusions into the front right passenger space included 17.0 cm (6.7 in) of longitudinal instrument panel intrusion, 8.0 cm (3.1 in) of longitudinal toepan intrusion, 28.0 cm (11.0 in) of lateral side panel intrusion and 7.0 cm (2.8 in) of vertical floor pan intrusion.

**Figure 4. Interior damage.**

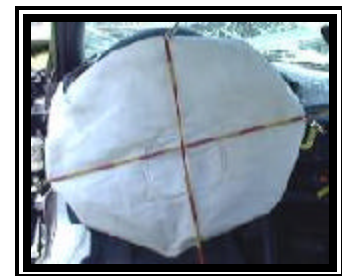
The 1999 Ford Taurus SE was equipped with redesigned frontal air bags for the driver and front right passenger positions. The air bags had deployed as a result of the crash. The driver air bag was housed in the center of the steering wheel with a horizontally oriented flap tear seam (H-configuration). No contact evidence was identified on the air bag or exterior surface of the module cover flaps. The flaps were rectangular in shape as the upper flap measured 15.5 cm (6.1 in) in width and 8.0 cm (3.1 in) in height while the lower flap measured 15.5 cm (6.1 in) in width and 6.0 cm (2.4 in) in height. Black vinyl transfers were noted to the

**Figure 5. 1999 Ford Taurus SE redesigned driver air bag.**

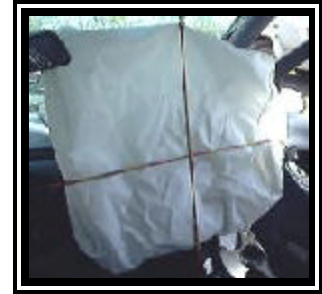
The front right passenger air bag deployed from a top mount module in the right instrument panel with a single cover flap design hinged at the forward aspect. No contact evidence was identified on the air bag or exterior surface of the module cover flap. The cover flap was rectangular in shape which opened in an upward direction toward the windshield (fractured) and measured 40.0 cm (15.7 in) in width and 25.0 cm (9.8 in) in height. The NASS researcher measured the passenger air bag at 50.0 cm (19.7 in) square in its deflated state (**Figure 7**). No tether straps were present. The bag was vented by two ports located at the 3 o'clock and 9 o'clock sectors on the side aspect of the air bag. No cutoff switch was reported for the front right air bag.

**Figure 6. 1999 Ford Taurus SE redesigned passenger air bag.**

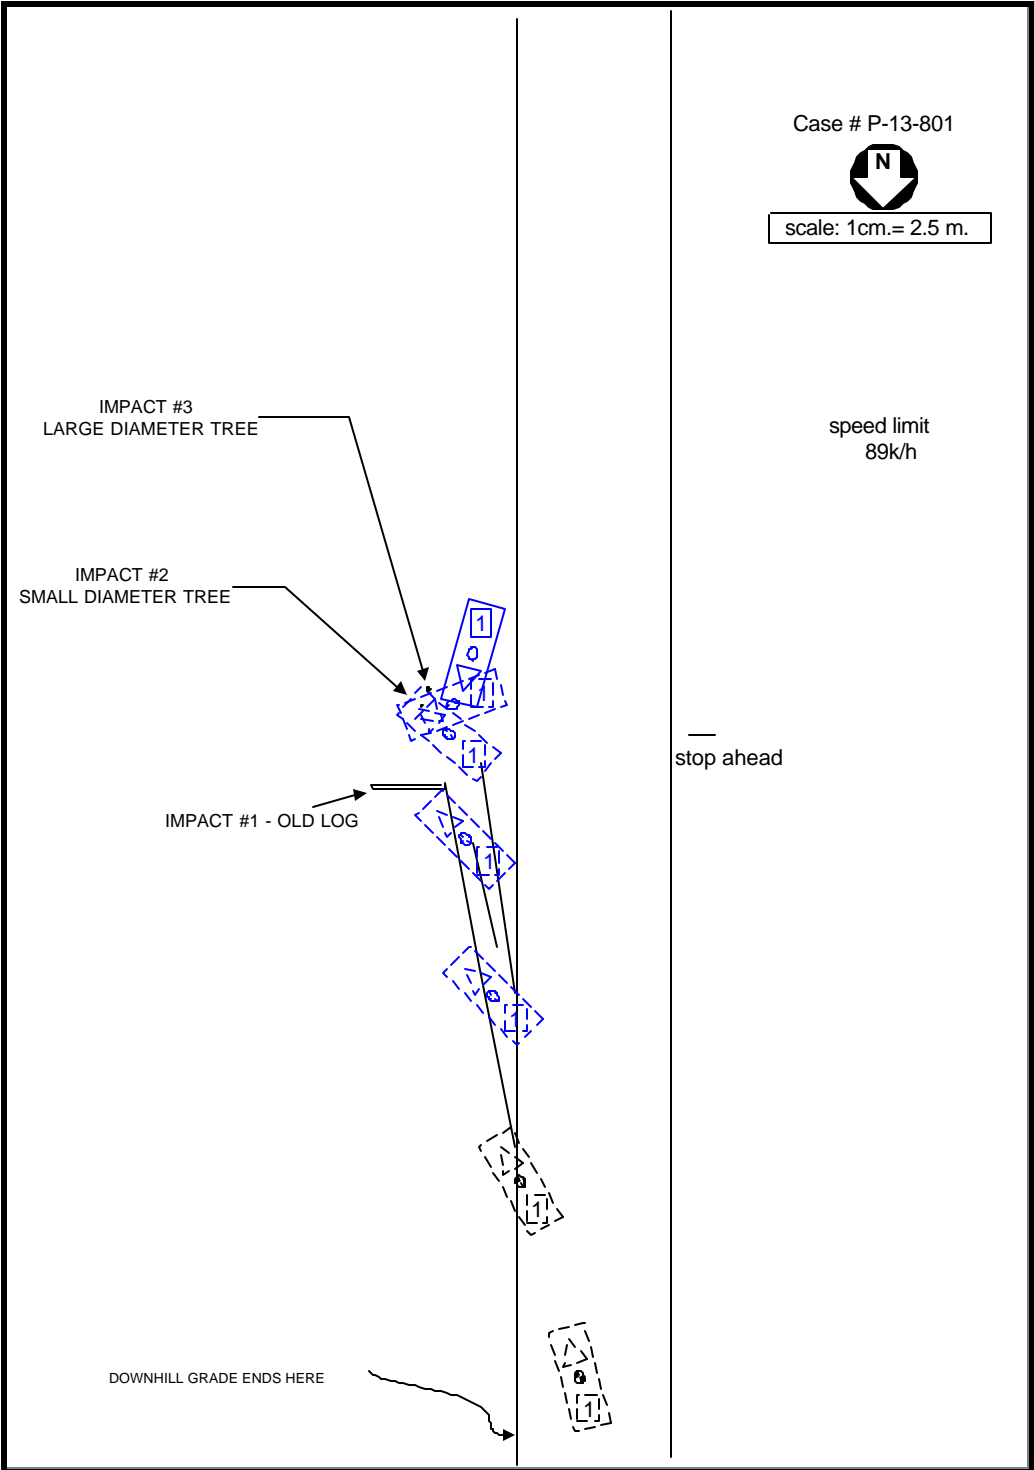
Figure 7. NASS Scene Diagram.

This single vehicle crash occurred during the early evening hours of May, 1999. At the time of the crash, it was daylight with no adverse conditions as the road was dry. The crash occurred off the east pavement edge of a 2 lane north/south dirt and gravel roadway (see **Figure 7 - page 6**) which has a posted speed limit of 89 km/h (55 mph). No traffic controls were present at the scene.
