SCI/NASS COMBINATION CASE REPORT

CASE NUMBER - NASS-99-41-042J

LOCATION - FLORIDA

VEHICLE - 1998 TOYOTA AVALON

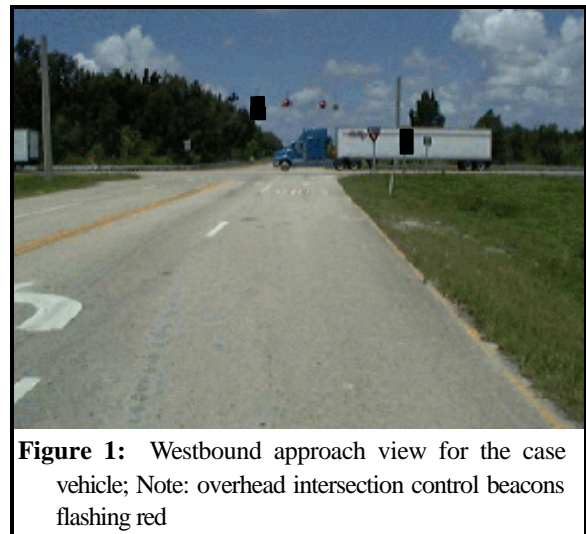
The case vehicle was traveling west in the outside westbound lane of a four-lane, two-way, undivided state highway (i.e., one left-turn lane and one through lane in each direction), approaching an intersection and intending to continue west (**Figure 1**). Vehicle #2 was traveling south in the outside, southbound through lane of a four-lane (i.e., left and right turn lanes and two through lanes), one-way roadway that was part of a six-lane (estimated), divided trafficway, approaching the same four-leg intersection and intending to continue south (**Figure 2**). The case vehicle entered the intersection, into the path of vehicle #2. The crash occurred within the intersection

Figure 1: Westbound approach view for the case vehicle; Note: overhead intersection control beacons flashing red

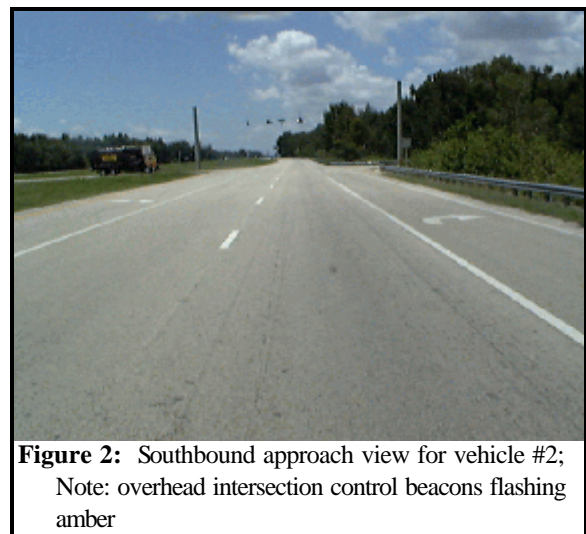
Figure 2: Southbound approach view for vehicle #2; Note: overhead intersection control beacons flashing amber

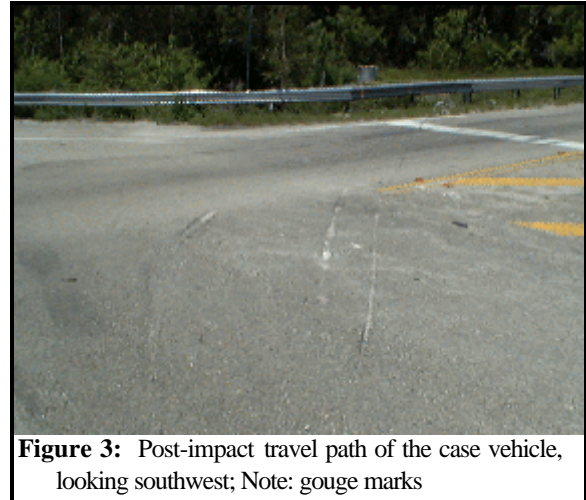
The right side of the case vehicle was impacted by the front of vehicle #2, causing the case vehicle's front right passenger side air bag to deploy (dual, redesigned front air bags and the driver's side air bag did not deploy). The case vehicle began a clockwise rotation (**Figure 3** below) that resulted in a two quarter-turn rollover onto its top, and came to rest atop a guardrail and a traffic sign on the intersection's southwest quadrant, facing southwest, with its CG having traveled a conservatively estimated 13.7 meters (45 feet) post-impact. Vehicle #2 also rotated in a clockwise direction that reached approximately 150 degrees and came to rest in its original travel

Figure 3: Post-impact travel path of the case vehicle, looking southwest; Note: gouge marks

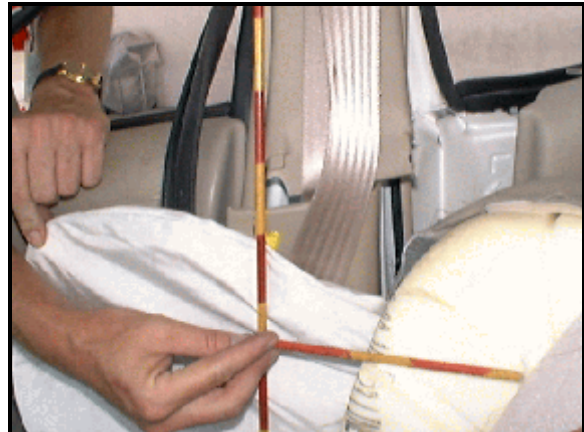
occupants were protected by a side air bag mounted within their respective seat back's outboard edge. Only the front right passenger side air bag deployed of the four air bags available in the case vehicle (**Figure 4**).

Figure 4: View of case vehicle's deployed side air bag at front right passenger's seat position

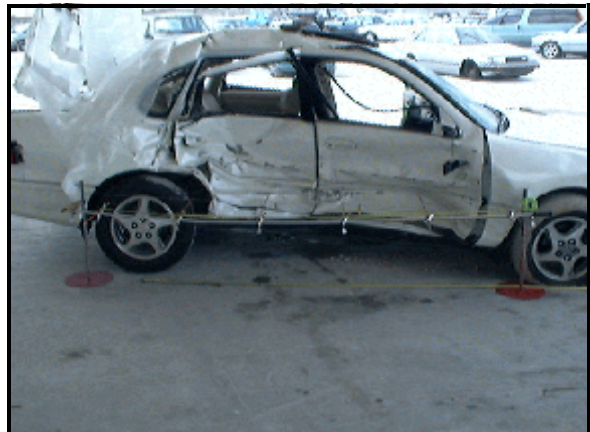
The first event in this crash sequence was a vehicle-to-vehicle collision. Vehicle #2's front plane impacted the right side of the case vehicle from the right front door's forward seam to near the right rear wheel well (**Figure 5**). Direct damage begins 75 centimeters (29.5 inches) forward of the rear axle and extends forward 209 centimeters (82.3 inches). Maximum penetration was 55 centimeters (21.7 inches) at C3. Both right side door panels were displaced inward, the right rocker panel was pushed in, the glazing in both right side doors was shattered, the right upper and lower B-pillars were shoved in, and the right outside rearview mirror was smashed. Induced damage included: buckling of the rear portion of the right front fender, the front right turn signal assembly dangling from its wire harness, slight rearward pull to the right upper A-pillar, downward pull of the right roof rail over the two right side doors, the outward pull to the upper right rear door frame, and the buckling of the right rear quarterpanel's sheet metal above the right rear wheel well.

Figure 5: Case vehicle's right side damage from contact with vehicle #2

Based on the vehicle inspection, a CDC for the vehicle-to-vehicle impact for the case vehicle (**Figure 5** and **Figure 7**) was determined to be: **03-RYEW-04 (+080)**. The WinSMASH reconstruction program, missing vehicle algorithm, was used on the case vehicle's highest severity impact. The Total, Longitudinal, and Lateral Delta Vs are, respectively: 46 km.p.h. (28.6 m.p.h.), 0.0 km.p.h. (0.0 m.p.h.), and -46 km.p.h. (-28.6 m.p.h.). Thus, the crash severity for the case vehicle was high [greater than 40 km.p.h. (25 m.p.h.)]. A CDC for the case vehicle rollover (**Figure 6** and **Figure 8**), the second event of this crash sequence, was also determined: **00-TDDO-03**. This rollover is outside the scope for the WinSMASH reconstruction program

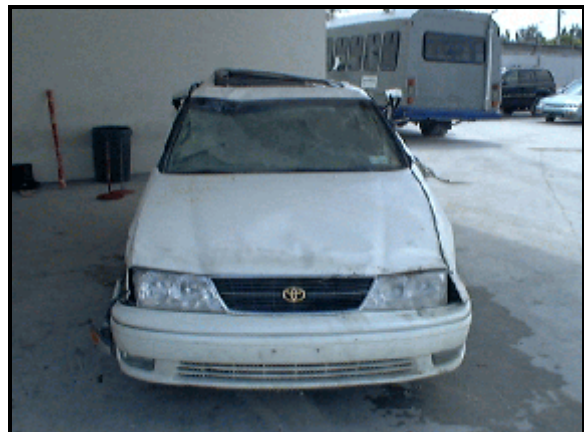
The second event in this crash sequence was the case vehicle's two quarter-turn rollover onto the guardrail (**Figure 6**). Direct damage to the case vehicle from this second impact included: the top of the front bumper fascia's left half, the right third of the front roof header, the forward edge of the hood, the top of the left front fender, the left upper A-pillar, camber of left rear wheel changed to top out and bottom in, top of left rear door frame pulled outward, and left rear door glazing disintegrated. Induced damage included: partially disintegrated sunroof glazing, left front door glazing shattered, and backlight glazing missing.

Figure 6: Case vehicle's damage from rollover; Note: front header and sunroof distortion

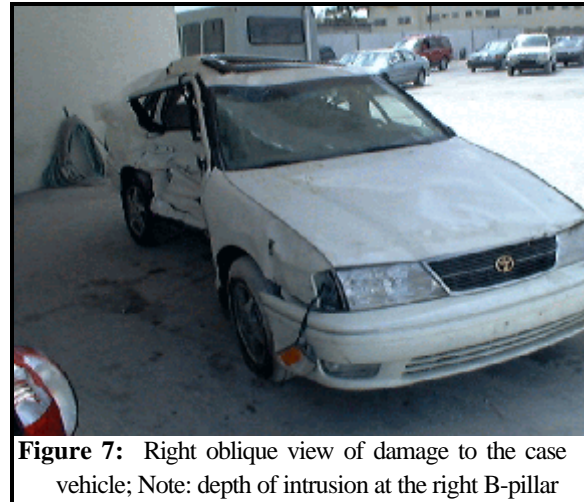
There were significant areas of intrusion resulting from the vehicle-to-vehicle collision, mostly to the right side of the case vehicle. There were lateral intrusions of 45 centimeters (17.7 inches) at the right rear door panel, 33 centimeters (13.0 inches) at the right upper and lower B-pillars, 32 centimeters (12.6 inches) at the right front door panel, 26 centimeters (10.2 inches) at the second seat right floor pan and sill, 24 centimeters (9.4 inches) at the front right seat floor pan and sill, 25 centimeters (9.8 inches) at the roof rail over both right side doors, and 4 centimeters (1.6 inches) at the C-pillar at the second seat right position. A longitudinal intrusion of 5 centimeters (2.0 inches) was measured at the windshield header forward of the front right seat position

Figure 7: Right oblique view of damage to the case vehicle; Note: depth of intrusion at the right B-pillar

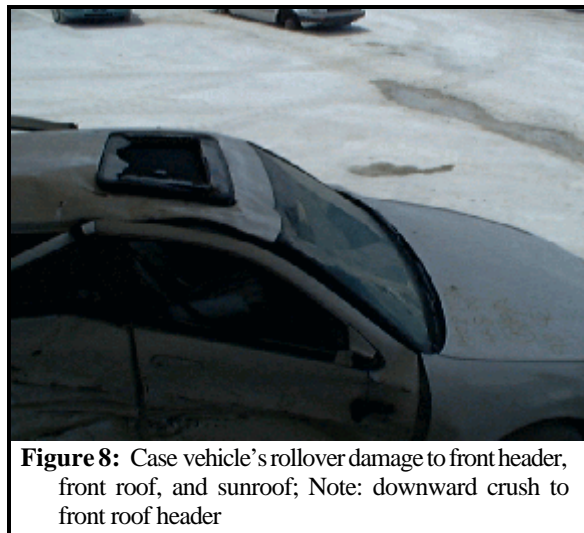
Figure 8: Case vehicle's rollover damage to front header, front roof, and sunroof; Note: downward crush to front roof header

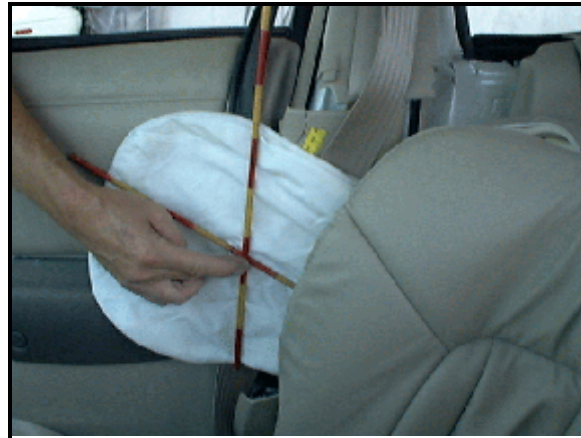
The case vehicle was equipped with a SRS system that included dual, redesigned front air bags at the driver and front right passenger positions. Those two modules did not deploy in this crash. The case vehicle was also equipped with side air bags at the driver and front right passenger positions. While the driver's side air bag did not deploy, the front right passenger's air bag did deploy (**Figure 9**). It was located at the outboard side of the passenger's seat back. The passenger's side air bag deployed through the seat back's right-side cloth seam. The air bag was characterized as oblong in shape, with a height of 27 centimeters (10.6 inches) and a width of 35 centimeters (13.8 inches). There were no tethers or vent ports. No damage to the module or air bag fabric was noted. The NASS investigator did not identify any occupant contact points to the deployed front right passenger's side air bag.

Figure 9: Case vehicle’s deployed front right passenger side air bag; Note: deformation to B-pillar’s vinyl cover

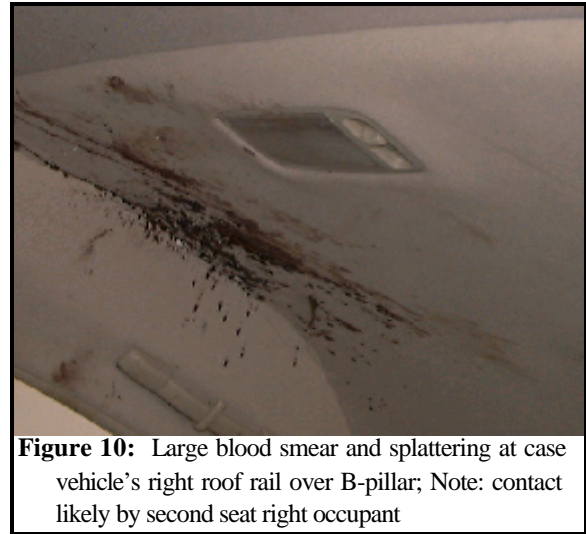
The NASS investigator identified two potential contact points from the case vehicle’s second seat right passenger: blood on the right roof rail and a dent and skin oil transfer to the right rear door interior panel. No information is available as to the driver’s posture at final rest. The NASS investigator assigned a large blood smear and splattering, centered at the B-pillar on the right interior roof rail, to a contact of this occupant’s hand (Figure 10).

Figure 10: Large blood smear and splattering at case vehicle’s right roof rail over B-pillar; Note: contact likely by second seat right occupant
