**REDESIGNED AIR BAG SPECIAL STUDY (RABSS)
SCI TECHNICAL SUMMARY REPORT**

NASS CDS CASE NO. 1999-43-067J

RABSS VEHICLE - 1998 CHEVROLET C-1500 PICKUP TRUCK

CRASH DATE - APRIL, 1999

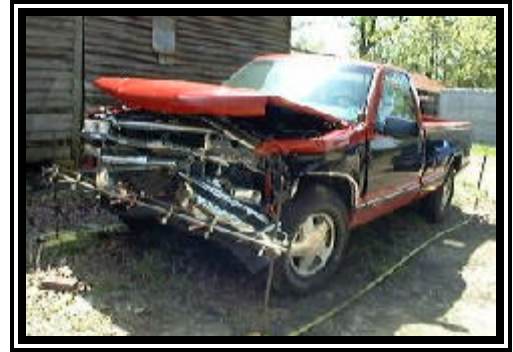
The 1998 Chevrolet C-1500 pickup truck sustained moderate frontal damage as a result of the impact with the Ford Ranger pickup truck (**Figure 3**). The *SCI revised* direct contact damage began at the front left bumper corner and extended 119.0 cm (46.9 in) inboard. The impact deformed the entire front end width resulting in a combined direct and induced damage length (Field L) of 170.0 cm (66.9 in). Six crush measurements were documented at the level of the bumper: C1= 24.0 cm (9.4 in), C2= 31.0 cm (12.2 in), C3= 41.0 cm (16.1 in), C4= 22.0 cm (8.7 in), C5= 17.0 cm (6.7 in), C6= 17.0 cm (6.7 in). The *SCI revised* Collision Deformation Classification (CDC) for this impact to the Chevrolet was 11-FYEW-2 with a principal direction of force of (-)20 degrees. The left fender was displaced rearward which restricted the left front wheel/tire (not deflated). The hood was deformed rearward from the impact force. Reduction in the right side wheelbase measured 7.0 cm (2.8 in). The windshield and tempered glazings remained undamaged. A chrome brush guard was attached to the front end structure which invalidated the WinSMASH program stiffness coefficient for this vehicle size.

Figure 3. Front left damage to the 1998 Chevrolet C-1500 pickup truck.

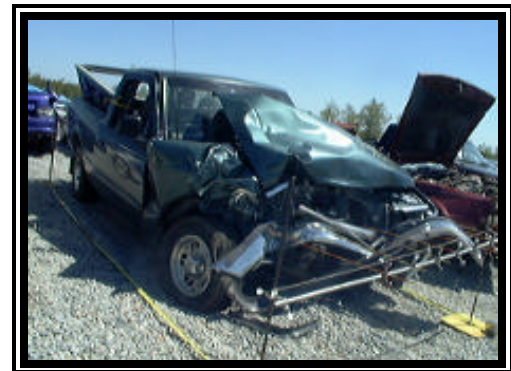
The 1995 Ford Ranger pickup truck sustained moderate frontal damage as a result of the impact with the Chevrolet pickup truck (**Figure 4**). The *SCI revised* direct contact damage began at the front right bumper corner and extended 88.0 cm (34.6 in) inboard. The impact deformed the entire front end width resulting in a combined direct and induced damage length (Field L) of 110.0 cm (43.3 in). Six crush measurements were documented at the level of the bumper: C1= 0 cm, C2= 16.0 cm (6.3 in), C3= 46.0 cm (18.1 in), C4= 48.0 cm (18.9 in), C5= 47.0 cm (18.5 in), C6= 64.0 cm (25.2 in). The *SCI revised* CDC for this impact to the Ford was 81-FZEW-3 with a principal direction of force of (+)40 degrees (principal direction of force incremented by "80" to reflect end structure shift to the left). Shifting of the end structure laterally displaced the left fender and jammed the left door. The left front tire was deflated (not restricted). Bed to cab contact was noted on the right side. The right fender was displaced rearward which restricted/deflated the right front wheel/tire and jammed the right door. Reduction in the left side

Figure 4. Front right damage to the 1995 Ford Ranger pickup truck.

wheelbase measured 3.0 cm (1.2 in) as elongation of the right side wheelbase measured 2.0 cm (0.8 in). The windshield was fractured from exterior impact forces as the back light glazing was disintegrated by (bed seated) occupant contact.

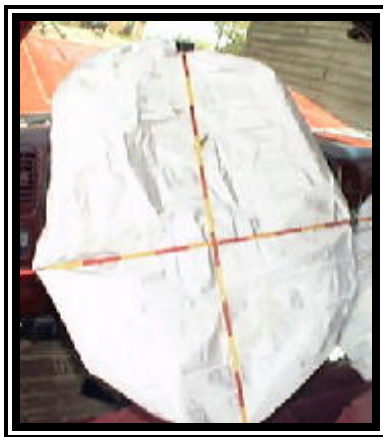
The 1998 Chevrolet C-1500 pickup truck was equipped with redesigned frontal air bags for the driver and front right passenger positions. The air bags deployed as a result of the crash. The driver air bag was housed in the center of the steering wheel with a vertically oriented flap tear seam (I-configuration). The flaps were symmetrical in shape and measured 10.5 cm (4.1 in) in width and 8.0 cm (3.1 in) in height. Although no contact evidence was identified on the exterior surface of the module cover flaps, black vinyl transfers were noted across the face of the bag from expansion within the module. The NASS researcher measured the diameter of the driver air bag at 65.0 cm (25.6 in) in its deflated state (**Figure 5**). The bag was tethered by two internal straps and vented by two ports located at the 11 o'clock and 1 o'clock sectors on the rear aspect of the air bag.

Figure 5. 1998 Chevrolet C-1500 pickup truck deployed redesigned driver air bag.

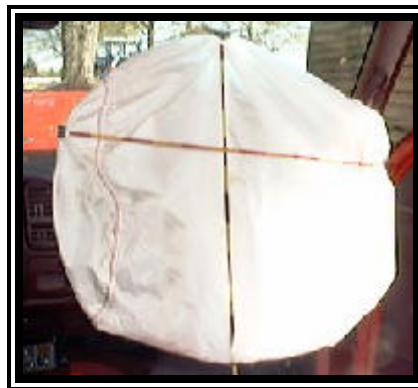
The front right passenger air bag deployed from the right mid-instrument panel area with a horizontally oriented flap tear seam (H-configuration). No contact evidence was identified on the air bag or exterior surface of the module cover flaps. The cover flaps were rectangular and nearly symmetrical in shape as the upper flap measured 18.0 cm (7.1 in) in width and 6.0 cm (2.4 in) in height as the lower flap measured 18.0 cm (7.1 in) in width and 4.0 cm (1.6 in) in height. The NASS researcher measured the passenger air bag at 45.0 cm (17.7 in) in width and 60.0 cm (23.6 in) in height in its deflated state (**Figure 6**). The bag was vented by two ports located at the 9 o'clock and 3 o'clock sectors on the side aspect of the air bag. No internal tether straps were present. The vehicle was also equipped with a passenger air bag cutoff switch which was set to the "on" position.

Figure 6. 1998 Chevrolet C-1500 pickup truck deployed redesigned passenger air bag.
