**REDESIGNED AIR BAG SPECIAL STUDY (RABSS)  
SCI TECHNICAL SUMMARY REPORT**

**NASS CDS CASE NO. 1999-45-154C**

**RABSS VEHICLE - 1999 FORD EXPLORER XLT 4X4**

**CRASH DATE - SEPTEMBER, 1999**

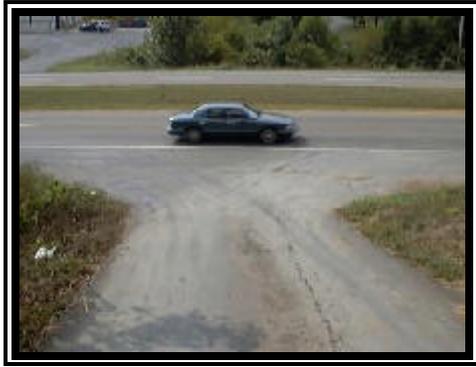
The 49 year old male driver of the 1996 Ford LTL9000 tandem dump truck was operating the vehicle southbound (**Figure 1**) and exiting a private driveway when he failed to observe the Ford Explorer as he turned right onto the (outboard) westbound lane.

**Figure 1. Southbound approach for the 1996 Ford LTL9000 dump truck.**

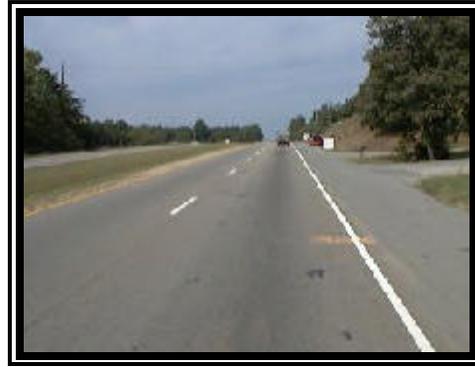
The 46 year old male driver of the 1999 Ford Explorer XLT was operating the vehicle in the (outboard) westbound lane (**Figure 2**) when he observed the dump truck encroach into his path of travel. Upon recognition of the impending harmful event, the driver steered left and braked in avoidance, partially remaining in the outboard lane prior to impact.

**Figure 2. Westbound approach for the 1999 Ford Explorer XLT.**

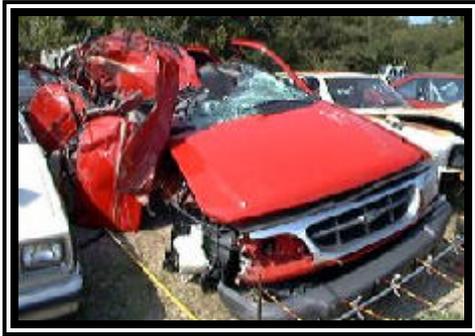
The 1999 Ford Explorer XLT sustained severe frontal damage as a result of the impact with the Ford dump truck (**Figures 3 & 4**). The direct contact damage (*narrow end engagement*) began at the front right bumper corner and extended 37.0 cm (14.6 in) inboard. The combined direct and induced damage length (Field L) measured 140.0 cm (55.1 in). Six crush measurements were documented at the level of the bumper: C1= 0 cm, C2= 0 cm, C3= 0 cm, C4= 0 cm, C5= 0 cm, C6= 28.0 cm (11.0

in). The Collision Deformation Classification (CDC) for this impact to the Ford Explorer was 12-FRAE-9 with a principal direction of force of 0 degrees. The direct contact damage extended rearward to the right B-pillar which sheared off the right fender, right front wheel/tire, and right side doors. Engagement along these areas displaced (“pulled”) the left roof side rail laterally into the passenger compartment, resulting in separation of the left upper A-pillar from the roof structure. The windshield was fractured and out-of-place as all right side tempered glazings were disintegrated. Pry marks were noted to the left front door, attributed to occupant extrication activities by rescue personnel post-crash. Reduction in the right side wheelbase measured 5.0 cm (2.0 in).

Figure 3. Front right damage (narrow end engagement) to the 1999 Ford Explorer XLT.

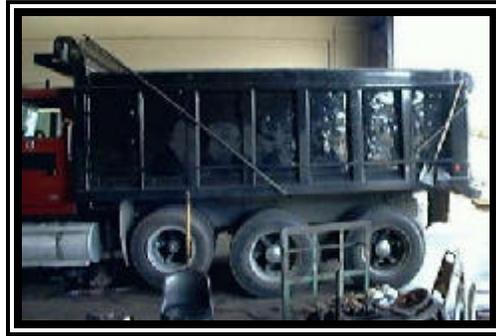
Figure 4. Left side surface view of the 1996 Ford LTL9000 dump truck.

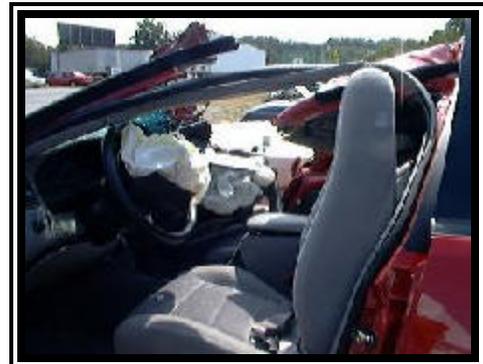
Interior damage to the Ford Explorer identified through the vehicle inspection was severe and was attributed to component intrusion and structure failure for the right side doors (Figure 5). Scuff marks were documented on the left knee bolster along with blood spattering to the left sunvisor. Loading marks were noted on the outboard aspect of the driver seat back along with blood on the shoulder belt webbing. The front/rear right seats were deformed by multiple component intrusions. Lateral intrusion of the left roof side rail slightly deformed the front left head restraint. Lateral intrusion of the left A-pillar measured approximately 37.0 cm (14.6 in). Longitudinal intrusions into the front occupant space involved 50.0 cm (19.7 in) of right windshield header, 26.0 cm (10.2 in) of left header, 25.0 cm (9.8 in) of right instrument panel, and 22.0 cm (8.7 in) of front seat back intrusion into the rear left space. Vertical intrusions into the front occupant space involved 14.0 cm (5.5 in) of right roof, and 8.0 cm (3.1 in) of left roof intrusion.

Figure 5. Interior view.

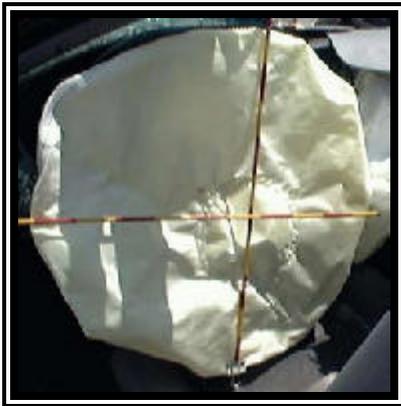
The 1999 Ford Explorer XLT was equipped with redesigned frontal air bags for the driver and front right passenger positions. The air bags deployed as a result of the crash. The driver air bag was housed in the center of the steering wheel with a horizontally oriented flap tear seam (H-configuration). The flaps were rectangular in shape as the upper flap measured 20.0 cm (7.9 in) in width and 12.0 cm (4.7

in) in height while the lower flap measured 20.0 cm (7.9 in) in width and 6.0 cm (2.4 in) in height. Although no contact evidence was identified on the exterior surface of the module cover flaps, a small 4.0 cm (1.6 in) tear was documented to the lower right quadrant (source unknown) along with scuff marks to the upper right quadrant of the air bag face. The NASS researcher measured the diameter of the driver air bag at 54.0 cm (21.3 in) in its deflated state (**Figure 6**). The bag was tethered by two internal straps and vented by two ports located at the 11 o'clock and 1 o'clock sectors on the rear aspect of the air bag.

**Figure 6. 1999 Ford Explorer XLT deployed redesigned driver air bag.**

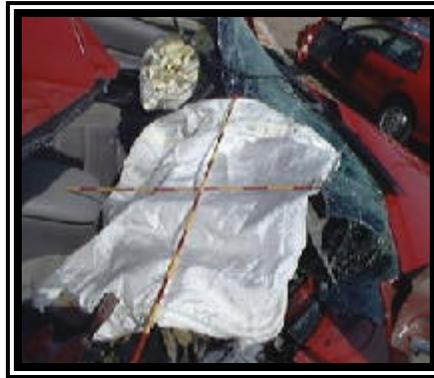
The front right passenger air bag deployed from the right mid-instrument panel area with a single cover flap design hinged at the top aspect. No contact evidence was identified on the air bag or exterior surface of the module cover flap, however, a 14.0 cm (5.5 in) tear was documented to the upper right quadrant of the air bag face attributed to intruded components. The cover flap was rectangular in shape and measured 38.0 cm (15.0 in) in width and 18.0 cm (7.1 in) in height. The NASS researcher measured the passenger air bag at 70.0 cm (27.6 in) in width and 55.0 cm (21.7 in) in height in its deflated state (**Figure 7**). The bag was vented by two ports located at the 10 o'clock and 2 o'clock sectors on the side aspect of the air bag. No internal tether straps were present.

**Figure 7. 1999 Ford Explorer XLT deployed redesigned passenger air bag.**

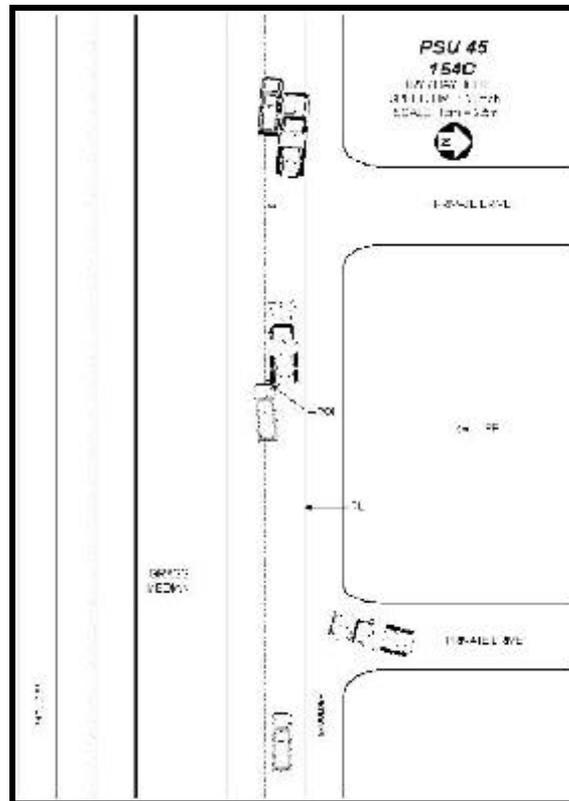
Figure 8. NASS Scene Diagram.

This two vehicle crash occurred during the morning hours of September, 1999. At the time of the crash, it was daylight (dawn) with no adverse conditions as the roads were dry. The crash occurred in the westbound lanes of a (straight/asphalt) 4-lane east/west state roadway (see **Figure 8 - page 5**) which was divided by a grass median with a positive grade for westbound traffic. The westbound lanes were bordered by a wide paved shoulder and private driveways to the north. No traffic control was present at the scene which had a posted speed limit of 89 km/h (55 mph).
