Remote, Redesigned Air Bag Special Study

Dynamic Science, Inc., Case Number (1999-48-802C)

1998 Nissan Frontier

Technical Report Documentation Page

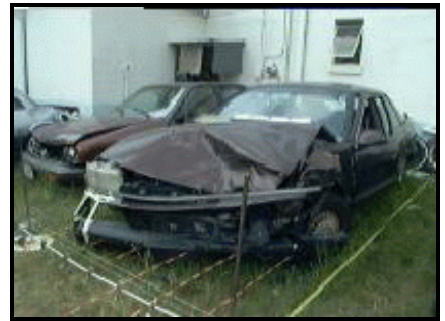
Figure 3. Frontal damage to Vehicle 1 (1989 Mercury Sable)

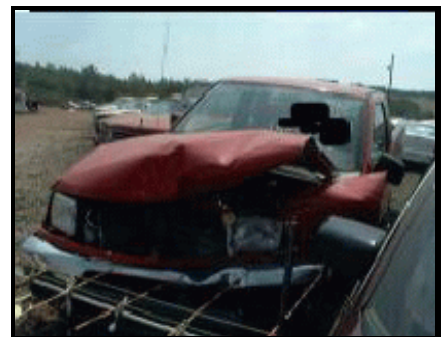
Figure 4. Frontal Deformation to Vehicle 2 (1998 Nissan Frontier)

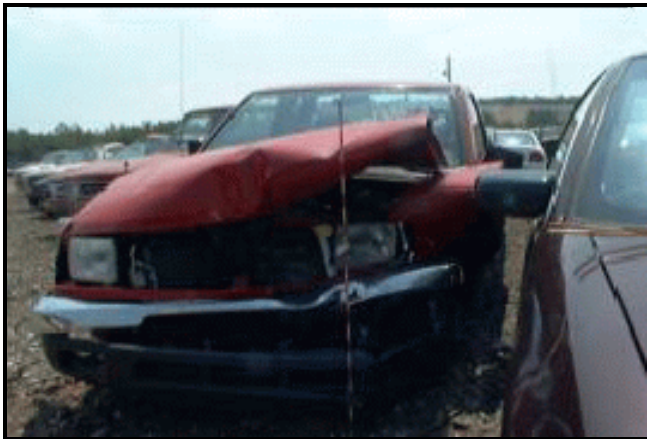
Figure 5. Exterior front view, Vehicle 2 (case vehicle)

Plane of Impact	Field L cm/in.	C1 cm/in.	C2 cm/in.	C3 cm/in.	C4 cm/in.	C5 cm/in.	C6 cm/in.
Front Bumper	141	61	45	35	17	3	0
	55.5	24	17.7	13.8	6.7	1.2	0

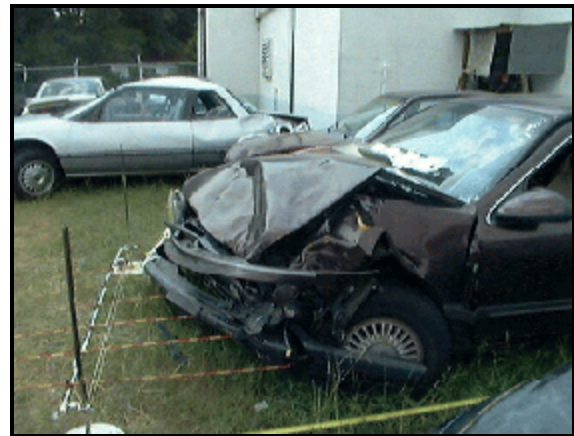
Figure 6. Perpendicular view, Vehicle 1

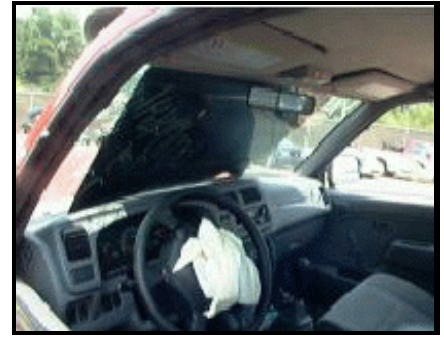
The interior of the Nissan Frontier pickup truck maintained its integrity and there were no intruding components. The driver's right hand contacted and broke the windshield glazing as evidenced by a spider web crack configuration. The driver's left knee and left hand contacted and cracked the plastic instrument panel covering and the fuse box door was displaced due to occupant contact. The windshield wiper lever was completely separated from the steering column. The center console cover/ transmission selector shroud was cracked and broken due to occupant contact. The case vehicle is equipped with cloth covered front bucket seats. The front bucket seats have a folding feature in order to gain access to the rear jump seat/cargo area. The folding jump seats are located at the rear outboard positions. The front seat backs are equipped with adjustable head restraints that were undamaged. Both front bucket seats were adjusted to their rearmost track position and the driver's shoulder belt adjustment was placed in the up position.

Figure 7. Three-quarter view of driver's seating area

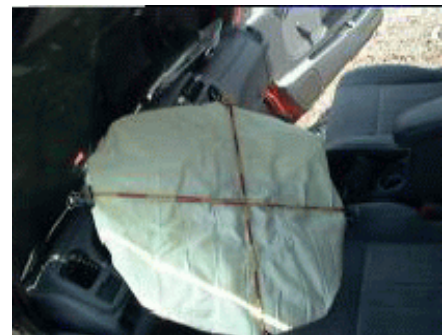
Figure 8. View showing deployed driver's air bag

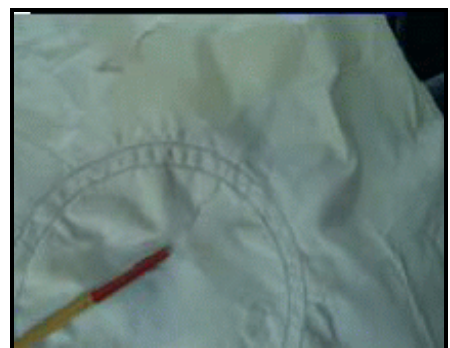
Figure 9. Close up of driver's air bag

The driver's air bag is housed in the steering wheel hub and encases the nylon air bag unit. The double symmetric, horizontal module cover flaps opened at their designated tear points and were undamaged. The circular air bag is tethered by two straps and two exhaust vent port holes are present. The lower instrument panel is shrouded by a rigid plastic knee bolster. The upper knee bolster was contacted and damaged due to left knee loading by the driver. There was a dark cloth transfer to the air bag fabric due to driver contact.

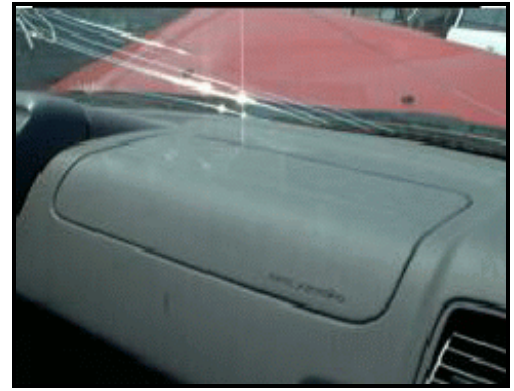
The front, right passenger air bag is located on the instrument panel (top mount). The module deployment door is rectangular in shape. The passenger air bag did not deploy due to the activation of the air bag shut off switch.

Figure 10. Passenger side air bag module cover (non-deployed)

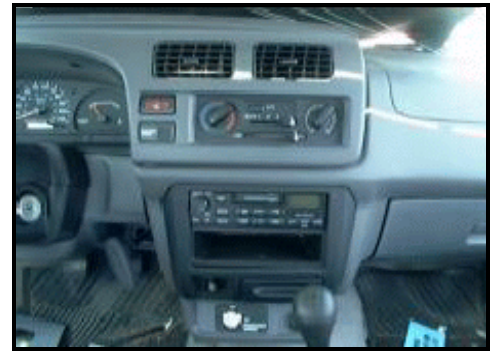
Figure 11. View showing air bag shut off switch

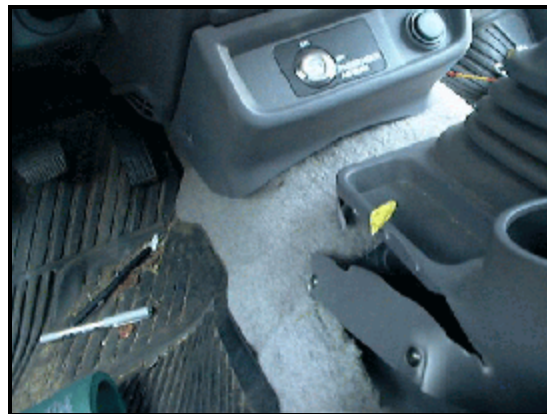
Due to the driver's large stature, his left knee contacted and broke the rigid plastic cover to the upper knee bolster. His right leg contacted and broke the center console cover.

Figure 13. Close up view showing damaged center console due to right leg contact. Note: air bag shut off switch in off position

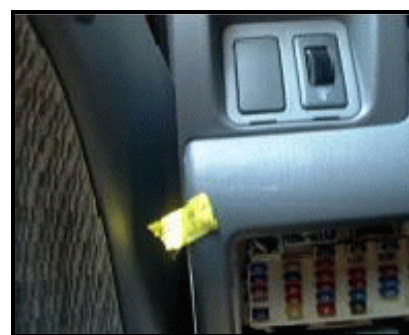
When the driver's air bag deployed, both of his hands were thrust from the steering wheel rim. His right hand contacted and broke the windshield wiper lever. His right hand flailed upward, contacting and breaking the laminated windshield glazing. His left hand contacted and cracked the instrument panel cover (refer to Figure 18). The driver's upper chest and face contacted the deploying air bag. This was evidenced by a documented dark cloth transfer to the air bag fabric. He sustained a left forearm abrasion (AIS-1) to his ventral aspect as a result of contacting the air bag. He also sustained a cervical neck strain (AIS-1) due to his involvement with the driver's air bag. He rebounded directly rearward into his respective seat back support where he came to rest.

Figure 14. Left hand contact to instrument panel
