Remote, Redesigned Air Bag Special Study

Dynamic Science, Inc., Case Number ( 1999-49-004F)

1999 Chevrolet Blazer Tahoe

Texas

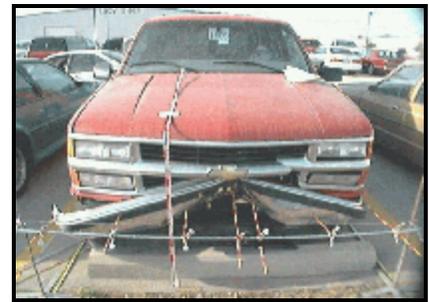
**Figure 3.** View showing frontal damage to Vehicle 2 (1999 Blazer)

Plane of Impact	Field L cm/in.	C1 cm/in.	C2 cm/in.	C3 cm/in.	C4 cm/in.	C5 cm/in.	C6 cm/in.
Front Bumper	174	8	13	25	15	2	0
	68.5	3.1	5.1	9.8	5.9	0.8	0

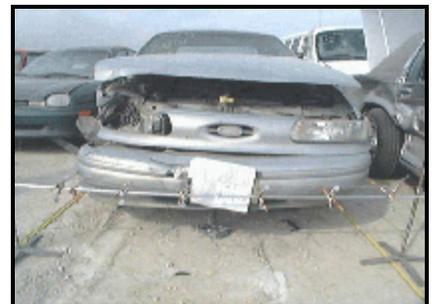
**Figure 4.** View showing frontal damage to Vehicle 1 (1994 Taurus)

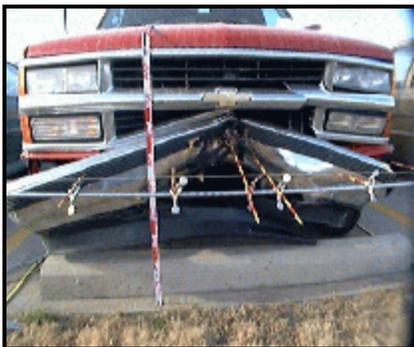
**Figure 5.** Close-up frontal view of 1999 Blazer Tahoe

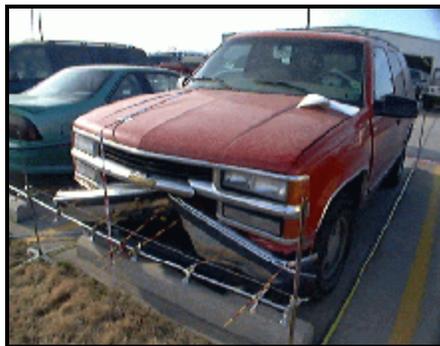
**Figure 6.** Three-quarter view of Vehicle 2 (Blazer)

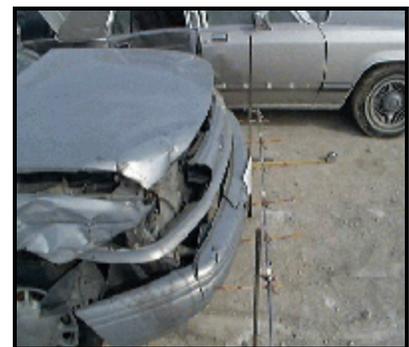
**Figure 7.** Perpendicular view of Vehicle 1 (1994 Ford Taurus)

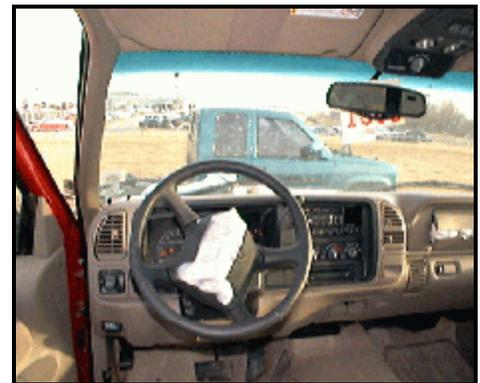
**Figure 8.** View showing the driver's seated position

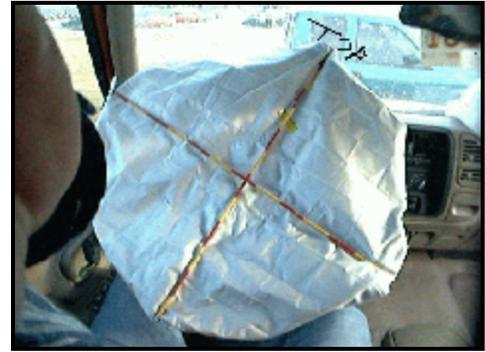
The driver's air bag is housed in the steering wheel hub and encases the nylon air bag unit. The double, vertical, module cover flaps are symmetrical in design and opened at their designated tear points. The circular air bag is equipped with four internal tether straps and two exhaust vent port holes. The vent ports are located at the 11 and 1 o'clock positions respectively. The rigid plastic knee bolster was undamaged and did not reveal any damage or detectable occupant contacts.

**Figure 9.** View showing deployed driver's air bag

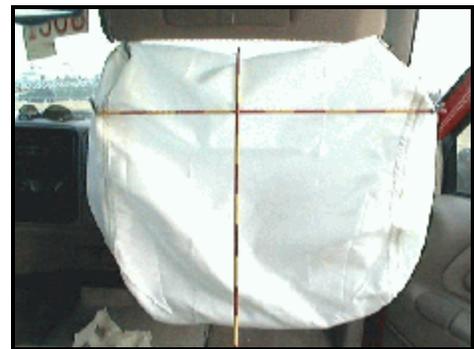
The front, right passenger instrument panel module air bag is located above the glove compartment box (mid-mount). The module deployment door is rectangular in shape and is equipped with double horizontal cover flaps that are symmetrical in design. The module cover flaps opened at their designated tear points and were undamaged. The nylon air bag was undamaged, untethered and was equipped with two exhaust vent port holes. The vent ports were located at the 10 o'clock and 2 o'clock directions respectively.

**Figure 10.** View showing deployed passenger air bag

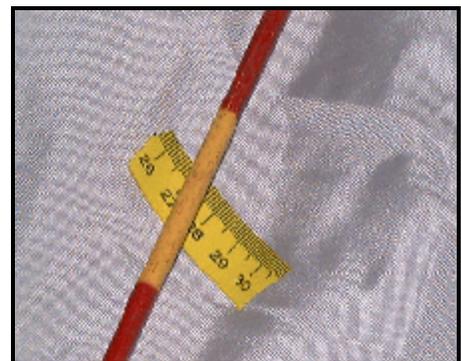
The interior of the 1999 Chevrolet Blazer Tahoe was devoid of interior deformation due to intrusion or occupant contacts. There was a minor scuff mark noted to the nylon fabric of the driver’s air bag. The passenger compartment remained intact and no integrity was lost. All vehicle glazing remained intact and was undamaged. The case vehicle is equipped with front bucket seats with adjustable head restraints. The second seat consists of a bench seat with folding backs. There are adjustable head restraints available at the outboard positions of the second seat. The front, left seat track and the front, right seat tracks were adjusted at their rear most track positions.

He responded to the 340 degree principle direction of force by moving forward and to her left. He loaded the applied lap and shoulder belt webbing which prohibited extended forward movement of his upper and lower torso. As his upper torso was restricted from further forward movement, his head pitched downward probably contacting the deploying air bag. The driver rebounded back into his respective seated position and was uninjured during the crash.

**Figure 11.** Close-up view showing possible occupant contact to driver's air bag
