Remote, Redesigned Air Bag Special Study

Dynamic Science, Inc., Case Number (1999-049-136J)

1999 Chrysler Sebring

July/1999

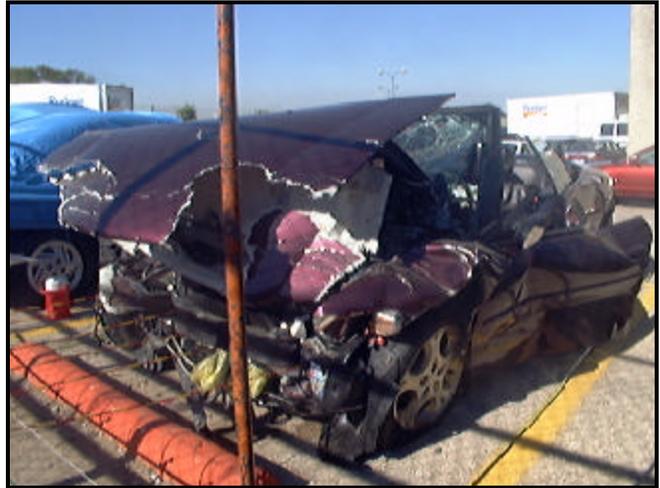
Figure 1. Exterior, Vehicle1 (Chrysler Sebring)

Vehicle 1 crossed from the single lane exit ramp over both northbound travel lanes and entered the eastbound leg of the intersection, where Vehicle 2 was stopped. The front plane of Vehicle 1(12FDEW3) impacted the left plane of Vehicle 2 (unknown CDC) in the right eastbound travel lane.

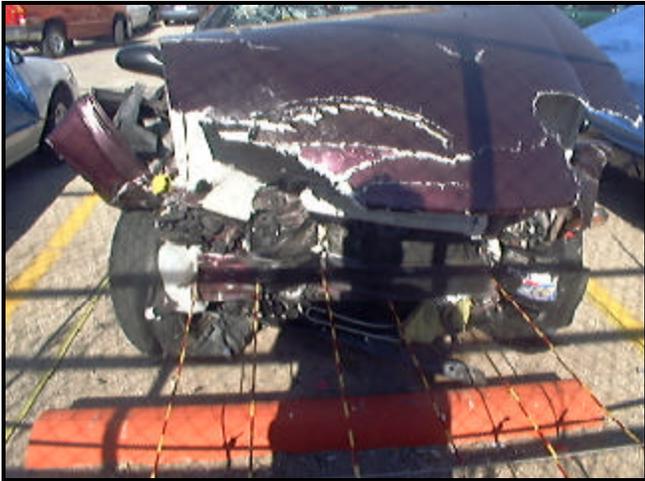
Figure 4. Exterior, Vehicle 1 (1999 Chrysler Sebring)

Model year, make and model	1999 Chrysler Sebring
VIN	3C3EL55H5XT
CDC	12FDEW3

Plane of Impact	Field L cm/in.	C1 cm/in.	C2 cm/in.	C3 cm/in.	C4 cm/in.	C5 cm/in.	C6 cm/in.
Bumper	104	75	52	50	62	51	51
	40.9	29.5	20.5	19.7	24.4	20.1	20.1

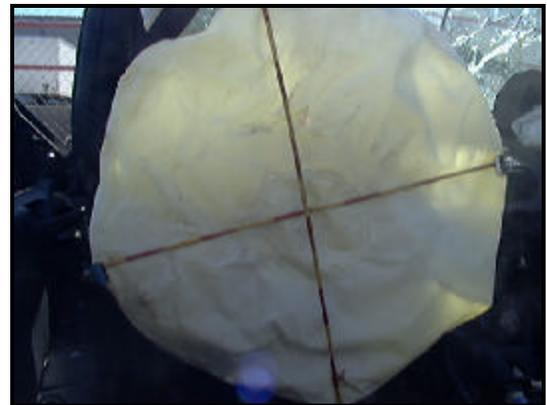
Figure 6. Driver's frontal air bag.

The front left air bag was housed in the steering wheel hub and was concealed by asymmetrical H-configuration cover flaps which were not damaged in the crash. The circular air bag was equipped with two tether straps and one vent port. Contact evidence consisting of blood was found primarily on the lower half of the front of the bag. The air bag was not damaged.

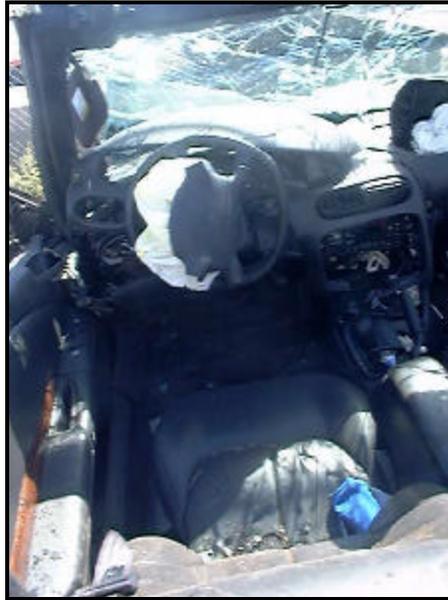
Figure 7. Case occupant 01 seating position.

At impact, the occupants reacted to the 0 degree principle direction of force by moving sharply forward. The driver's lower extremities severely loaded the knee bolster-causing the right femur, fibula, and tibia fractures, as well as the knee laceration, abrasion, contusion, and avulsion. The driver also impacted the left instrument panel-causing the upper extremity abrasions and lacerations. As the driver's frontal air bag deployed, the occupant's upper torso was

struck by the opening air bag cover flaps-causing the rib fractures and chest laceration. The front right passenger was moving forward as the right toe pan was intruding rearward. Impact with the intruding toe pan caused the right fibula fracture and right ankle dislocation. The passenger's left foot contusion and toe dislocation was also caused by impact with the toe pan. Case occupant 02 also came into contact with the glove compartment door-causing the right femur fracture and knee laceration. The passenger's upper torso also came into contact with the deploying passenger's frontal air bag-causing the chest abrasion. Both occupants of the case vehicle were transported from the scene to a trauma center with incapacitating injuries. The driver was hospitalized for 10 days and the passenger was hospitalized for six days.
