On-scene Investigation / Vehicle to Vehicle  
Dynamic Science, Inc. / Case Number: 1999-74-013A  
1999 Mitsubishi Galant GTZ  
Nebraska  
February 1999

1. Report No. 1999-74-013A	2. Government Accession No.	3. Recipient Catalog No.	
4. Title and Subtitle <b>In-Depth Accident Investigation</b>		5. Report Date January 14, 2000	6. Performing Organization Report No.

**Description:** This case was initiated in response to a report of a driver fatality involving a steering wheel failure in a moderate-to-high speed crash. This case is being conducted as a remote, follow-up investigation to a NASS investigation. NHTSA was notified by the NASS team. DSI was notified on March 2, 1999.

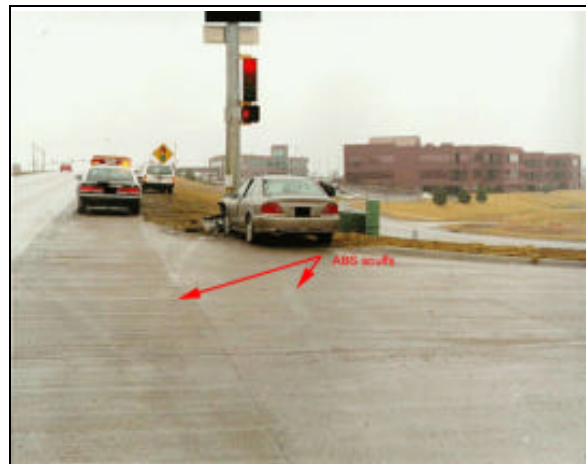
**Figure 1.** Final rest, Vehicle 1 (facing east)

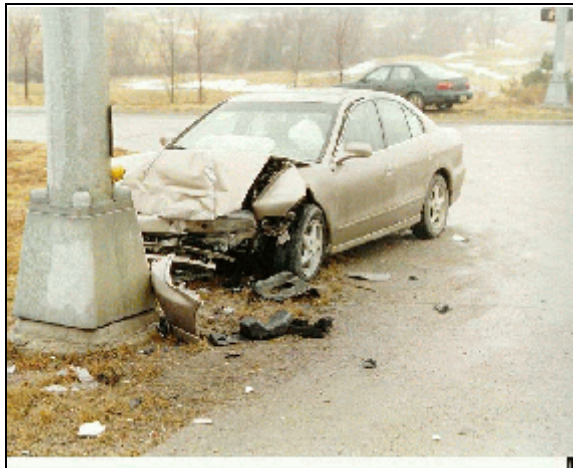
**Figure 2.** Final rest, Vehicle 1 (facing west)

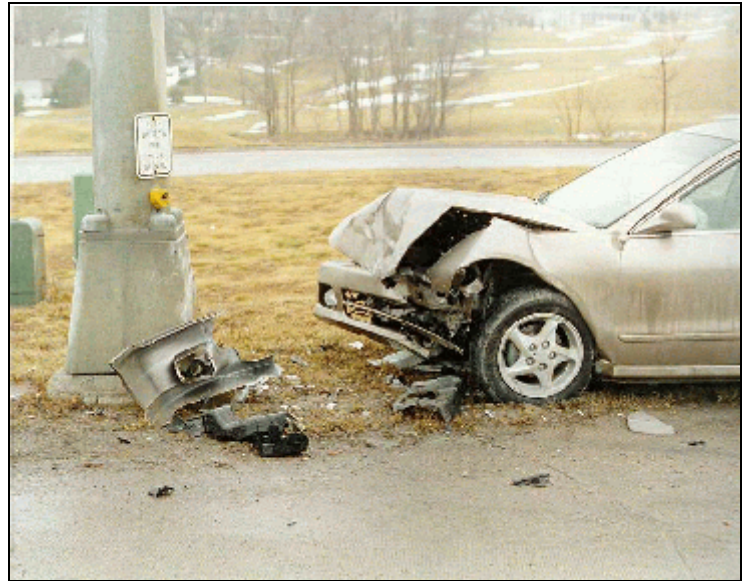
**Figure 3.** Final rest, facing south.

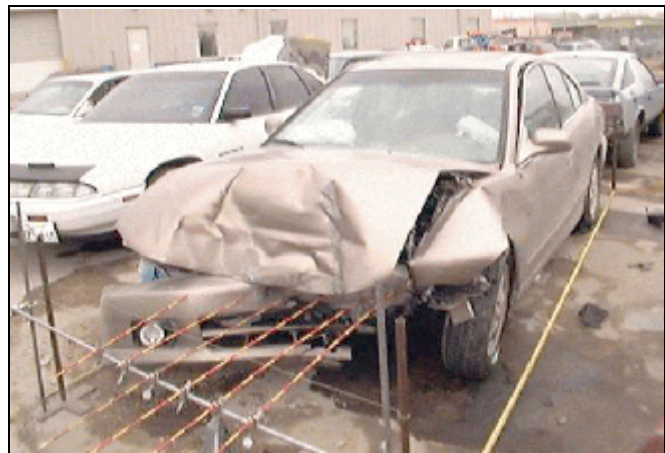
**Figure 4.** Vehicle 1, exterior

Vehicle 1 was towed from the scene due to damage and subsequently totaled by the insurance company. The vehicle sustained substantial frontal crush. There was intrusion of the toe pan and of the left portion of the instrument panel. The left rear door was jammed shut. The steering wheel rim was loaded and failed.

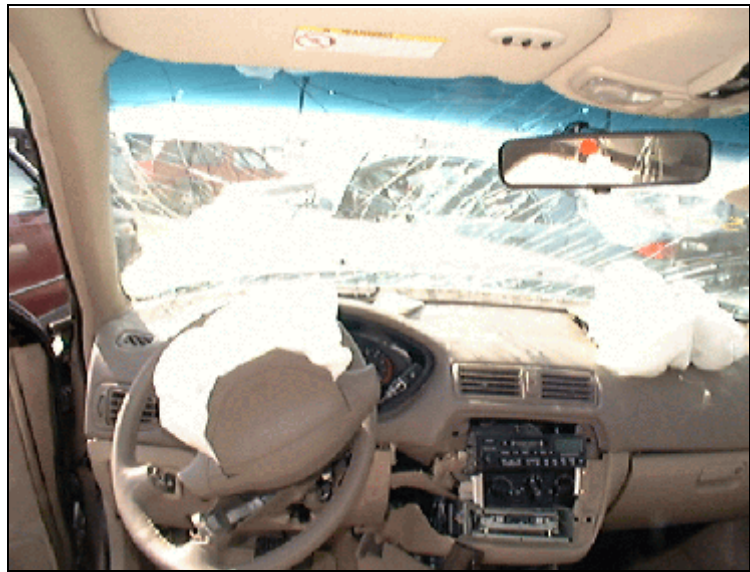
The driver of Vehicle 1 was not using the available lap and shoulder restraints. He was seated in a forward facing position in a fabric-covered bucket seat; the seat was at the middle track position. The tilt steering wheel was adjusted to the center position. The driver had his foot on the brake. At impact, the rear end of Vehicle 1 pitched upward and the vehicle began a sharp counterclockwise rotation around the pole. The driver responded to this motion by moving upwards and to the right. The upwards motion caused the driver to load the steering wheel in a positive vertical direction<sup>6</sup>. The driver was forward of the normal seated position at this time—this is based on the bilateral contusions found on the anterior aspect of the driver's upper arms. The movement to the right caused the driver to by-pass the deploying air bag to some extent and to engage the center instrument panel and center windshield.

**Figure 5.** Vehicle 1, interior

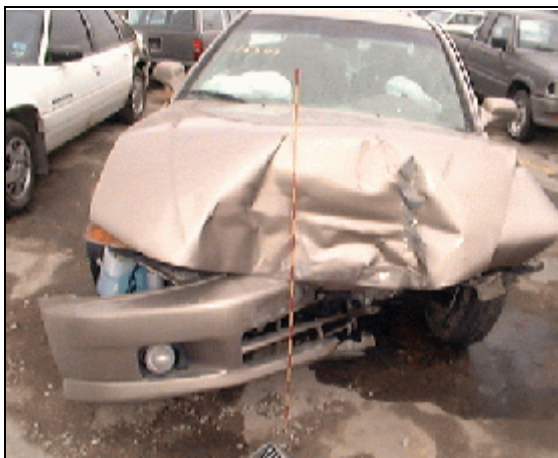
Description:	1999 Mitsubishi Galant GTZ four-door sedan	
VIN:	4A3AA46G3XExxxxx	
Odometer:	Unknown	
Engine:	2.4 L SOHC MFI	
Reported Defects:	None	
Cargo:	None	
Damage Description:	Major frontal damage to front bumper, grille, and hood. Maximum crush was found at C <sup>1</sup> and measured 69 cm (27.1 in.). There was intrusion through the toe pan and the left instrument panel. The steering wheel failed.	
CDC:	12FYEW3	
Delta V:	Total	61 km/h (37 mph)
	Longitudinal	-61 km/h (-37 mph)
	Latitudinal	0 km/h (0 mph)
	Energy	213035 joules (157,126 ft-lbs.)

**Figure 7.** Exterior, Vehicle 1.

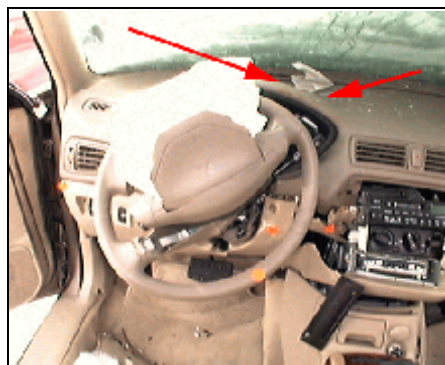
seat; the seat was at the middle track position. The tilt steering wheel was adjusted to the center position. The driver had his right foot on the brake. Based on the bilateral contusions to the upper arms, it is believed that both hands were on the steering wheel. The left hand would have been higher than the right. The driver was not using the available lap and shoulder restraints. Given the cold temperatures--1 to 2 degrees C (33 to 35 degrees F)--the driver was likely wearing winter clothing, but this could not be determined with certainty. At impact, the driver responded to the 12 o'clock direction of force by moving forward. As the vehicle engaged the pole its rear end pitched upward and the vehicle began a sharp counterclockwise rotation around the pole. The driver responded to this motion by moving upwards and to the right. The upwards motion caused the driver to load the steering wheel in a positive vertical direction. The driver was forward of the normal seated position at this time--this is based on the bilateral contusions found on the anterior aspect of the driver's upper arms. The movement to the right caused the driver to by-pass the deploying air bag to some extent and to strike the left side of his face on the curved portion of the instrument panel to the right of the steering wheel--likely causing the blow-out fracture of the left orbit and nose fracture. The driver continued forward and engaged the right side of the steering wheel rim with his left chest--causing the rib fractures. The driver completed the forward motion and struck his head on the lower center windshield--leaving trace evidence of a head contact.

**Figure 8.** Interior, Vehicle 1.

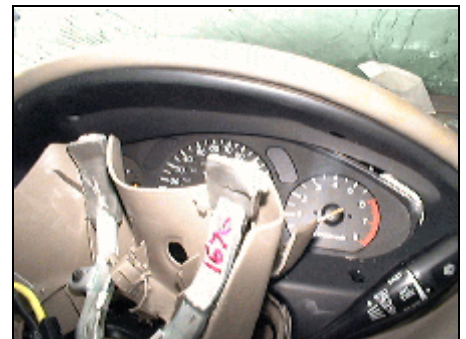
**Figure 9.** Closeup of upper instrument panel.

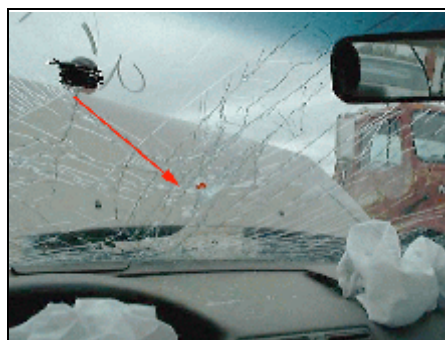
The driver had sustained a massive subarachnoid hemorrhage, a brain stem injury, right side rib fractures, a nose fracture, a maxilla fracture, and a variety of contusions and abrasions. It is this investigator's opinion that the head injuries were due to contact with the windshield/instrument panel, and the rib injuries due to contact with the steering wheel rim.

**Figure 10.** Windshield contact.

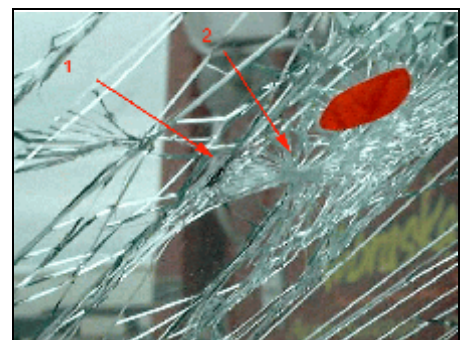
**Figure 11.** Close-up of windshield contact
