Remote, Redesigned Air Bag Special Study

Dynamic Science, Inc., Case Number (1999-074-802E)

1999 Chevrolet Cavalier

May/1999

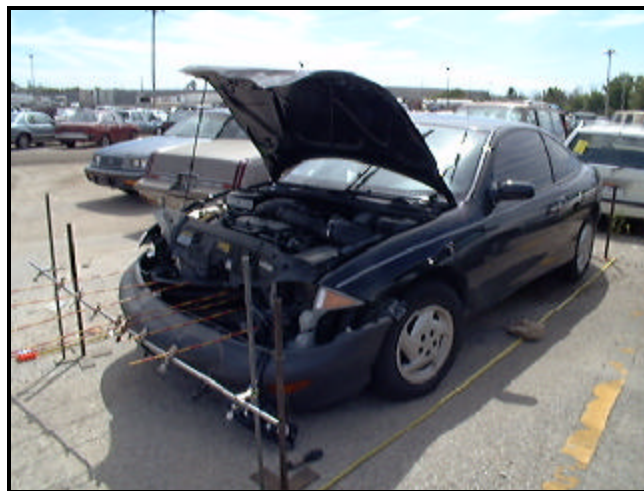
**Figure 1.** Exterior, Vehicle 1 (Chevrolet Cavalier)

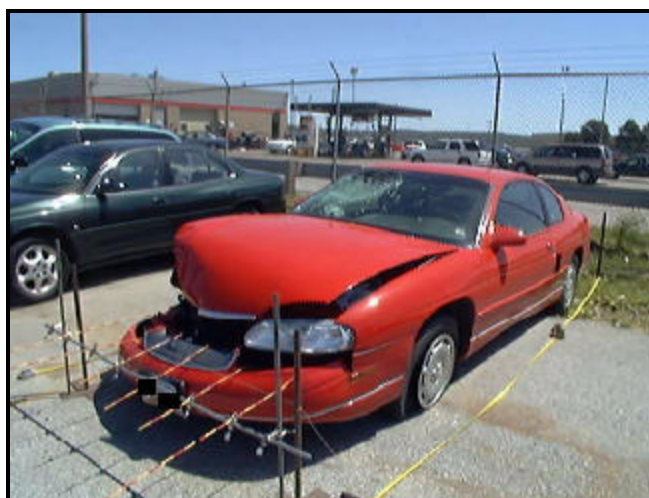
**Figure 2.** Exterior, Vehicle 2 (Chevrolet Monte Carlo)

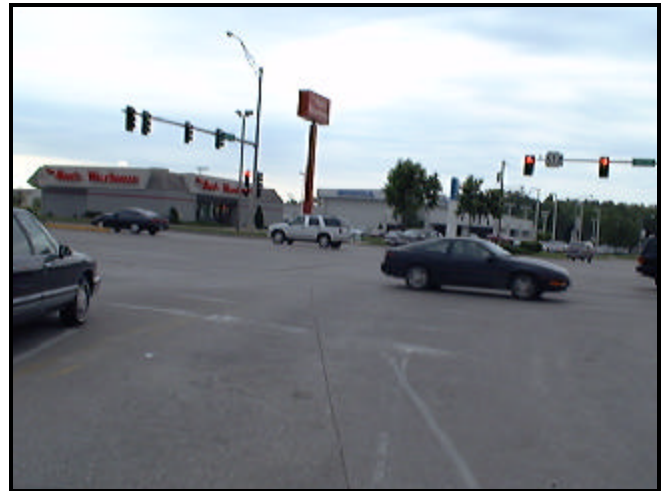
**Figure 3.** Crash scene. Vehicle 1 approach path.

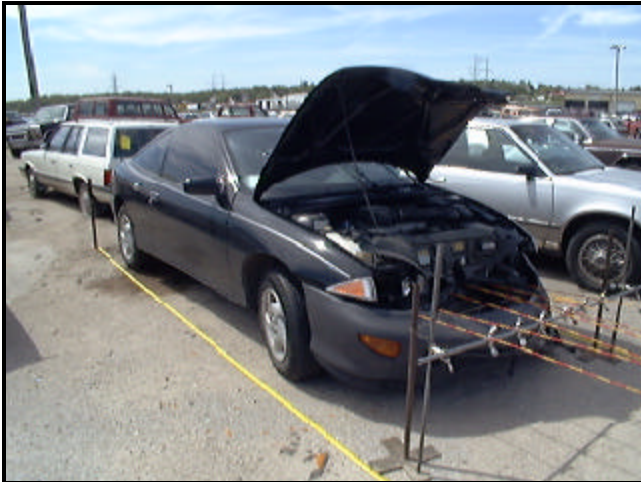
The driver of Vehicle 2 initiated the left turn in the path of Vehicle 1 and was struck. The front plane of Vehicle 1 (12FDEW2) struck the front plane of Vehicle 2 (01FZEW1) in the intersection.

**Figure 4.** Exterior, Vehicle 1 (1999 Chevrolet Cavalier)

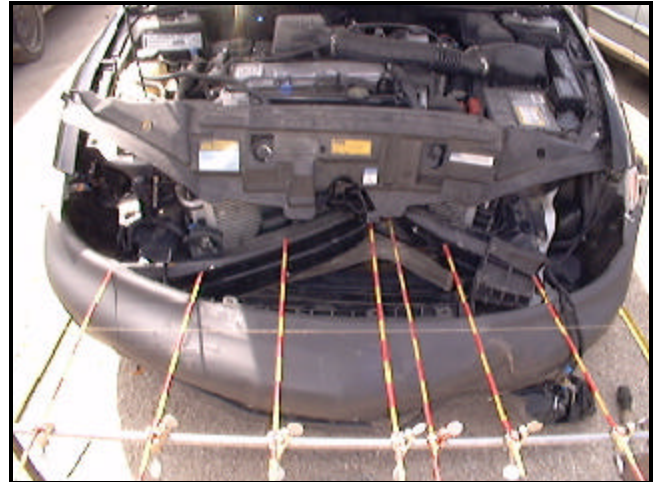
**Figure 5.** Exterior, Vehicle 1 (1999 Chevrolet Cavalier)

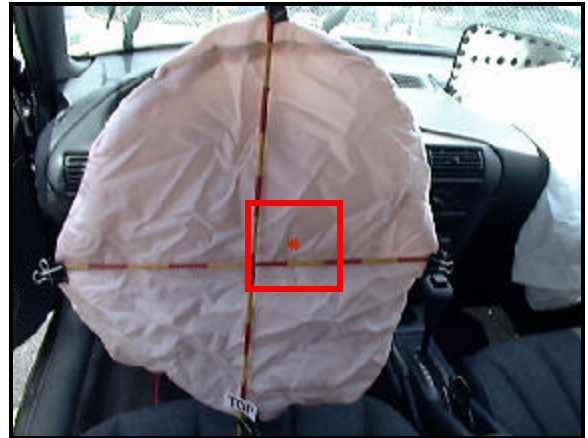
The front left air bag was housed in the steering wheel hub and was concealed by symmetrical I-configuration cover flaps which were not damaged in the crash. The circular air bag was equipped with two vent ports and no tether straps. Contact evidence consisting of a "yellowish transfer" was found near the center of the front of the bag. The air bag was not damaged.

**Figure 6.** Driver's frontal air bag. Box indicates location of transfer.

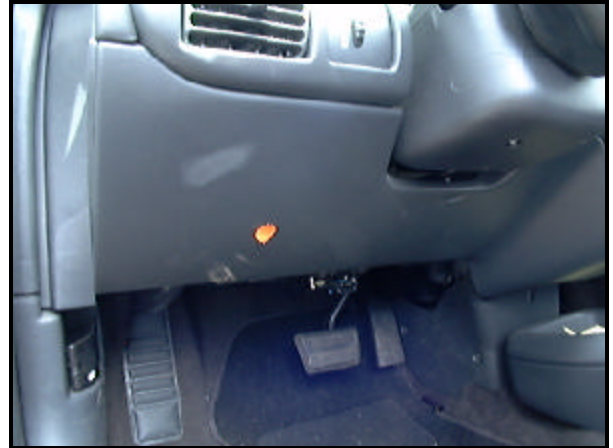
At impact, the occupants reacted to the 350 degree principle direction of force by moving forward and slightly left. The driver engaged the deploying driver's frontal air bag-causing the bilateral forearm and wrist abrasions. The driver's knees came into contact with the knee bolster-causing the bilateral knee contusions. A large scuff was found on the knee bolster (see Figure 7). The front right passenger moved sharply forward and impacted the front windshield header-causing the loss of consciousness and scalp contusion. The passenger's knees came into contact with the right instrument panel-causing the bilateral knee contusions and right knee abrasion. Both occupants sustained cervical strains most likely caused by impact forces rather than contact with any component of the vehicle's interior. Both occupants were transported from the scene to a local hospital where they were both treated and released.

**Figure 7.** Interior, case vehicle. Knee bolster contact.
