Remote, Redesigned Air Bag Special Study

Dynamic Science, Inc., Case Number (1999-074-803E)

1999 Suzuki Esteem

Summary

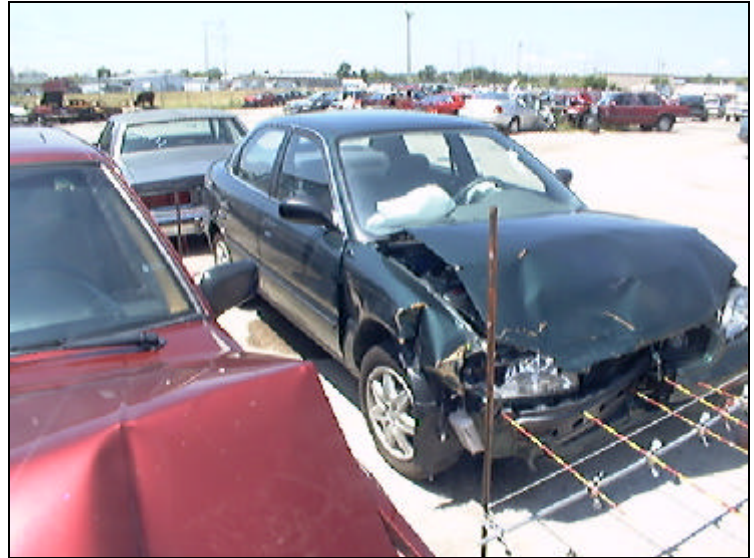
Figure 1. Exterior, Vehicle 1 (Suzuki Esteem)

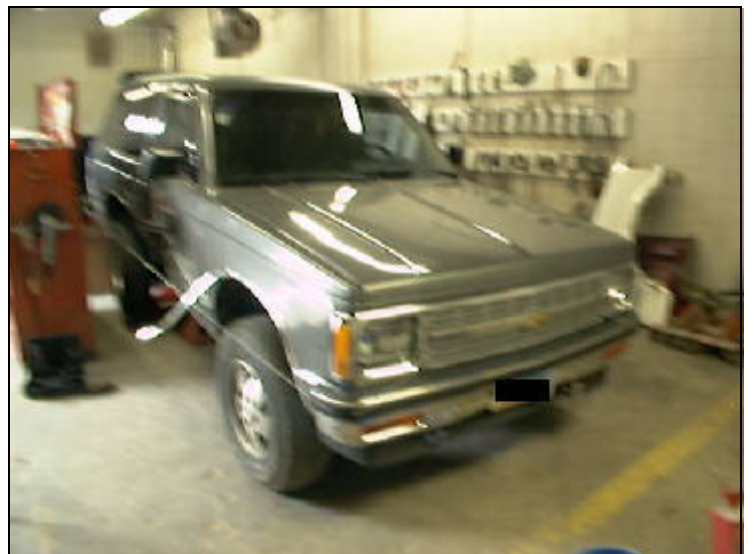
Figure 2. Exterior, Vehicle 2 (Chevrolet S-10 Blazer)

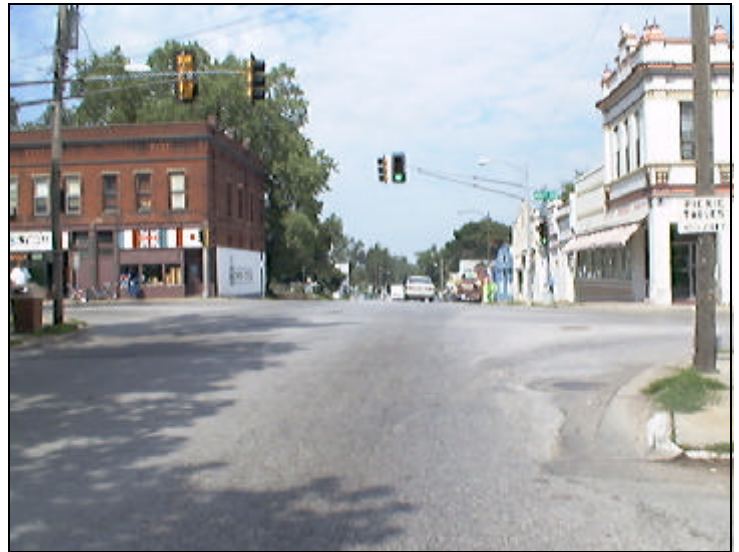
Figure 3. Crash scene. Vehicle 1 approach path.

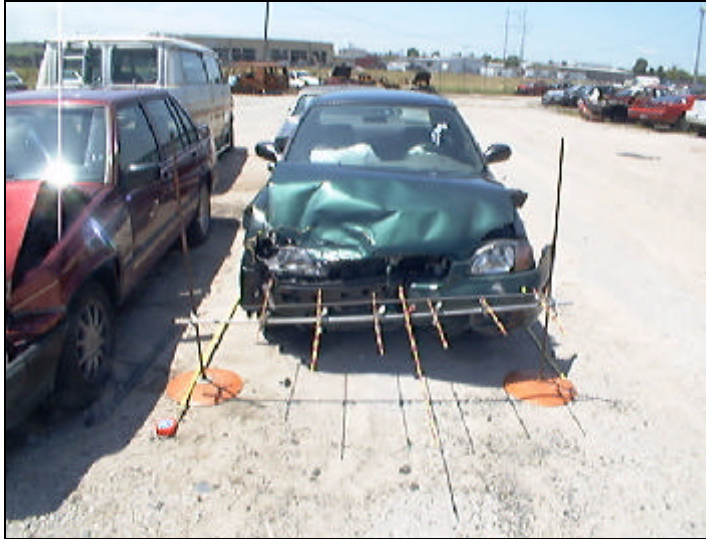
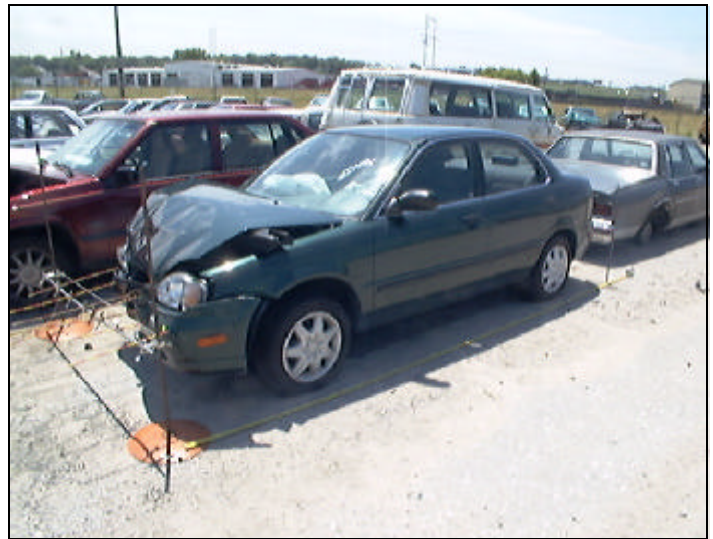
Vehicle 2 entered the intersection against the red traffic signal and entered the path of Vehicle 1. The front plane of Vehicle 1 (11FDEW1) struck the right plane of Vehicle 2 (02RPEW2) in the intersection.

Figure 4. Exterior, Vehicle 1 (1999 Suzuki Esteem)

Figure 5. Exterior, Vehicle 1 (1999 Suzuki Esteem)

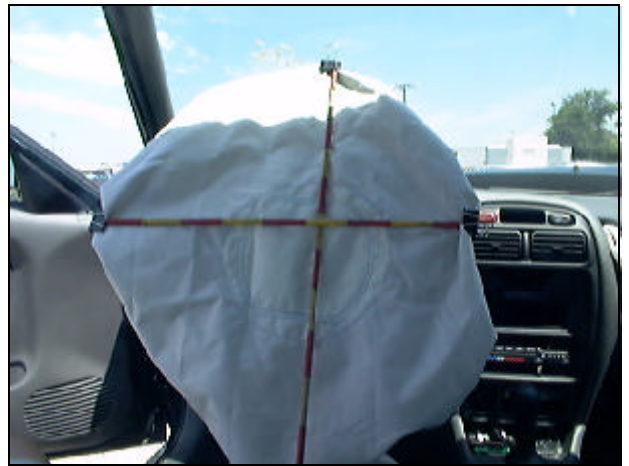
The front left air bag was housed in the steering wheel hub and was concealed by symmetrical I-configuration cover flaps which were not damaged in the crash. The circular air bag was equipped with two tether straps and two vent ports. No contact evidence was found on the air bag and the bag was not damaged.

Figure 6. Interior, case vehicle. Driver's frontal air bag.

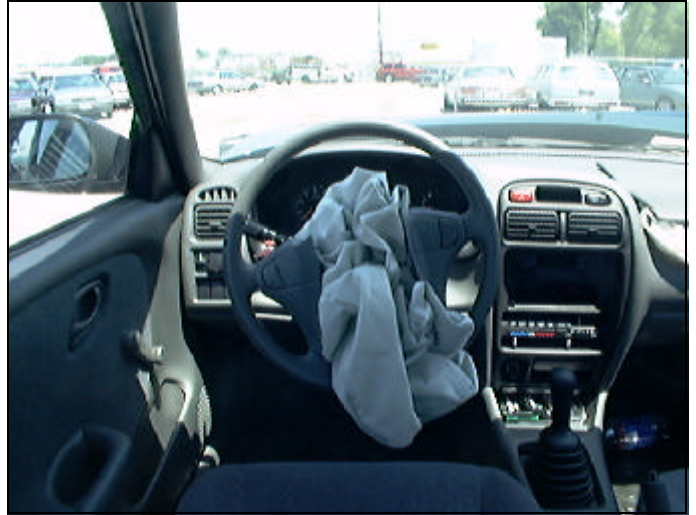
The case vehicle was equipped with bucket seats with adjustable head restraints (which were not damaged) in the front left and front right seating positions. The front left seat was adjusted to the rear most track position. The front right seat was adjusted to the middle track position. The rear of the vehicle was equipped with bench seats with no head restraints in all three seating positions. The back seats were not adjustable.

Figure 7. Interior, Vehicle 1. Case occupant seating position.
