Remote, Redesigned Air Bag Special Study
FOR NHTSA'S INTERNAL USE ONLY
Dynamic Science, Inc., Case Number (1999-75-110J)
1998 Ford Ranger & 1999 Mercury Tracer
Colorado
July/1999

Summary

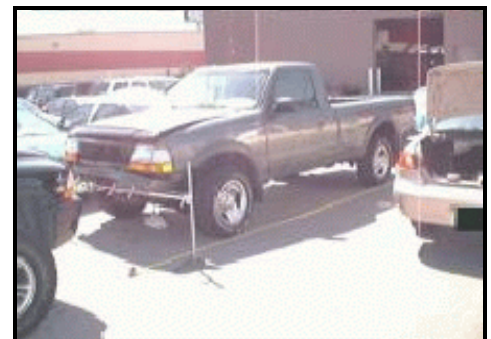
Figure 3. Frontal damage to Vehicle 1 (Ford Ranger)

Note: The above crush profile is inadequate for a Delta V determination due to overlapping damage from two separate crashes.

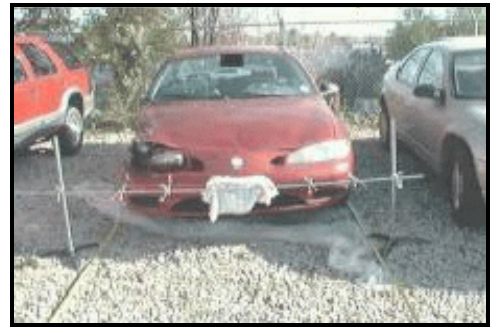
The front right corner of Vehicle 2 (01FREE7) impacted the front of Vehicle 1 (70FDEW1-10 o'clock direction of force incremented 60 for endshift to the right¹). The frontal air bag systems in both vehicles deployed. The corner impact to Vehicle 2 (Mercury Tracer) violated an application of the WinSmash program, therefore, a Delta V could not be adequately derived. Vehicle 1 rotated clockwise approximately 18 degrees in clockwise direction before coming to rest facing south. Vehicle 2 continued in a forward trajectory and was deflected to the left. Vehicle 2 came to rest in the west leg of the intersection and was straddling the roadway center lines.

Figure 4. Front right corner damage to Vehicle 2 (Mercury Tracer)

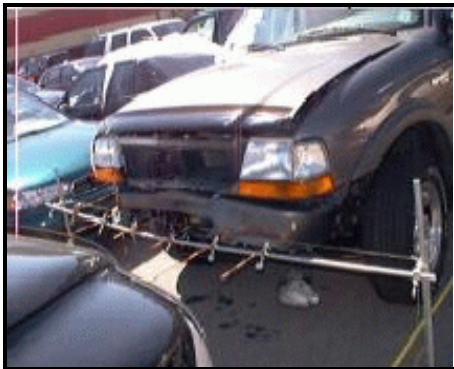
Figure 5. Front of Vehicle 1

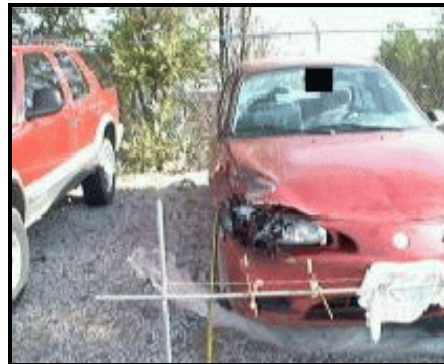
Figure 6. Front right corner damage to Vehicle 2

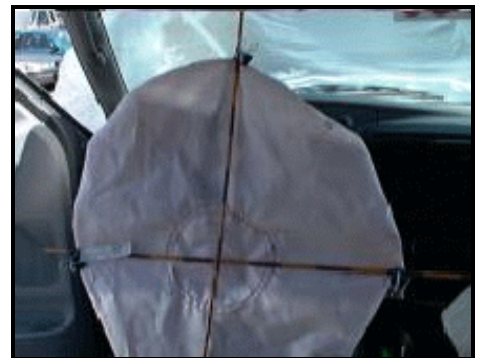
Figure 7. Driver's front air bag, Vehicle 1

The driver's air bag is housed in the steering wheel hub and encases the nylon air bag unit. The double, horizontal module cover flaps are asymmetric in design and opened at their designated tear points. The circular air bag is tethered by one strap and equipped with two exhaust vent port holes that are located at the 11 and 1 o'clock positions respectively. The rigid plastic knee bolster was undamaged and did not reveal any detectable occupant contacts.

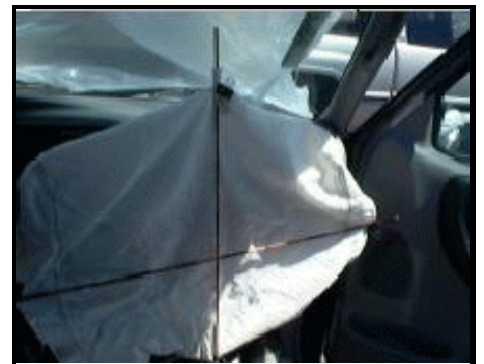
Figure 8. Passenger front air bag, Vehicle 1

The front, right passenger air bag is located in the right hand side of the instrument panel (mid-mount). The single module deployment door is rectangular in shape and opened at its designated tear points. Upon deployment, the encased air bag fully deployed. The non-tethered air bag was undamaged and was equipped with two exhaust vent port holes.

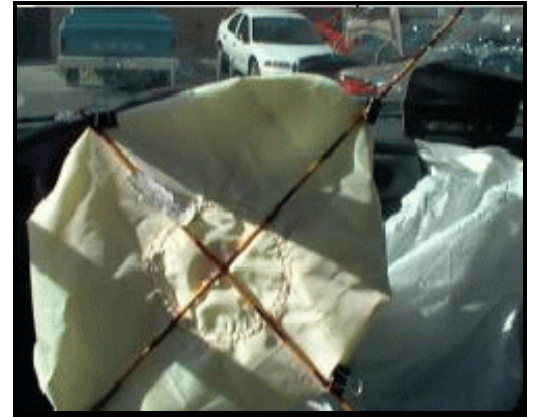
The driver's air bag is housed in the steering wheel hub and encases the nylon air bag, inflator unit, mounting plate, retainer ring and the air bag sliding contact. These components are concealed by the steering wheel trim cover which is equipped with standard horizontal tear seams. The circular air bag was tethered by two straps and two exhaust vent ports are present.

Figure 9. View showing deployed driver's air bag, Vehicle 2

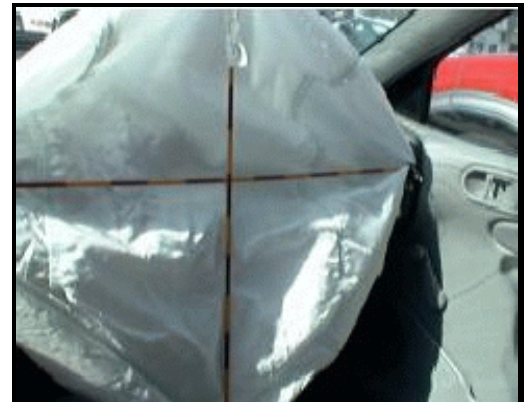
The front, right passenger air bag was located on the instrument panel (mid-mount type). The module deployment door is rectangular in shape and was equipped with a tear seam that is designed to allow the door to hinge outward during deployment. The inflator unit is supported by a metal reaction housing unit. There was no residual damage to the air bag and the module cover deployment door opened at the designated tear point. The deployment door cover opened with enough force to break the laminated windshield glazing.

Figure 10. Passenger front air bag, Vehicle 2
