Remote, Redesigned Air Bag Special Study

Dynamic Science, Inc., Case Number (1999-075-132K)

1998 Dodge Neon

September/1999

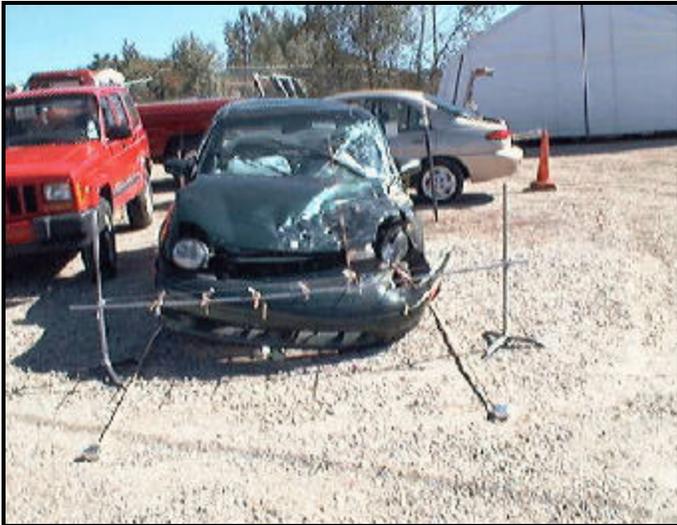
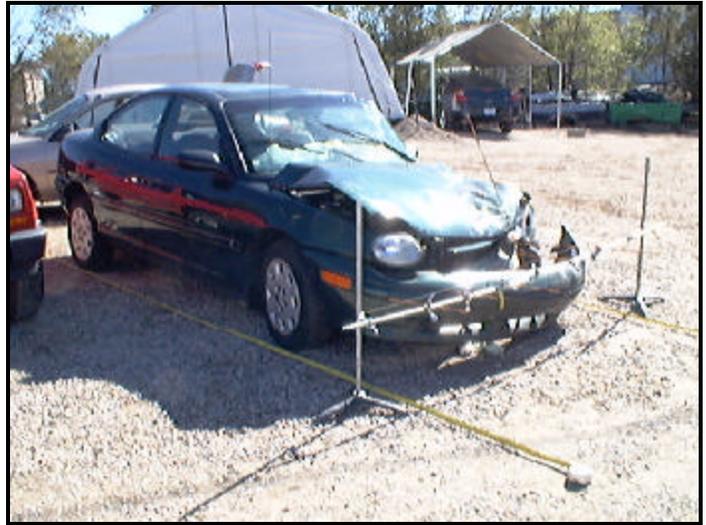
Model year, make and model	1998 Dodge Neon
VIN	1B3ES47C9WD
CDC	11FYAW6

Figure 4. Exterior, Vehicle 2 (1998 Dodge Neon 4-door sedan)

Figure 5. Exterior, Vehicle 2 (1998 Dodge Neon 4-door sedan)

Plane of Impact	Field L cm/in.	C1 cm/in.	C2 cm/in.	C3 cm/in.	C4 cm/in.	C5 cm/in.	C6 cm/in.
Bumper	131	21	19	15	11	2	0
	51.6	8.3	7.5	5.9	4.3	0.8	0

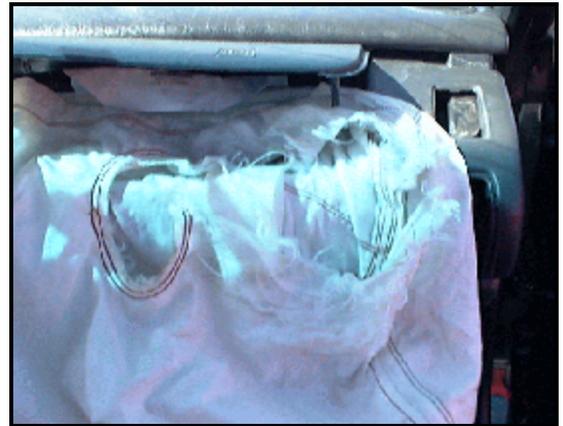
The front right air bag was housed in the mid-instrument panel position and was concealed by a single rectangular cover flap which was not damaged in the crash. The rectangular air bag was equipped with one vent port and no tether straps. No contact evidence was found on the bag but a large tear was evident to the top half of the back of the bag from an unspecified source.

Figure 6. Passenger's frontal air bag damage.

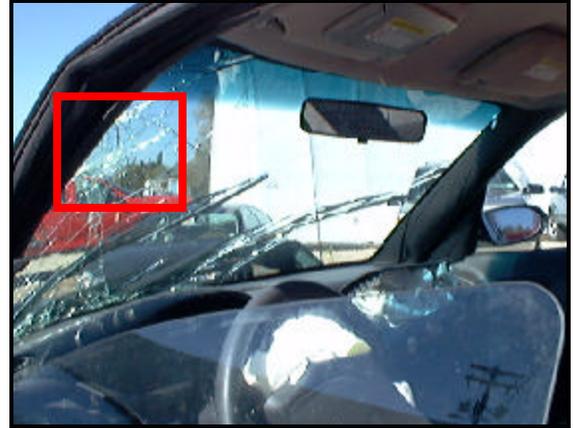
The interior of the Dodge Neon sustained minor damage from occupant contact. There was a minimal amount of intrusion of the A-pillar and windshield in the front left section of the vehicle. The intruded values are reported in Table 4. There was occupant contact evidence present to the windshield and driver's frontal air bag.

Injury	Injury Severity (AIS)	Injury Mechanism
Left radius fracture	3	Windshield
Left arm skin contusion	1	Windshield
Right knee skin contusion	1	Knee bolster
Left chest skin contusion	1	Driver's air bag
Facial skin contusion	1	Driver's air bag
Left knee skin contusion	1	Knee bolster

Figure 7. Interior, case vehicle. Box shows location of left arm contact.
