SCI/NASS COMBINATION CASE REPORT

CASE NUMBER - NASS-1999-75-176G

VEHICLE - 1999 VOLKSWAGEN JETTA

CRASH DATE - December 1999

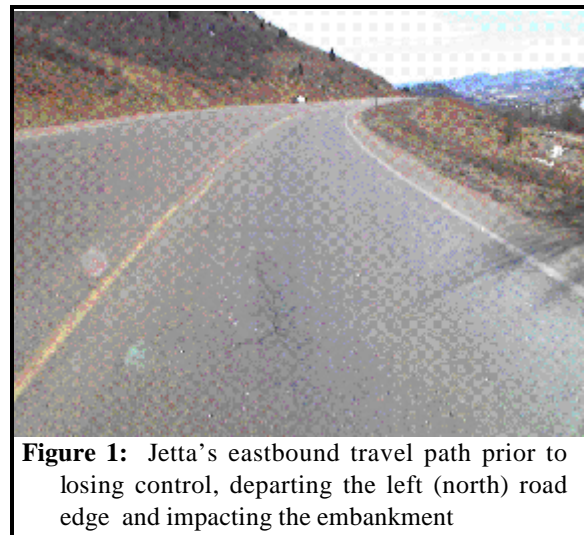
The Jetta was traveling east in the eastbound lane of a three-lane, undivided state roadway (one lane eastbound and two lanes westbound) and was negotiating a curve right. It was dark and the weather was clear. The bituminous roadway was dry with an uphill grade of over 2% for eastbound traffic. The posted speed limit was 72 km.p.h. [45 m.p.h.]. There were no traffic controls other than painted lane and edge lines. According to the driver's statement to the investigating officer, the Jetta encountered a patch of loose dirt/gravel and the driver lost control, crossing into the westbound lanes. The driver overcorrected by steering sharply to the right, causing the Jetta to go into a clockwise yaw and depart the left (north) edge of the roadway (**Figure 1**). The crash occurred off the left (north) side of the roadway.

Figure 1: Jetta's eastbound travel path prior to losing control, departing the left (north) road edge and impacting the embankment

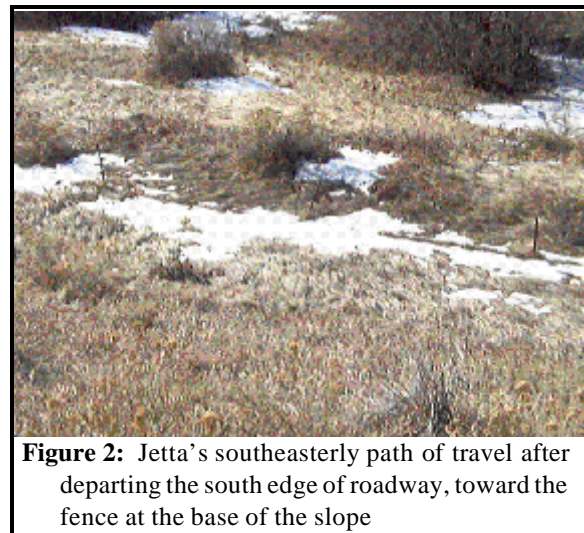
The Jetta's front left corner and left side impacted an embankment in a swiping-type engagement, causing the driver's seat back-mounted side air bag to deploy. The Jetta was redirected to the right and, continuing its clockwise rotation, traveled across the westbound and eastbound lanes and departed the right (south) side of the roadway. From the point where the Jetta lost control to its departure off the south edge of the roadway, it traveled approximately 49 meters [162 feet]. The Jetta continued in a southeasterly direction approximately 14 meters [46 feet] diagonally down a grassy slope, with its left side leading, and impacted a barbed wire fence (**Figure 2**) with its left and back planes. The Jetta

Figure 2: Jetta's southeasterly path of travel after departing the south edge of roadway, toward the fence at the base of the slope

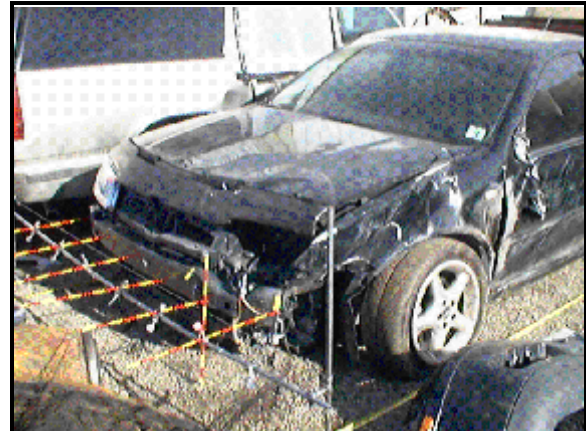
Figure 3: Front left view of damage to Jetta's front left corner from impact with embankment, which extended down left side

The Jetta's initial contact with the embankment involved the front left bumper corner and extended down the left side (**Figures 3 and 4**). The bumper cover was torn off, the front left corner of the fender was pushed inward and slightly rearward and there was abrading along the entire left side. The Jetta's impact with the fence involved a penetrating-type impact with scraping and minor deformation to the entire left side, the top and across the entire back plane. The wheelbase on the left side was shortened 6 centimeters [2.4 inches]. Both left side tires were deflated. There were no areas of integrity loss to the Jetta, although the windshield was cracked from the embankment impact.

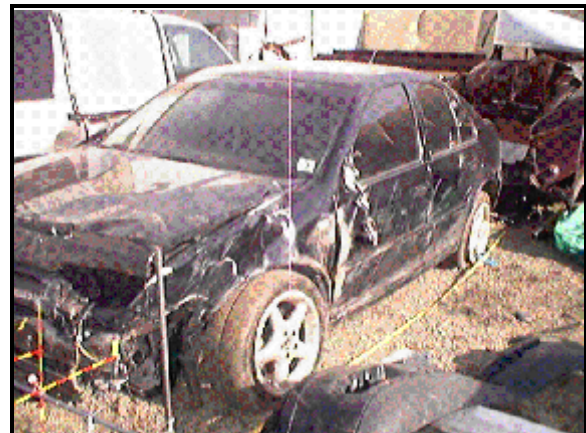
Figure 4: Jetta's left side damage from impacting embankment, with overlapping fence damage

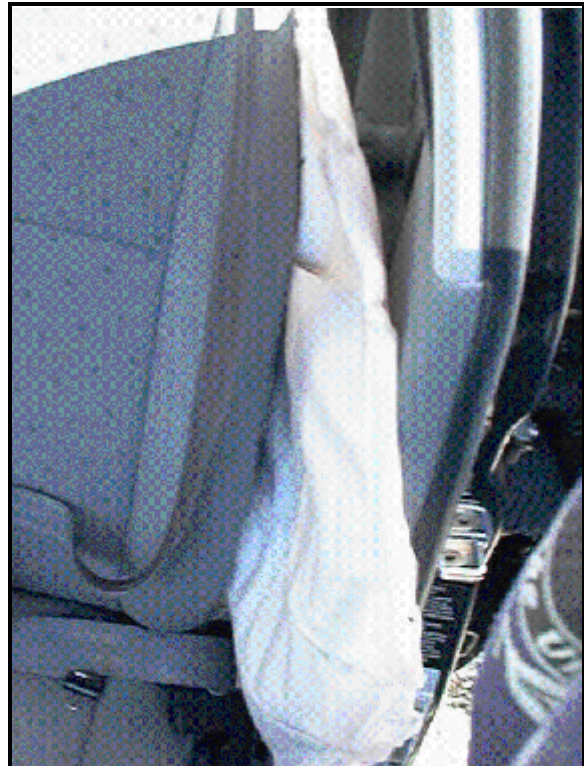
The Jetta's driver side air bag deployed from along the outside seam of the driver's bucket seat back. The side air bag's dimensions were estimated to be 20 centimeters [7.9 inches] horizontally and 48 centimeters [18.9 inches] vertically and it was not tethered or vented (**Figures 5 and 6**). There was no visible evidence of contact or damage on the air bag.

Figure 5: Deployed driver's seat back-mounted side air bag, looking rearward

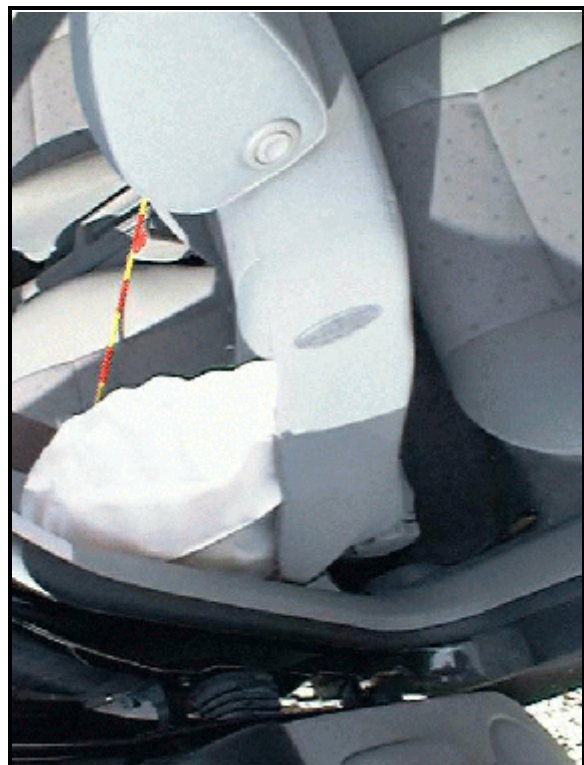
Figure 6: Looking down on deployed driver's seat back-mounted side air bag

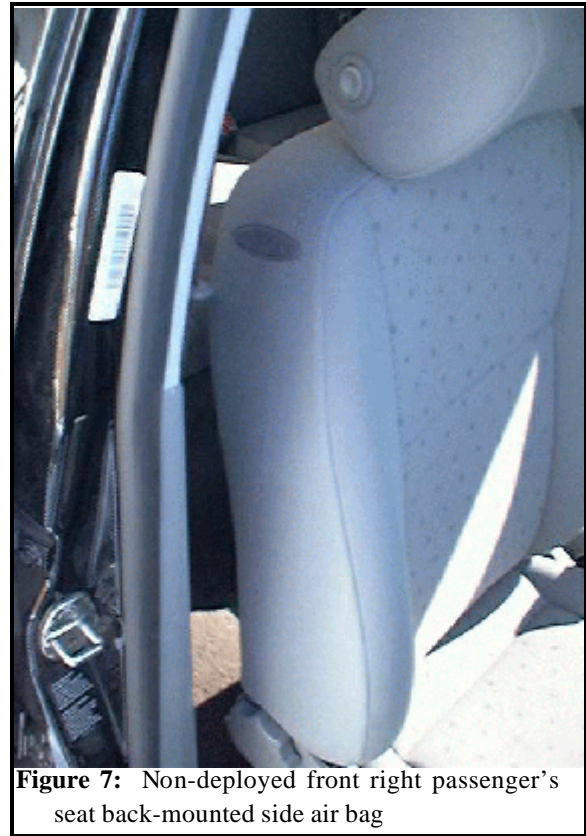
Figure 7: Non-deployed front right passenger's seat back-mounted side air bag
