Remote, Redesigned Air Bag Special Study
Dynamic Science, Inc., Case Number (1999-079-044)
1998 Honda Accord
California
April /1999

Summary

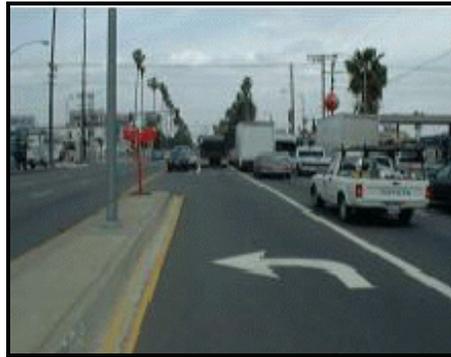
Figure 1. Pre-impact trajectory for Vehicle 1 (Dodge Caravan)

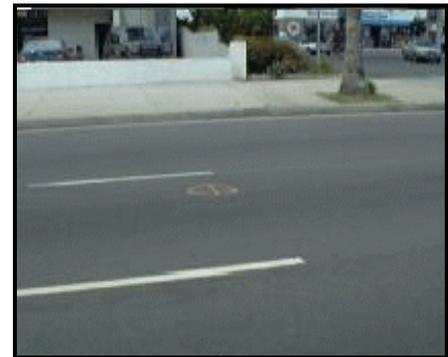
Figure 2. Vehicle 1 initiates a U-turn (point of impact)

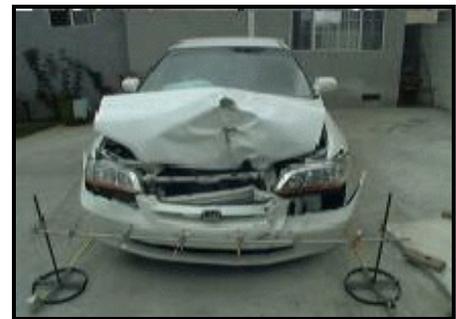
Figure 3. View showing frontal damage to Vehicle 2 (Honda)

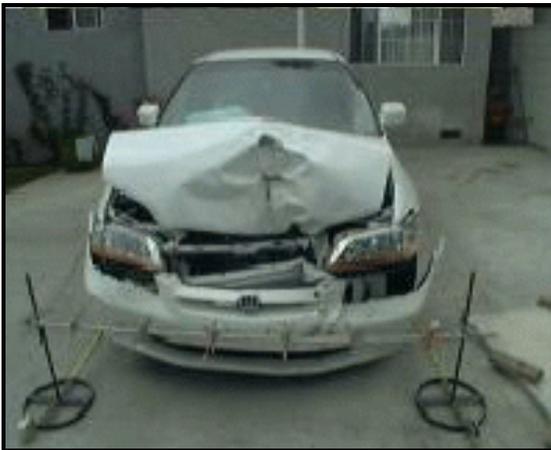
Figure 4. Front view, Vehicle 2

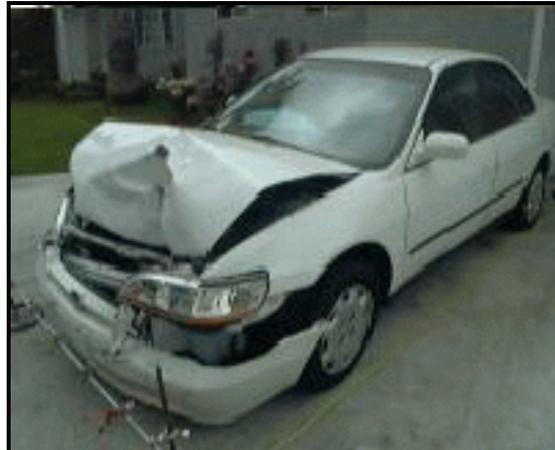
Figure 5. Three-quarter view of frontal damage to Vehicle 2

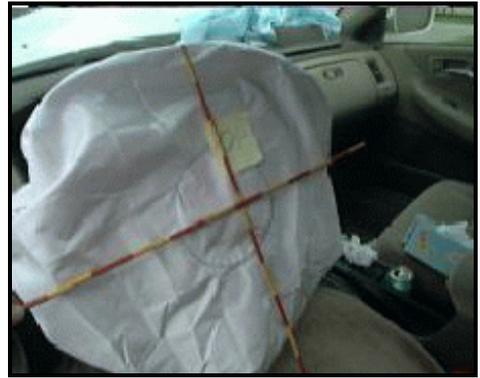
The driver's air bag is housed in the steering wheel hub and encases the nylon air bag unit. The double, horizontal, module cover flaps are asymmetric in design and opened at their designated tear points. The circular air bag is 62 cm (24.4 in.) in diameter and is equipped with two tether straps¹ and two exhaust vent port holes. The vent ports are located at the 11 and 1 o'clock positions respectively. The rigid plastic knee bolster was undamaged and did not reveal any detectable occupant contacts.

Figure 6. View showing deployed driver's air bag

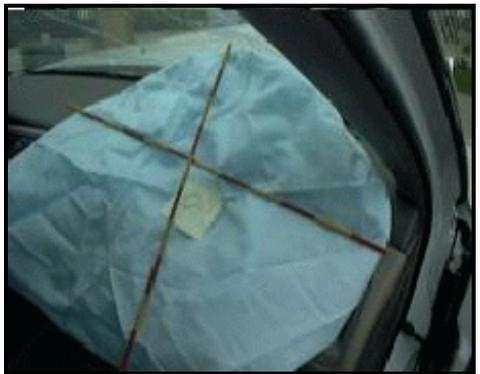
The front, right passenger air bag is located on the instrument panel (top mount). The module deployment door is rectangular in shape and is equipped with double horizontal cover flaps that are symmetrical in design (23 cm wide x 4.7 cm in height). The non-tethered air bag was undamaged and was equipped with two vent port holes which are at the 10 and 2 o'clock positions.

Figure 7. View showing deployed passenger air bag

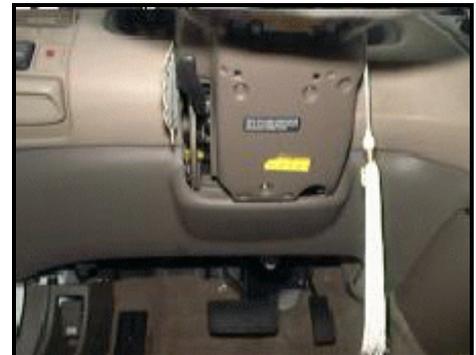
The interior of the 1998 Honda Accord sustained minor interior damage due to occupant contact and passenger air bag deployment. The driver's right knee impacted the lower steering wheel column cover as evidenced by a residual scuff mark. The driver's right hand flailed upward breaking the underlying vanity mirror of the front, left sunvisor. The laminated windshield was broken due to the front, right passenger air bag deployment. There were no intruding components and the passenger compartment integrity was not compromised. The case vehicle is equipped with front bucket seats with adjustable head restraints. The second seat consists of a bench seat with integral head restraints located at the outboard positions. The front, left seat track was adjusted between the middle and rearmost seat track position.

Figure 9. Close up showing knee contact to lower steering column cover

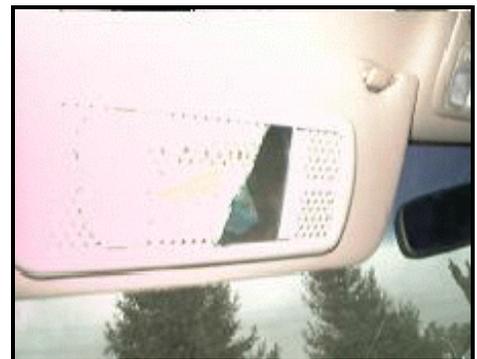
The restrained 22 year-old-female responded to the 12 o'clock principle direction of force by moving directly forward. She loaded the lap belt webbing as her left knee impacted the knee bolster resulting in a contusion (AIS-1). Her right knee contacted the lower steering column cover which did not result in injury but did leave a residual scuff mark to the cover. Her chest loaded the applied shoulder belt webbing which prohibited extended forward motion of her upper torso. As the air bag deployed, her right hand was thrust off of the steering wheel rim and flailed upward impacting the sunvisor. This contact was evidenced by the broken underlying vanity mirror. She sustained a left forearm abrasion (AIS-1) which occurred during the air bag deployment and a contused right hand (AIS-1) due to the sunvisor contact. Driver 1 rebounded rearward into her respective seat back.

Figure 10. Damaged vanity mirror due to right hand contact
