Remote, Redesigned Air Bag Special Study

Dynamic Science, Inc., Case Number (1999-79-122J)

1998 Ford Taurus station wagon

September/1999

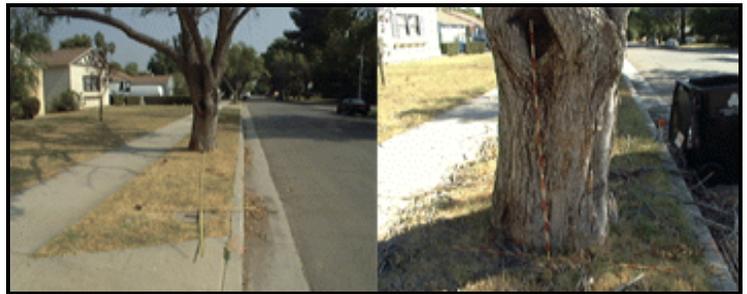
Figure 1. Impact area with tree

For reasons not known, as Vehicle 1 was negotiating the curve the driver veered to the left, overrode the curb and struck a large tree with its front end (12FCEN3).

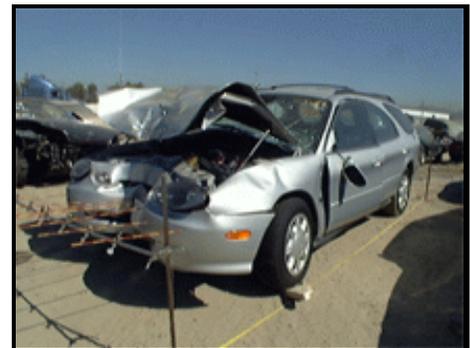
Figure 2. Left front corner view of Vehicle 1

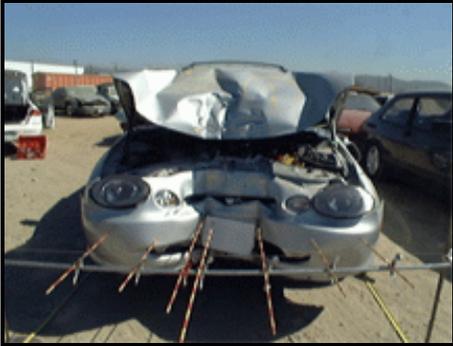
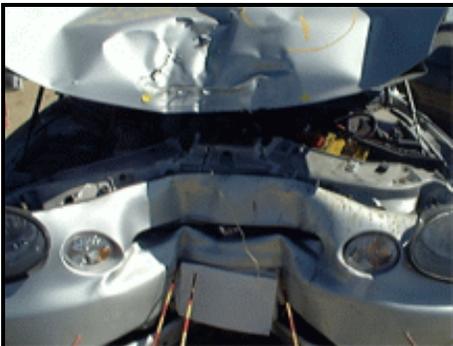
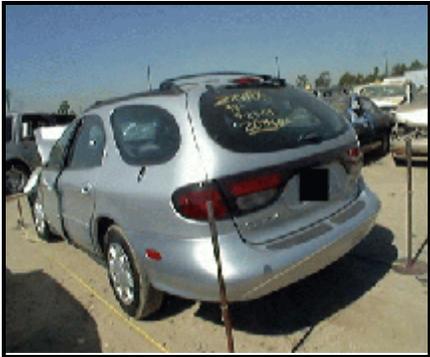
Figure 3. Front view	Figure 4. Close-up, front view	Figure 5. Left rear quarter view
CDC	12FCEN3

Plane of Impact	Field L cm/in.	C1 cm/in.	C2 cm/in.	C3 cm/in.	C4 cm/in.	C5 cm/in.	C6 cm/in.
Bumper	152	12	24	53	56	28	9
	59.8	4.7	9.4	20.9	22	11	3.5

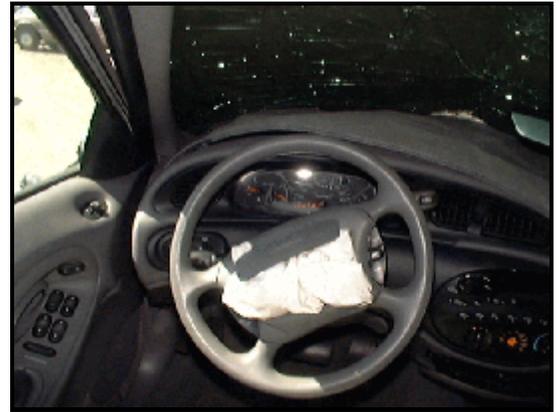
Figure 6. Driver’s seated position

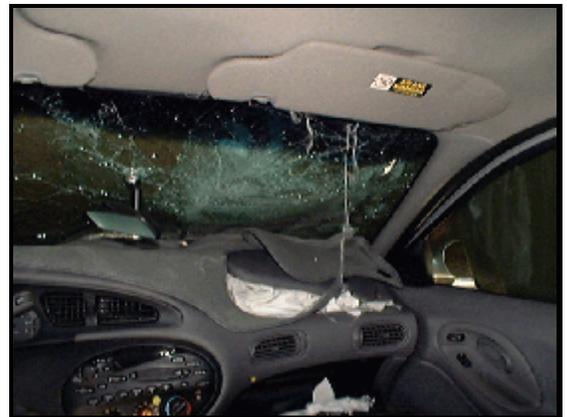
The interior of the Ford Taurus sustained minor damage from occupant contact. There was minor intrusion to the toe pan area on the driver’s side, and some seat back intrusion on the passenger’s side. There was occupant contact evidence to the seat belt, lower instrument panels, center instrument panel, and the glove compartment door.

Figure 7. Front right occupant’s seated position

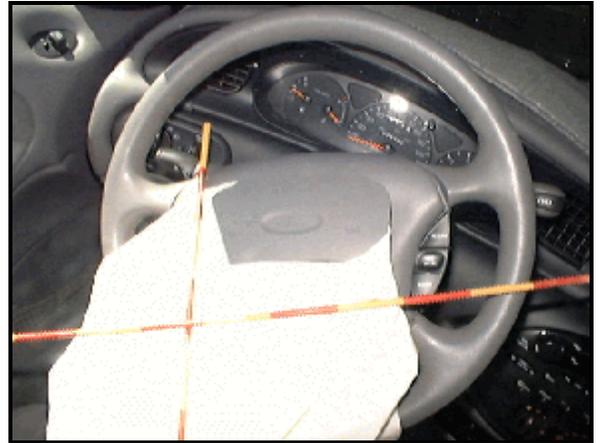
The front left air bag was housed in the steering wheel hub and was concealed by H-configuration cover flaps that were not damaged in the crash. The circular air bag was equipped with four tether straps and two vent ports. Some evidence of scuffing/occupant contact was found on the air bag.

Figure 8. Driver's frontal air bag

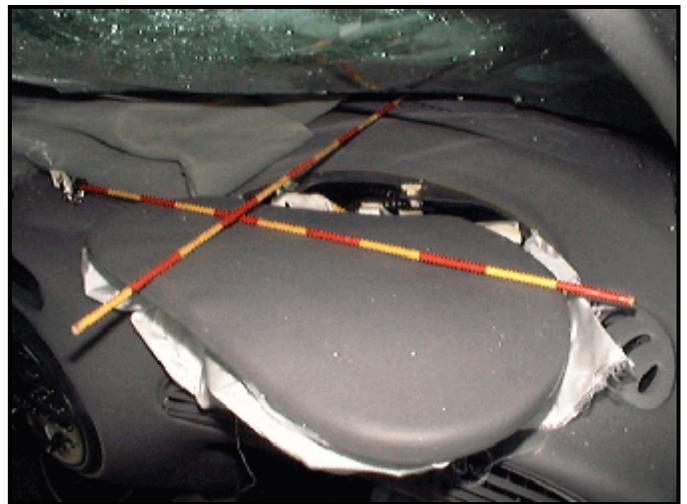
The front right air bag was located in the top-instrument panel position. The single air bag module cover flap was an irregularly shaped rectangular configuration. The module cover is held in place by two tethers.

Figure 9. Module cover, passenger's frontal air bag

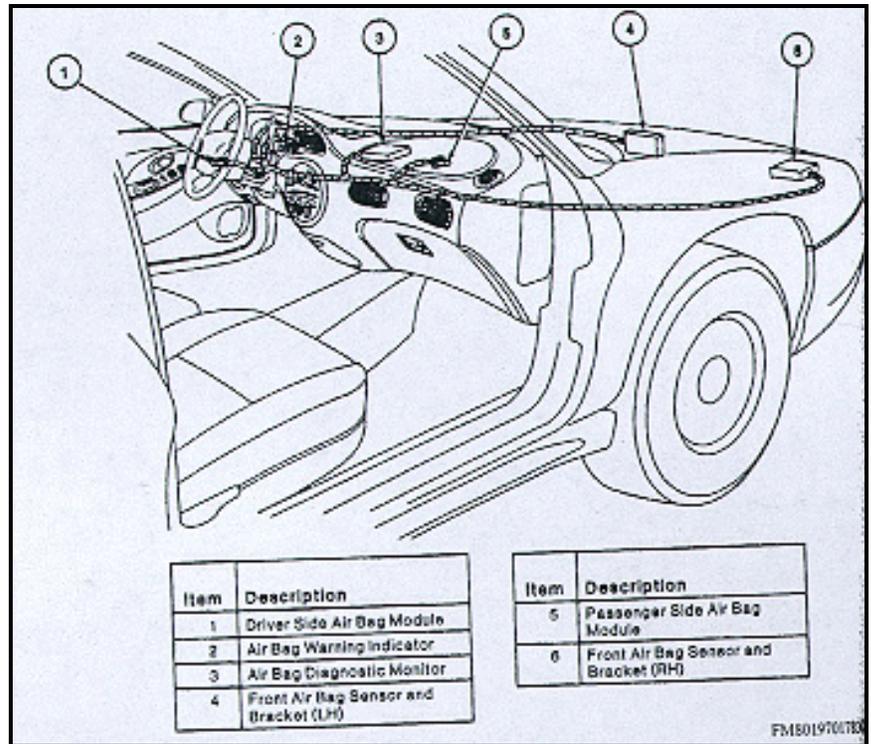
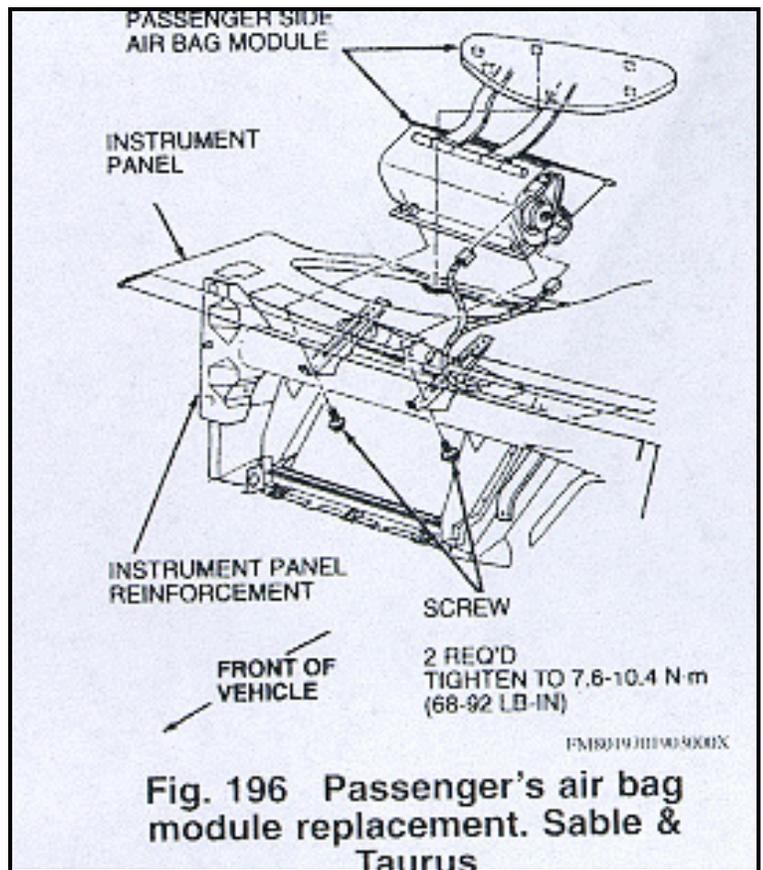
Figure 10. Passenger's frontal air bag

Figure 11. Passenger's frontal air bag

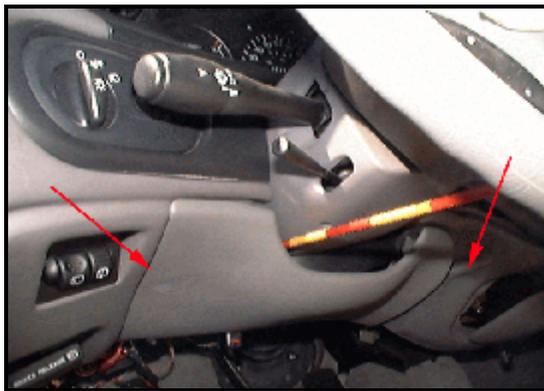
At impact, the driver reacted to the 0 degree principal force direction by pitching forward and loading the seat belt—causing the “seat-belt” injuries. The driver slid forward and struck the lower instrument panel with both knees—contusing both knees. As the air bag deployed it contacted both inner arms—causing bilateral contusions. The left arm was flung outward and contacted the door side panel—causing a contusion to the dorsal aspect of the left hand.

Figure 12. Contacts to the left lower instrument panel

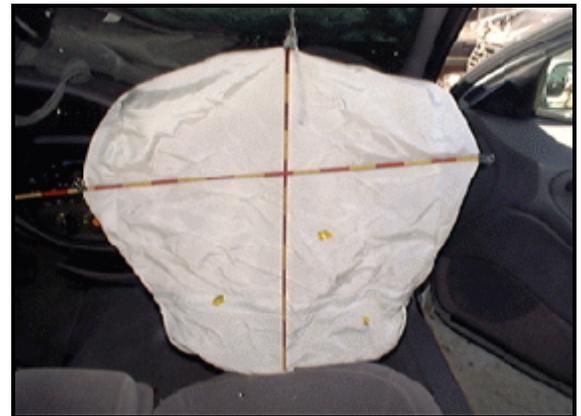
Figure 13. Passenger side frontal air bag

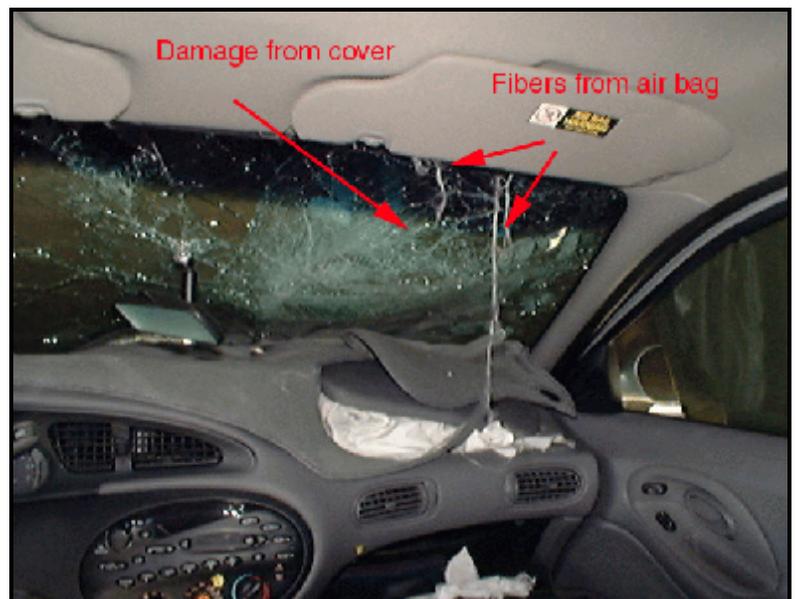
Figure 14. Front right passenger seating area

At impact, the front right occupant reacted to the 0 degree principal force direction by sliding forward then striking the lower instrument panel/glove box area with both knees. This impact loaded and then fractured both femurs. This occupant likely realized that an impact was imminent and tried to stop herself with her right hand. As she pitched forward, her right hand likely struck the instrument panel—causing the wrist dislocation and fracture of the distal radius. As the impact continued, this occupant slid below the instrument panel and came to rest on the floor. This occupant also sustained a corneal abrasion. The investigator attributed this to flying glass, but a more likely source is the deploying air bag that she engages as she submerges below the instrument panel.
