## SCI/NASS COMBINATION CASE REPORT

CASE NUMBER - NASS-99-79-176A

VEHICLE - 1996 VOLVO 850

CRASH DATE - December 1999

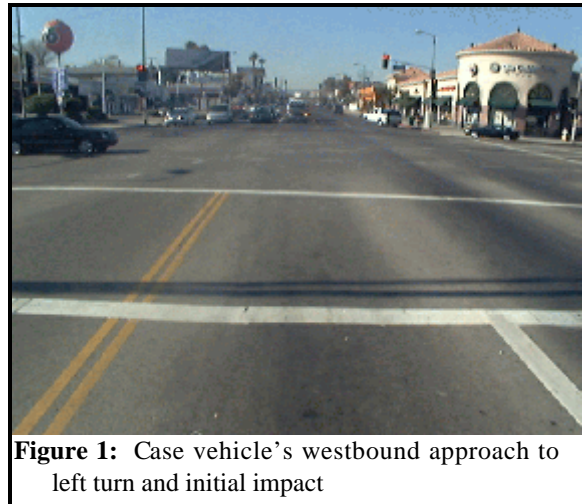
The case vehicle was traveling west in the westbound left turn lane of a six-lane, two-way undivided local road, approaching a four-leg intersection and intending to turn left to travel south. Vehicle #2 was traveling east in the inside eastbound through lane of the same roadway, approaching the same intersection and intending to pass through the intersection and continue east. Both roadways were asphalt, dry, straight, level, and with no defects. It was daylight with no adverse weather conditions. The speed limit for both vehicles was 56 km.p.h. [35 m.p.h.]. The intersection was controlled by on-colors automatic signals, with painted lane lines (**Figure 1**). The case vehicle turned left across the path of vehicle #2.

**Figure 1:** Case vehicle's westbound approach to left turn and initial impact

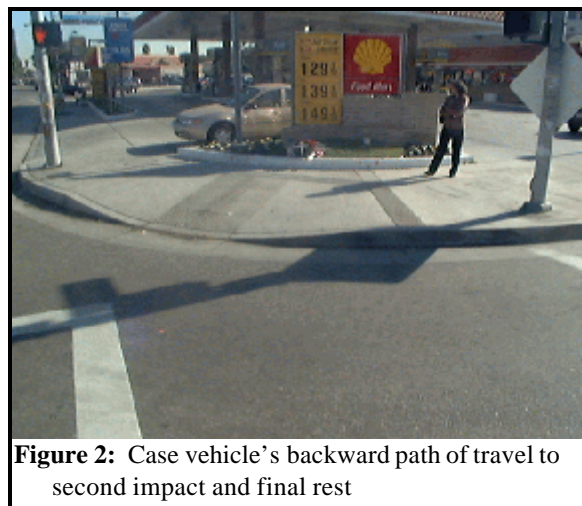
**Figure 2:** Case vehicle's backward path of travel to second impact and final rest

(Figure 2), where it came to rest heading northwest. Vehicle #2 rotated approximately 160 degrees clockwise and came to rest within the intersection heading southwest.

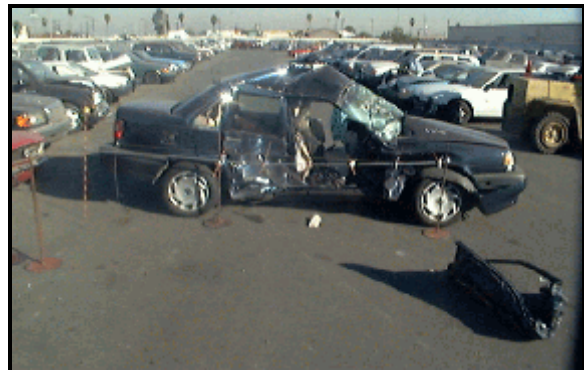
The case vehicle sustained heavy direct contact damage centered approximately on the right B-pillar (Figure 3), with direct contact above the belt line, including both right doors and extending forward of the right A-pillar into the right fender. The imprint of vehicle #2's bumper is plainly apparent along the midline of the right side doors. The right sill was overridden until vehicle #2's front had penetrated the case vehicle such that vehicle #2's undercarriage components caused direct contact on the case vehicle's sill (i.e., the case vehicle sustained right side override and vehicle #2 sustained front underride<sup>1</sup>). The B-pillar and the doors collapsed inward, causing major lateral intrusion into the front right seat area (Figure 4). The right roof rail and roof were buckled downward, causing vertical intrusion. All glazing on the right side was shattered (kernelized). The right A-pillar was also pushed inward, pulling the windshield header down, and the windshield was shattered across its entire width. The CDC was determined to be **61-RYAW-4**, with direction of principal force 30 degrees [one o'clock] and reflecting the NASS investigator's judgement that the vehicle sustained bowing of the frame with end shift to the right. Maximum crush was 65 centimeters [26 inches] at the B-pillar. The

**Figure 3:** Case vehicle's right side damage; note, right front door in foreground

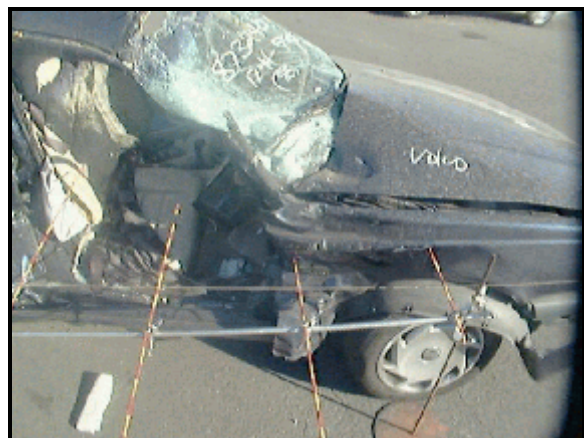
**Figure 4:** Case vehicle's front right seat position; note, relatively undamaged seat cushion

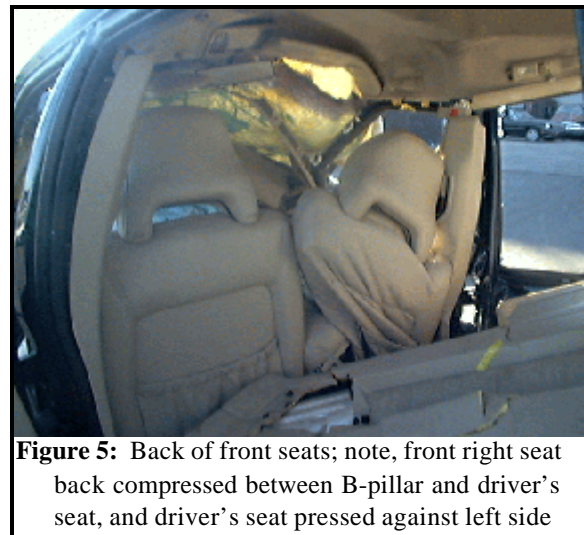
Virtually all components on the right side caused intrusion into the right side seating areas, including the A- and B-pillars, the roof side rail, the roof, the interior surfaces of the two doors and the floor pan. The front right seat position sustained very heavy intrusion. The seat back of the front right bucket seat was pushed laterally such that it was compressed between the collapsed right B-pillar and the driver's seat back, and was bent and folded (**Figure 5**). It appears that the front right seat cushion was essentially undamaged (the available photos do not permit a complete evaluation due to debris). This configuration of damage to the seat back but not to the seat cushion reflects the side override component of the impact. The right front door interior panel intruded beyond the right third into the middle third of the front seat row, for a measured total intrusion of 56 centimeters [22 inches] laterally. The right side front and back doors were jammed shut.

**Figure 5:** Back of front seats; note, front right seat back compressed between B-pillar and driver's seat, and driver's seat pressed against left side

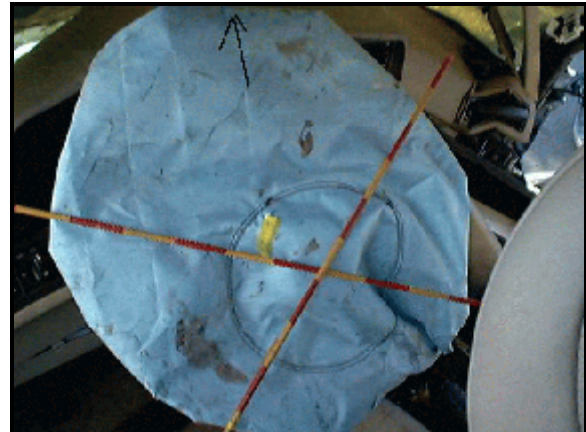
The driver's front air bag was located in the steering wheel hub with the cover flaps in the H-configuration. The deployed air bag was round with diameter 54 centimeters [21 inches], with four tethers and two vent ports. There was no indication of any problem with the driver's front air bag. There were numerous blood spots all over the front of the air bag and scuffing on the back (**Figure 6**).

**Figure 6:** Deployed driver's air bag

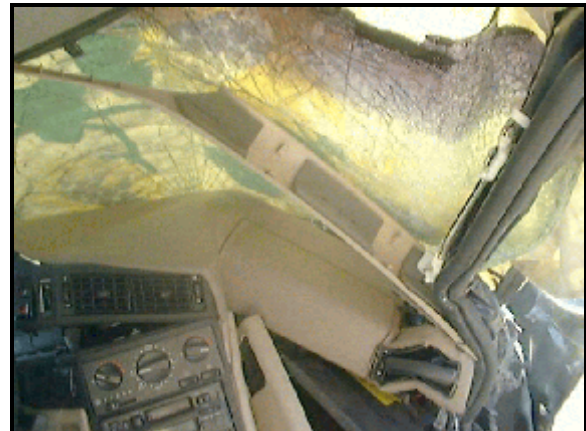
The front right passenger's front air bag was located in the top of the instrument panel and did not deploy. The center-right area of the instrument panel was bent sharply upward along the inboard edge of the air bag module cover flap, where the instrument panel is molded to form the center console. The outboard edge of the instrument panel was bent downward and crushed against the intruded A-pillar (**Figure 7**). Although the longitudinal Delta V was sufficient to deploy the driver's front air bag, the passenger's front air bag did not deploy.

**Figure 7:** Non-deployed front right passenger's air bag module cover

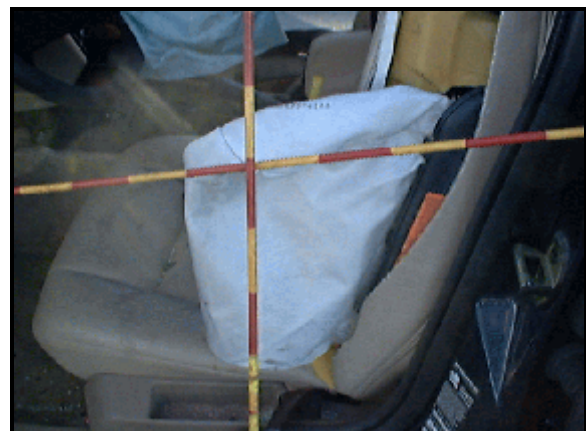
The driver's and front right passenger's side air bags were both mounted in the outboard edge of the respective seat backs. Both of these air bags deployed through a pre-stressed seam in the vinyl upholstery (**Figure 8**). Both side air bags were rectangular, 21 centimeters [8 inches] long and 27 centimeters [11 inches] high. The side air bags each had two vent ports and no tethers. There was no indication of any problem with either of the side air bags, except the right side air bag had a hole near the top where it was probably pinched by the intruding B-pillar. The right side air bag deployed as a result of the direct compression of the right side sensor by the impact with vehicle #2 (**Figure 9**, below). The left side air bag deployed when the massive lateral intrusion forced the outboard edge of the driver's seat against the left side interior surface, resulting in compression of the left side air bag sensor.

**Figure 8:** Driver's deployed side air bag

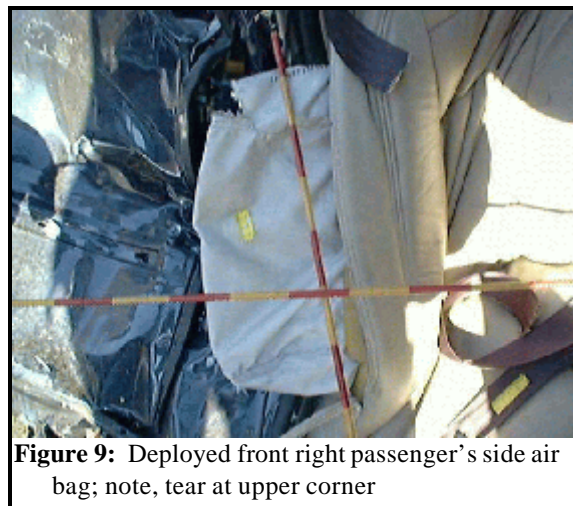
**Figure 9:** Deployed front right passenger’s side air bag; note, tear at upper corner
