Remote, Redesigned Air Bag Special Study  
Dynamic Science, Inc., Case Number ( 1999-79-501F)  
1998 Nissan Pathfinder  
California  
April/1999

1. Report No. 1999-79-501F	2. Government Accession No.	3. Recipient Catalog No.	
4. Title and Subtitle		5. Report Date May 24, 2000	6. Performing Organization Report No.

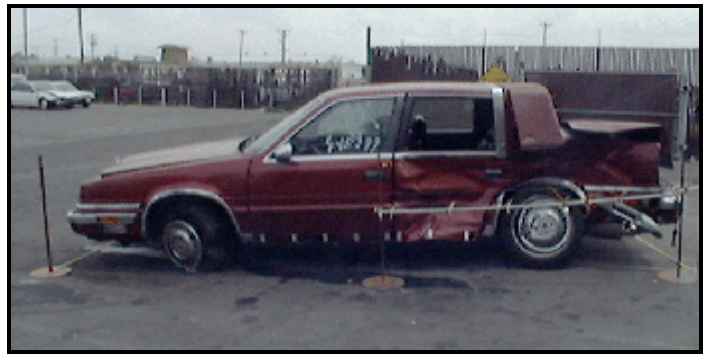
Figure 3. Left side, Vehicle 1

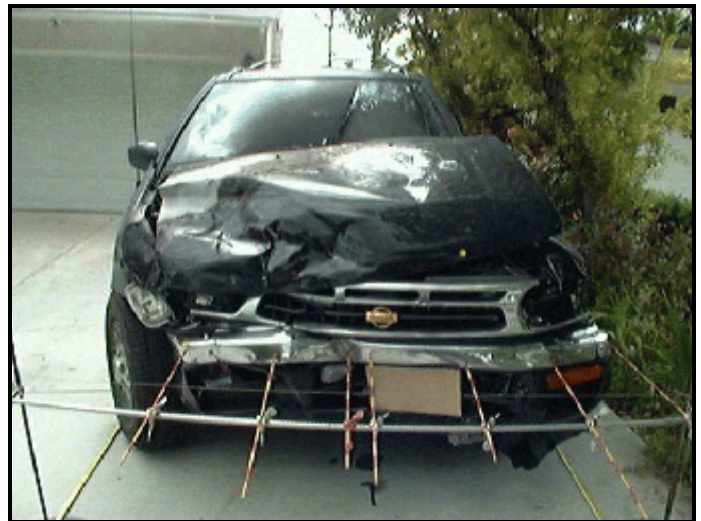
Figure 4. Front view, Vehicle 2

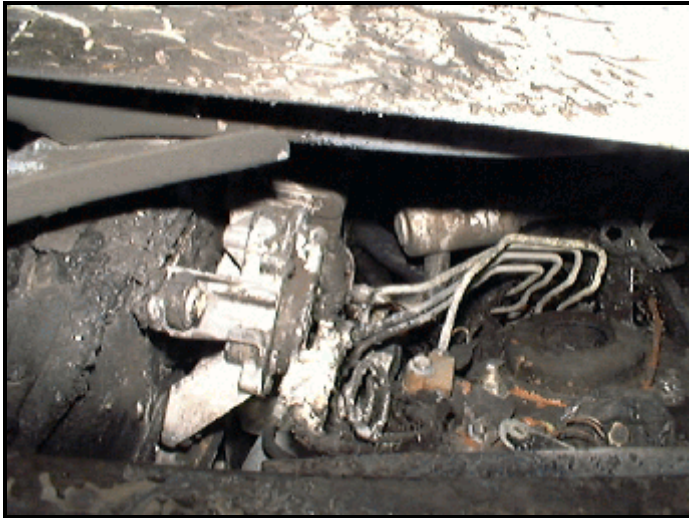
Vehicle 1 was redirected into a counterclockwise rotation and came to rest in the western part of the intersection facing south. Vehicle 2 was redirected in a counterclockwise direction and came to rest on the raised median on the northern leg of the intersection. Immediately after the crash, the driver of Vehicle 2 noticed “sparking” under the hood near the battery. A minute or two later, flames appeared. Approximately 3-4 minutes after the fire began, the fire department arrive and extinguished the flames.

**Figure 5.** Fire damage

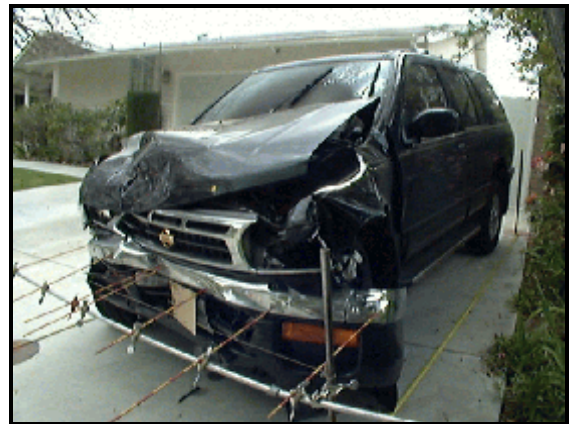
**Figure 6.** Exterior, Vehicle 2

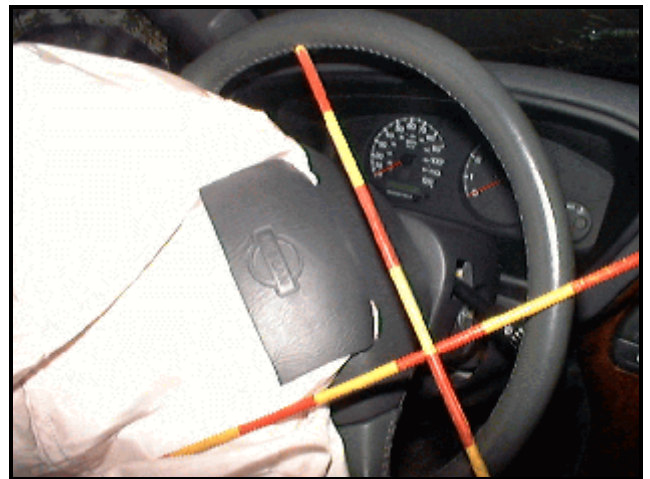
The 1998 Nissan Pathfinder was equipped with redesigned air bag systems. The driver's air bag was housed in the steering wheel hub. The module cover was essentially symmetrical and opened in an "H" pattern. The circular air bag was equipped with four tethers and two vent ports. Neither the module cover nor the air bag itself was damaged. This air bag had been replaced after being stolen.

**Figure 9.** Driver's front air bag

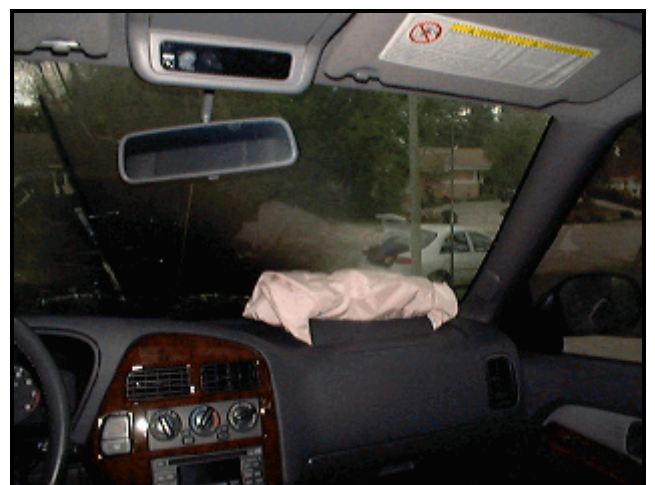
The front, right passenger's air bag was located on the instrument panel (top mounted). The module cover was rectangular. The air bag was equipped with two vent ports and does not have any tethers. This air bag had been replaced after being stolen.

**Figure 8.** Front right seating position

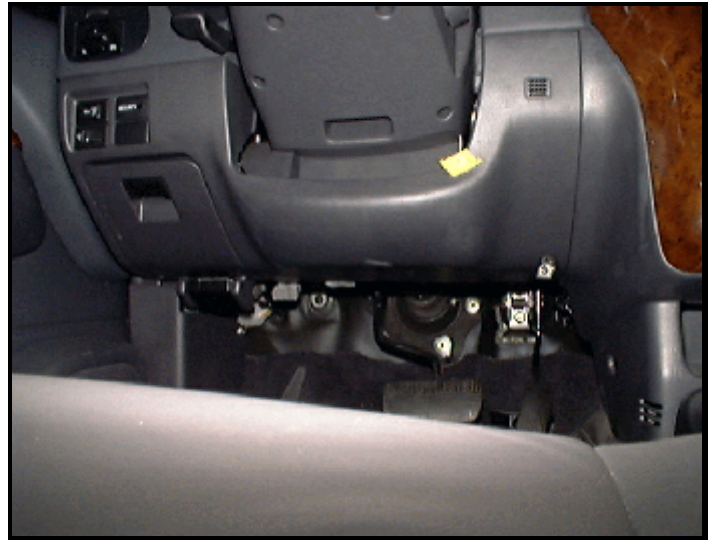
The interior of the 1998 Nissan Pathfinder did not sustain any integrity loss nor any intrusion. There was some minor scuffing to the right side of the left lower instrument panel from a probably knee contact.

The driver responded to the 10E direction of force by moving forward and to the right. He was restrained by the lap and shoulder belt, but did move forward enough to engage the lower instrument panel/knee bolster with his left knee and with his right lower leg causing minor contusions (AIS1). As he moved forward he engaged and loaded the lap portion of the seat belt which resulted in causing some pain to his right hip area. As the driver's air bag deployed, he engaged it with his face. There were no resultant injuries from the air bag contact, but the driver did report some minor pain. The driver was maintained in his respective seated position and did not sustain any fractures or internal injuries.

**Figure 10.** Lower instrument panel-right leg contact
