Remote, Redesigned Air Bag Special Study

Dynamic Science, Inc., Case Number (1999-079-802E)

1998 Toyota Camry 4-door sedan

August/1999

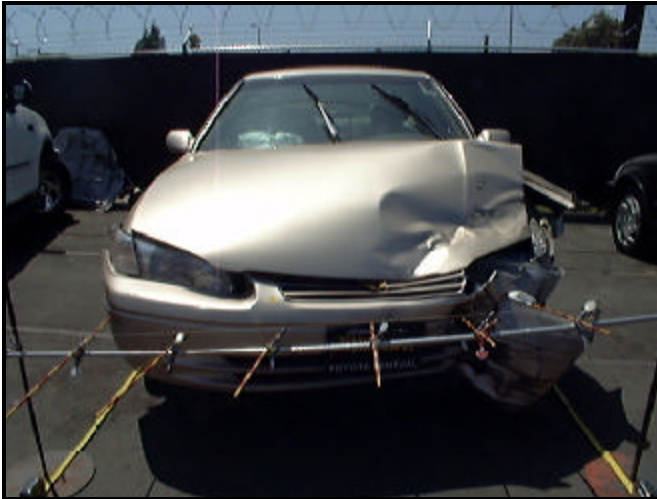
Figure 4. Exterior, Vehicle 1 (1998 Toyota Camry)

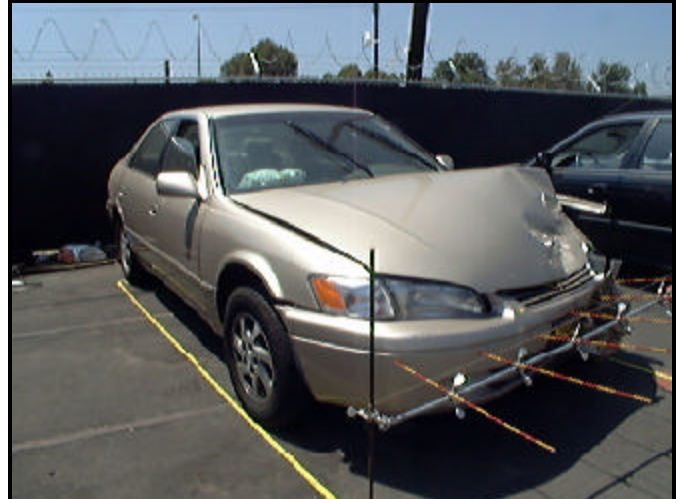
Figure 5. Exterior, Vehicle 1 (1998 Toyota Camry)

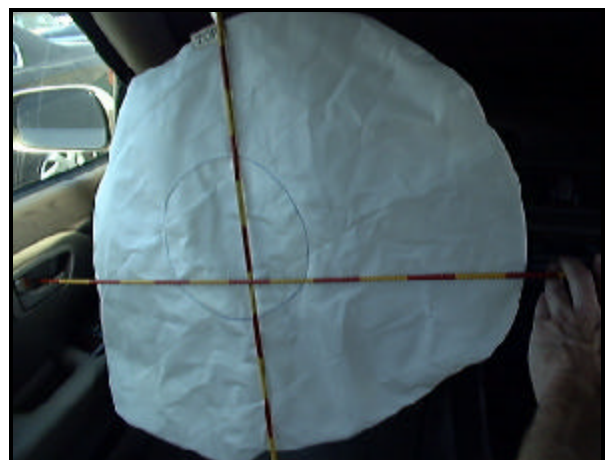
Figure 6. Interior, case vehicle. Driver's frontal air bag.

The front left air bag was housed in the steering wheel hub and was concealed by asymmetrical H-configuration cover flaps which were not damaged in the crash. The circular air bag was equipped with four tether straps and two vent ports. Contact evidence consisting of a “very light gray scuff” was found on the upper left quadrant of the front of the bag. The air bag was not damaged.

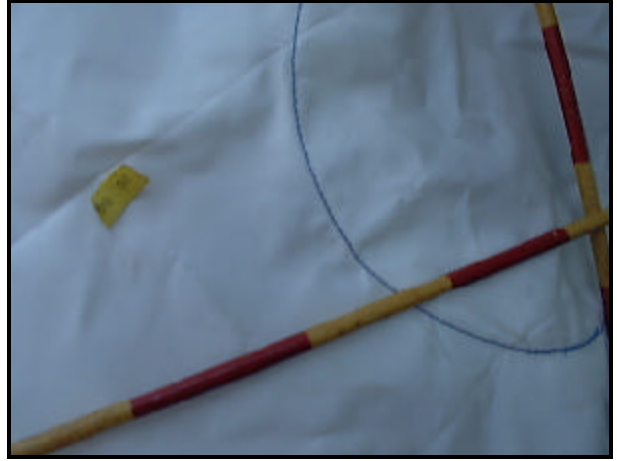
At impact, the driver responded to the 1 o'clock direction of force by moving forward and to the right, loading the manual lap and shoulder restraint. As the restraints locked, further forward movement of the case occupant was prevented. It appears that the driver came into contact with the deploying driver's frontal air bag-causing the fractured sternum, chest contusion, and forearm contusion. A small grayish scuff was found on the front of the bag (see Figure 7). It is believed that loading of the shoulder belt contributed to the sternum fracture. The case occupant was transported from the scene to a hospital where she was treated and released.

Figure 7. Interior, case vehicle. Air bag contact.
