**TRANSPORTATION SCIENCES  
CRASH RESEARCH SECTION**

Veridian  
Calspan Operations  
Buffalo, New York 14225

**VERIDIAN ON-SITE DRIVER/SEAT BELT FATALITY INVESTIGATION  
VERIDIAN CASE NO. CA99-002  
VEHICLE: 1993 SUBARU LEGACY  
LOCATION: VIRGINIA  
CRASH DATE: FEBRUARY 1999**

U.S. Department of Transportation  
National Highway Traffic Safety Administration  
Washington, D.C. 20590

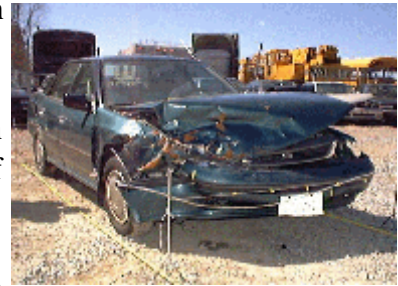
This on-site investigation focused on a two-vehicle intersection crash that involved a 1993 Subaru Legacy (subject vehicle) and a 1999 Pontiac Grand AM. The Subaru was equipped with a frontal driver air bag that deployed as a result of an offset frontal impact (**Figure 1**) with the left front side area of the Pontiac. The 77 year old female driver of the Subaru was restrained by the automatic motorized shoulder belt system, however, she did not wear the manual lap belt. At impact, the driver initiated a forward trajectory into the path of the deploying driver air bag. The expanding air bag contacted the face of the driver which resulted in multiple abrasions of the cheeks, nose, lips, and chin. She loaded the automatic shoulder belt webbing which resulted in multiple bilateral rib fractures, a ruptured spleen, ruptured heart, ruptured liver, a left pulmonary contusion, and a band-like contusion across the anterior chest. Although the driver was within the deployment path of the air bag, the bag was not a mechanism for the internal injuries. She was removed from the vehicle and transported to a local hospital where she expired within 30 minutes of the crash.

**Figure 1. Front right 3/4 view of the Subaru Legacy.**

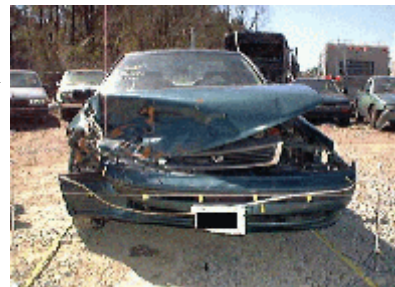
The Subaru sustained moderate frontal damage (**Figure 2**) from the initial impact sequence with the Pontiac Grand Am. The direct contact damage began 22.9 cm (9.0") left of center and extended 94.6 cm (37.25") to the right corner of the front bumper. Maximum crush was documented at 34.9 cm (13.75") which was located at the right bumper corner (**Figure 3**). The combined induced and direct contact damage was 139.7 cm (55.0") which involved the full frontal width of the vehicle. The crash profile at bumper level was as follows: C1 = 2.5 cm (1.0"), C2 = 4.4 cm (1.75"), C3 = 10.4 cm (4.1"), C4 = 15.7 cm (6.2"), C5 = 20.3 cm (8.0"), C6 = 34.9 cm (13.75"). The Collision Deformation Classification (CDC) for this impact was 01-FZEW-2 with an improved

**Figure 2. Frontal damage to the Subaru Legacy.**

principal direction of force (PDOF of 20 degrees. Damaged components included the front bumper system, grille, hood, radiator and radiator support, and both front fenders. There was no glass damage and all four doors remained closed and operational.

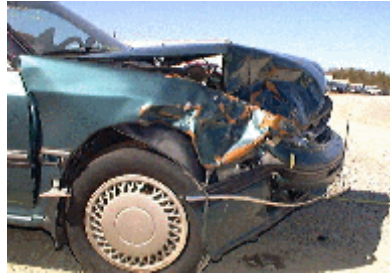
**Figure 3. Profile view documenting the extent of frontal crush.**

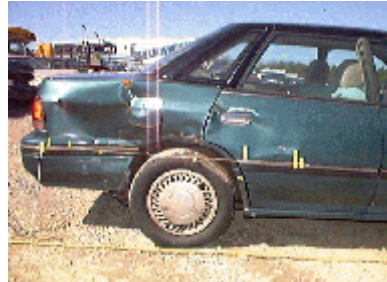
**Figure 4. Sideslap damage to the right rear side area of the Subaru.**

The secondary sideslap (**Figure 4**) resulted in a damage profile that began 59.9 cm (23.6") forward of the right rear axle and extended 139.1 cm (54.75") to the trailing edge of the right quarter panel. Maximum crush was 10.4 cm (4.1") located on the quarter panel 22.9 cm (9.0") rearward of the axle position. The crush profile for this sideslap was as follows: C1 = 0 cm , C2 = 7.6 cm (3.0"), C3 = 8.9 cm (3.5"), C4 = 2.5 cm (1.0"), C5 = 0 cm, C6 = 0 cm. The CDC for this damage pattern was 03-RZEW-2.

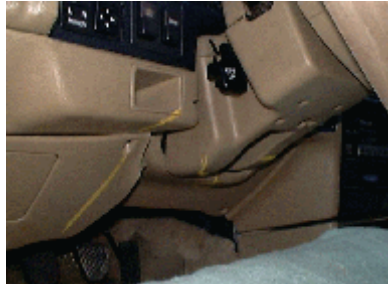
The driver's knees contacted and fractured the knee bolster on each side of the steering column (**Figure 5**). The combination of air bag expansion against the driver and driver loading of the expanding air bag

**Figure 5. Driver knee contact damage to the bolster cover.**

Due to the lack of lap belt usage, the driver partially submarined the shoulder belt webbing and loaded the knee bolster with both knees. The knee contacts fractured the bolster on each side of the steering column and displaced the plastic panel approximately 5.1 cm (2.0") forward. As a result of the knee contact, the driver sustained purple contusions over the right knee and the anterior lower right leg.

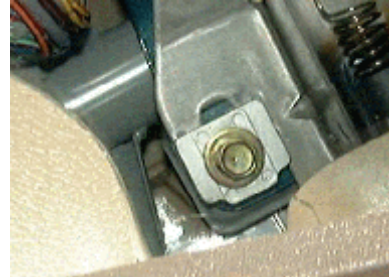
resulted in minimal compression of the energy absorbing steering column. The left shear capsule (**Figure 6**) was compressed 4.8 mm (3/16") while the right capsule was compressed 7.9 mm (5/16"). There was no bending of the steering wheel rim and/or spokes.

**Figure 6. Left shear capsule displacement.**

The energy absorbing steering column was partially compressed due to driver loading and/or air bag expansion against the driver. This was evidenced by partial compression of the shear capsule assemblies. The left shear bracket was displaced 4.8 mm (3/16") while the right shear was displaced 7.9 mm (5/16").

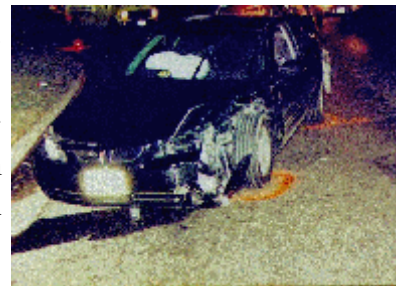
The initial impact damage was located on the left front fender area of the Grand Am (**Figure 7**). An exemplar vehicle was examined for comparison measurements. The overall length of the damage profile was approximately 130 cm (51") which extended from the front bumper corner to the left A-pillar. Maximum crush was approximately 30 cm (12") located at the leading edge of the left front fender. The crush profile at mid fender height was estimated as follows: C1 = 2 cm (1"), C2 = 10 cm (4"), C3 = 15 cm (6"), C4 = 20 cm (8"), C5 = 30 cm (12"), C6 = 25 cm (10"). Damaged components included the left front fender, the bumper fascia and reinforcement bar, left front shock tower and inner fender structures, the radiator support panel, left headlight and turn signal assembly, and the hood. There was no glazing damage noted in the photographs. The CDC for this impact event was 10-LYEW-4.

**Figure 7. Left front damage to the Pontiac Grand Am.**

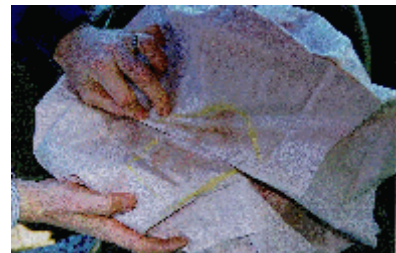
The driver's face was positioned within the deployment path of the frontal air bag system. This was evidenced by numerous make-up and lipstick transfers on the face of the bag. A make-up and partial lipstick transfer was documented to the left side of the bag, 15.9-23.5 cm (6.25-9.25") left of center which extended 6.4 cm (2.5") to 3.8 cm (1.5")

**Figure 8. Make-up transfer to folded sides of bag face.**

below the vertical centerline of the bag. A similar contact pattern was located on the right side of the air bag 12.7-21.6 cm (5.0-8.5") right of the centerline which extended 5.1 cm (2.0") above to 3.8 cm (1.5") below the horizontal centerline. These transfers originated as a single contact point as the bag deployed from the module assembly. As the sides of the bag were folded inward, the make-up and lipstick transfers matched (**Figure 8**) which identified the driver's forward position at the time of deployment.

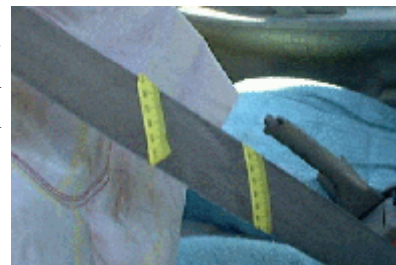
The driver loaded the automatic shoulder belt webbing as she began to submerge the belt system due to the lack of use of the manual belt system. A zipper-type abrasion pattern was evident to the inside surface (aspect exposed to the chest of the driver) of the webbing at the level of the mid chest. This abrasion was 10.2 cm (4.0") in length and extended the full width of the belt.

The automatic motorized belt system was in use by the driver at the time of the crash. This was confirmed by the initial observations of the first arriving officer at the scene of the crash and by a load induced abrasion to the belt webbing. The driver loaded the belt webbing during the initial impact with the Pontiac which produced a zipper-like abrasion (**Figure 9**) pattern to the inner surface of the webbing (side of webbing exposed to the body of the driver). This abrasive type pattern was located 48-58 cm (19-23") below the track mounted buckle assembly and extended across the full width of the webbing. The location of this abrasion was consistent with proper usage of the automatic system. There was no further damage or loading evidence to the shoulder belt webbing and/or hardware.

**Figure 9. Zipper-like abrasion pattern top the belt webbing.**

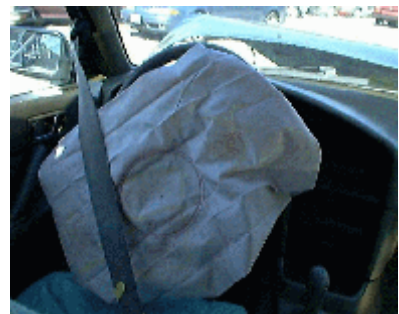
**Figure 10. Overall view of the deployed front driver air bag .**

The continued expansion of the air bag resulted in the tether reinforcement contacting the face of the driver resulting in an additional, but separate make-up transfer pattern. The continued expansion of the bottom of the bag resulted in another transfer pattern of make-up and lipstick. This pattern was centered around the 6-8 o'clock sector of the tether reinforcement panel (**Figure 10**). There was no evidence of contact on the H-configuration module cover flaps.
