**TRANSPORTATION SCIENCES
CRASH RESEARCH SECTION**

**VERIDIAN ON-SITE REDESIGNED AIR BAG DEPLOYMENT INVESTIGATION
VERIDIAN CASE NO. CA99-003
VEHICLE: 1999 LEXUS LX470 SPORT UTILITY
LOCATION: TENNESSEE
CRASH DATE: MARCH 1999**

14. <i>Sponsoring Agency Code</i>	
15. <i>Supplementary Notes</i> On-site investigation of a single vehicle run-off road crash that involved a 1999 Lexus LX470 sport utility vehicle with redesigned frontal air bags.

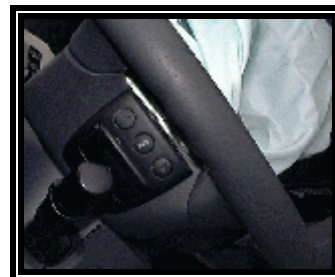
Figure 4. Side view of the remote control module.

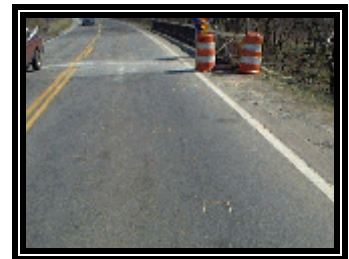
The front center and right area of the Lexus impacted the 25 cm (10") wide concrete bridge rail (**Figure 7**) resulting in an 11 o'clock impact force. The damage and trajectory algorithm of the WinSMASH program computed an impact speed of 59.3 km/h (36.8 mph). The impact crushed the bumper reinforcement bar to a maximum depth of 82.8 cm (32.6"), located inboard of the right frame rail (**Figure 8**). The velocity change was computed by the damage algorithm of the WinSMASH program at 48 km/h (30 mph) with a longitudinal component of -41.5 km/h (-25.8 mph) which deployed the vehicle's redesigned air bag system. The impact fractured approximately 3 m (10') of the concrete

Figure 7. Struck bridge railing and final rest area of the Lexus.

bridge railing which redirected the Lexus back onto the travel lanes. It should be noted that an estimated 70 kg (150 lb) segment of the bridge railing was displaced 22 m (72') to the far side of the creek, located 4 m (13') below the bridge.

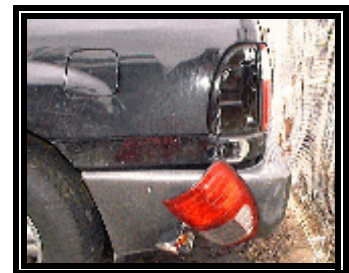
The secondary damage to the left rear quarter panel area was minor in severity (**Figure 10**). The direct contact damage began 63.5 cm (25.0") rearward of the left rear axle and extended 43.2 cm (17.0") to the rear corner of the bumper fascia. The damage consisted of vertically oriented abrasions with a maximum crush depth of 0.9 cm (0.375"). The assigned CDC for this damage pattern was 09-LBEW-1. The Lexus was considered a total loss with a replacement value of approximately \$60K.

Figure 10. Secondary sideslap damage to the left rear quarter panel.

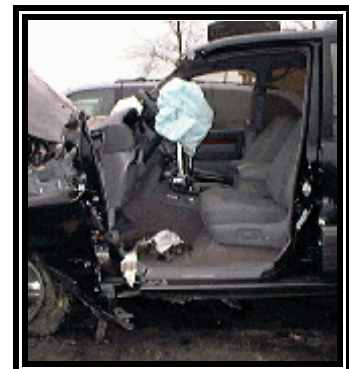
The interior of the Lexus sport utility vehicle sustained moderately severe damage that was associated with air bag deployment, driver contact, and exterior deformation that resulted in intrusion of numerous frontal components (**Figure 11**). The supplemental redesigned frontal air bag system deployed as designed. The driver air bag deployed from the steering wheel mounted module assembly while the passenger air bag deployed from the top right instrument panel. Damage was limited to the tearing of the cover flaps at the designated tear points.

Figure 11. Overall view of the driver compartment.

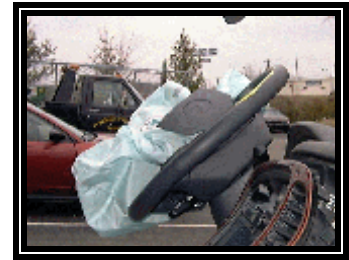
The driver's chest and abdominal regions loaded the deployed air bag, however, due to the high severity of the crash, and the vertical displacement of the steering column, he loaded through the bag and engaged the steering wheel rim. The upper aspect of the rim was displaced 1.9 cm (0.75") forward (**Figure 12**) which resulted from his thoracic loading against the bag and subsequent compression of the bag against the wheel assembly. As the column rotated upward due to rearward displacement of the engine into the cowl, The driver's right upper abdomen loaded the edge of the steering wheel rim at the 5 o'clock sector. This was within the area of the spokes where the wheel rim was the most rigid. The right spokes were deflected forward minimally, evidenced by expansion of the gap between the air bag module cover and the covered spokes of the wheel (**Figure 13**). In addition to wheel deformation, the driver minimally compressed the energy absorbing column. The left shear capsule was displaced 0.6 cm (0.25") while the right shear capsule was (**Figure 14**) separated 1.2 cm (0.5").

Figure 12. Deflection of the upper steering wheel rim.

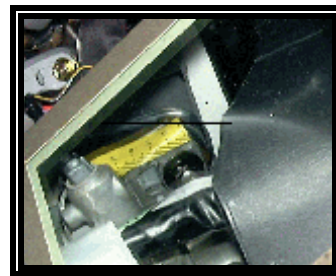
Figure 14. Right shear capsule separation.

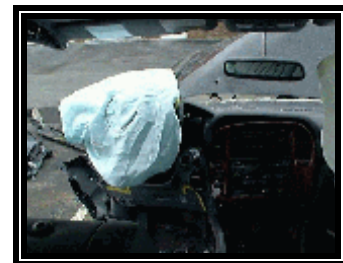
The driver responded to the 11 o'clock impact force by moving forward and to his left (**Figure 15**). His buttocks slid on the relatively flat profile of the leather front bucket seat as he moved into the deployed redesigned air bag. His upper thoracic area loaded the deployed air bag, however, due to the high severity of the crash, he compressed the air bag against the wheel rim which deformed the upper steering wheel rim 1.9 cm (0.75") forward. Air bag and the subsequent wheel loading resulted in an apparent collapse of one of the driver's lungs. The right upper quadrant of his abdominal region loaded the edge of the steering wheel rim at the right spoke location resulting in a ruptured liver. The edge loading of the right steering wheel spokes resulted in minimal forward displacement of the right spokes. The combination of thoracic and abdominal loading compressed the energy absorbing steering column 1.2 cm (0.5"). Column displacement was documented by forward movement of the shear capsules.

Figure 15. Trajectory of the driver into the deployed redesigned front left air bag.

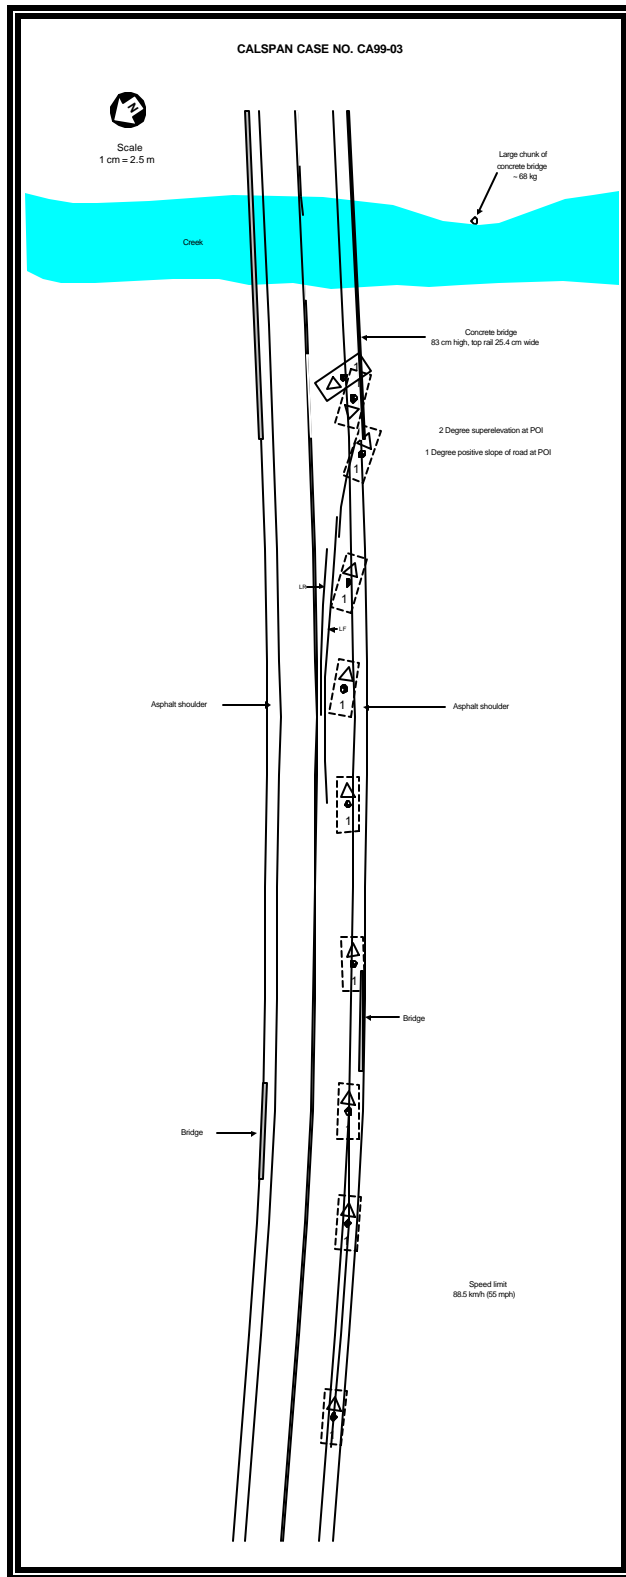
Figure 17. Crash Schematic

The Lexus continued to rotate CW and traveled a longitudinal distance of 6.4 m (21.0') from its initial point of impact (POI) to final rest. At rest, The Lexus had rotated approximately 216 degrees CW from the initial POI, coming to rest facing in a northerly direction, diagonal to the eastbound travel lane. The crash schematic is attached as **Figure 17** (Page 13).
