**ON-SITE FRONT PASSENGER AIR BAG DEPLOYMENT/  
CHILD FATALITY INVESTIGATION**

**CASE NO. CA99-04**

**VEHICLE - 1995 HYUNDAI SONATA**

**CRASH DATE - MARCH 1999**

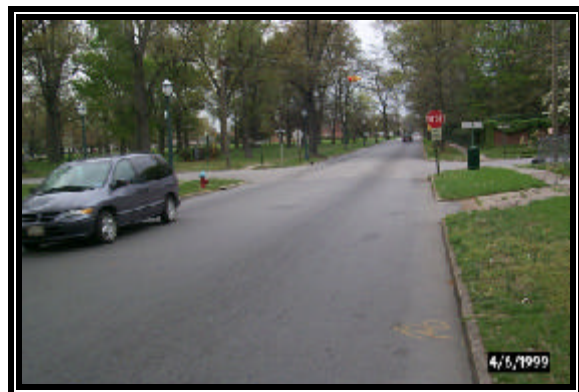
**Figure 1:** Hyundai trajectory view 30 m (100 ft) west of the intersection.

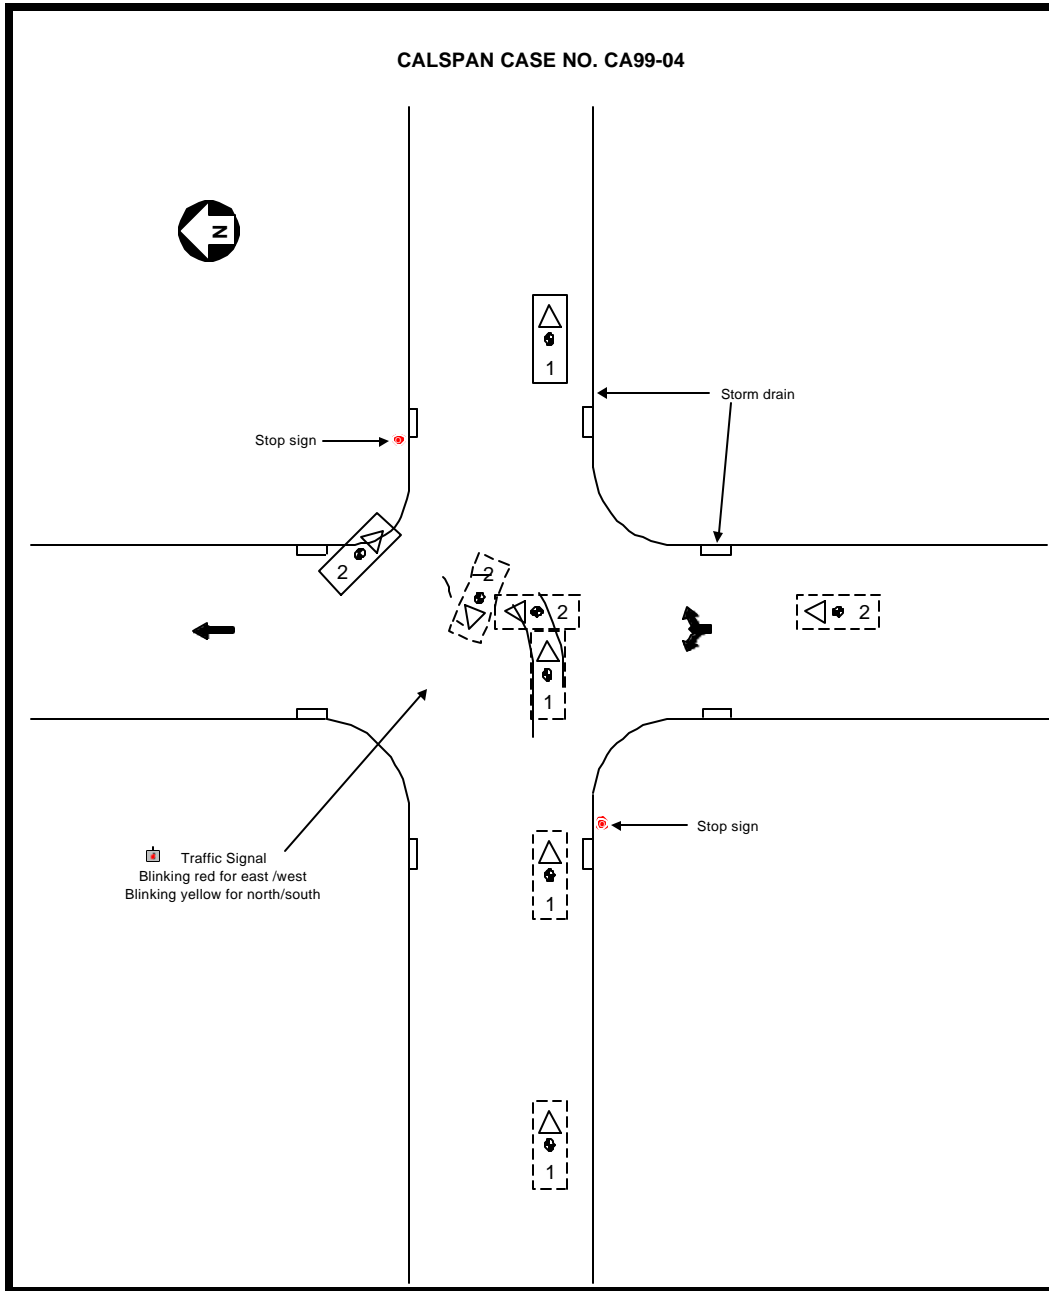
The crash occurred with the front plane of the Hyundai striking the left side plane of the Dodge in a 1/10 o'clock impact configuration. The Hyundai impacted the Dodge in the area of the left door's trailing edge and left rear axle. The impact force caused the deployment of the Hyundai's Supplemental Restraint System. The northbound momentum of the Dodge deflected the skidding Hyundai to the northeast. The deflection in the skid marks identified the point of impact. The Hyundai probably came to rest near the end of the skid marks. The vehicle was then driven forward to the final rest location identified by the police investigation, approximately 17 m (58 ft) east the point of impact. The impact caused the Dodge to rotate counterclockwise approximately 225 degrees and slide approximately 10 m (33 ft) to final rest in the northeast quadrant of the intersection. Refer to the crash schematic **Figure 2**. The Hyundai and Dodge were both towed from the crash scene.

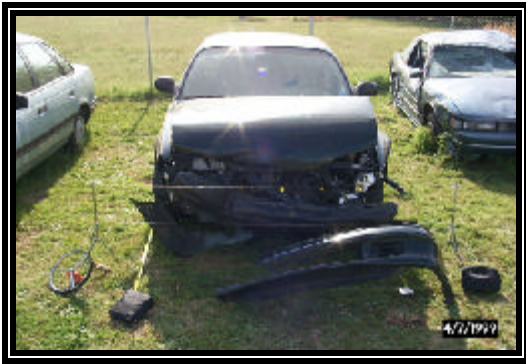
The Hyundai sustained direct contact damage across the vehicle's entire 147 cm (58 in) frontal end width. The impact damage was weighted more heavily to the vehicle's left side due to the lateral momentum of the Dodge Daytona. The front bumper structure was shifted laterally left approximately 8.9 cm (3.5 in) The bumper cover was fractured and dislodged by the impact. The measured crush profile at the bumper

elevation was as follows: C1=14.7 cm (5.8 in), C2=12.7 cm (5.0 in), C3=12.7 cm (5.0 in), C4=13.5 cm (5.3 in), C5=15.2 cm (6.0 in), C6=4.6 cm (1.8 in). The Collision Deformation Classification (CDC) of the damage was 01-FDEW-1. The impact energy was managed primarily by the vehicle's structures forward of the radiator support plane and forward uni-body structure. The hood buckled and folded in the typical manner. The left front fender was buckled but did not restrict the operation of the left front door. All doors were operational and all window glazings were in-tact. The wheelbase dimensions were unchanged. The barrier equivalent speed (delta V) calculated by the barrier model of the WINSMASH program was approximately 21.4 km/h (13.3 mph). The longitudinal and lateral components of the delta V were approximately -20.6 km/h (-12.8 mph) and -5.5 km/h (-3.4 mph), respectively. **Figures 3 and 4** are front and left lateral views of the Hyundai Sonata.

**Figure 3:** Front view of the Hyundai.

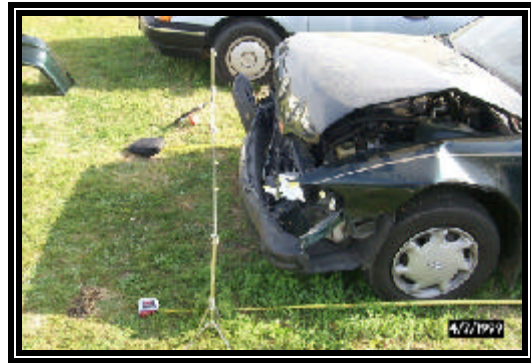
**Figure 4:** Left lateral view of the Hyundai.

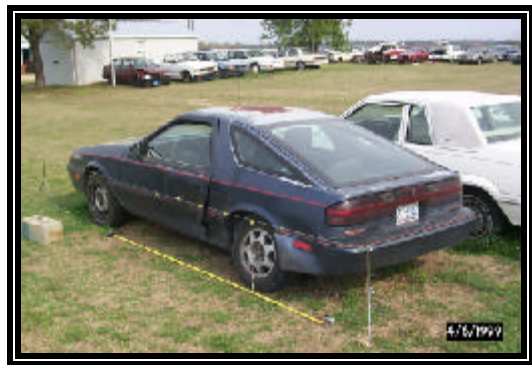
The 1988 Dodge Daytona, 2-door hatchback, was identified by the Vehicle Identification Number (VIN): 1B3CA44K6JG (production sequence deleted). The vehicle was equipped with a 2.5 liter, I4 engine linked to a 4-speed automatic transmission. The odometer read 270,922 km (167,348 miles) at inspection. The Dodge sustained 165 cm (65 in) of direct contact damage to the left side of the vehicle. The direct damage began 125.7 cm (49.5 in) forward and ended 39.4 cm (15.5 in) aft of the left rear axle. The maximum lateral deformation at the mid-door elevation measured approximately 7 cm (3 in). Maximum deformation at the lower sill measured 3.5 cm (1.5 in). The left rear axle was directly involved in the impact and was bent from the force of the crash. **Figure 5** is a left side view of the vehicle. The barrier equivalent speed (delta V) calculated by the WINSMASH model was approximately 14 km/h (9 mph).

**Figure 5:** Left rear view of the Dodge.

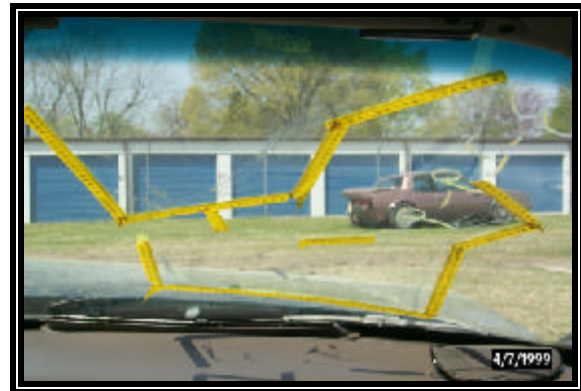
Contact evidence was identified on the right aspect of the windshield resultant to the altered deployment path of the air bag. The contact area consisted of two zones. The upper region measured approximately 41 cm x 23 cm (16 in x 9 in) width by height and was associated to direct contact from the air bag. Air bag fabric transfers to the laminate were identified throughout the region. The lower region measured 33 cm x 15 cm (13 in x 6 in) and resulted from contact with the module cover flap. Vinyl transfers were identified in the throughout the lower region. Refer to **Figure 6**.

**Figure 6:** Air bag transfers to the windshield.

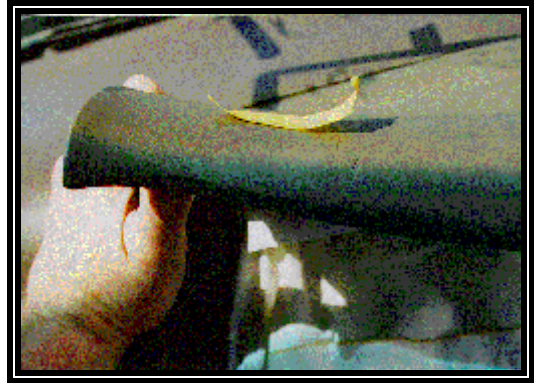
The right front passenger air bag was a mid-mount design configured in the typical manner in the right aspect of the instrument panel. The module cover flap was vinyl, approximately 1 cm (3/8 in) in thickness, and measured 34.3 cm x 20 cm (13.5 in x 8 in), width by height respectively. **Figure 7** is a close-up view of contact evidence identified on the cover flap. The lower corners of the flap and right aspect of the leading edge were slightly abraded from windshield contact. Located on the left aspect of the flap's leading edge was a 5 cm (2 in) area of polished vinyl. A 2.0 cm (0.8 in) gouge was identified on the leading edge of the flap, immediately to the right of the polished area. Reportedly, the right front passenger's hair was up in multiple pigtails fastened by berrettes. Pieces of a fractured barrette were found on the top of the instrument panel, forward of the module at the base of the windshield. The polished area and gouge probably resulted from contact with the face/head of the right front occupant.

**Figure 7:** Close-up; view of the contact evidence on the cover flap.

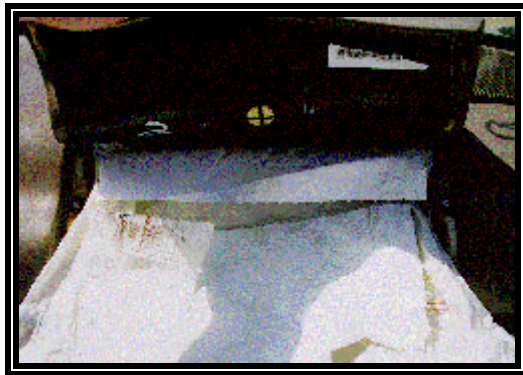
**Figure 8:** Abraded and scuffed cover flap and Tyvek wrap.

Inspection of the interior surface of the cover flap revealed the surface was scuffed and abraded during the deployment sequence, **Figure 8**. These scuffs and abrasions were caused by the impeded deployment, resultant to the forward position of the right front passenger. Her body position impeded the normal opening of the cover flap and inflation of the air bag. This resulted in frictional heating between the interior surface of the cover flap, protective wrap and air bag. The heating of the vinyl surfaces resulted in the vinyl transfers to the protective wrap and air bag.

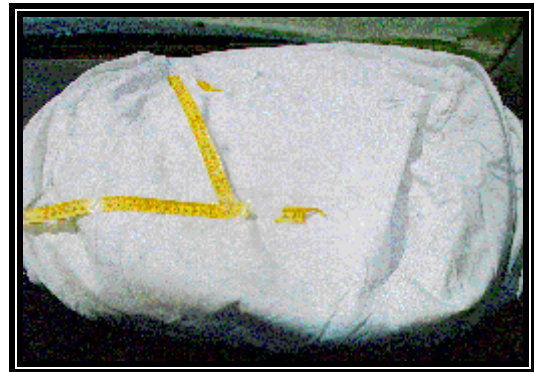
The face of the right front passenger air bag measured 51 cm x 56 cm (20 in x 22 in), width by height, and extended 53 cm (21 in) from the module, in its deflated state. The air bag was tethered by a single 15 cm (6 in) wide strap sewn to the upper aspect of the air bag's face. The bag vented internally back through the module. Inspection of the right front passenger air bag identified contact evidence distributed primarily over the inboard and bottom surfaces of the fabric, **Figure 9**. This evidence was associated directly with the altered deployment of the air bag. On the center

**Figure 9:** Vinyl scuffs to the lower and inboard surfaces of the right front PAB.

aspect of the bag's top surface was a 18 cm (7 in) black vinyl transfer. This vinyl transfer was caused by contact with the interior surface of the cover flap. The only contact evidence on the face of the bag was a 7 cm x 13 cm (3 in x 5 in) transfer localized on the inboard seam of the air bag's face. This transfer continued onto the inboard surface of the air bag and measured 15 cm x 20 cm (6 in x 8 in). These transfers were linked to contact with the windshield. Vinyl transfers were dispersed over a large area on the left aspect of the air bag's bottom surface. The area measured approximately 20 cm x 25 cm (8 in x 10 in), width by length. The vinyl transfers were patterned and linked to contact with the interior surface of the module cover flap.
