REMOTE AIR BAG DEPLOYMENT REPORT

CASE NUMBER - IN99-006

VEHICLE - 1998 DODGE STRATUS

CRASH DATE - February 1998

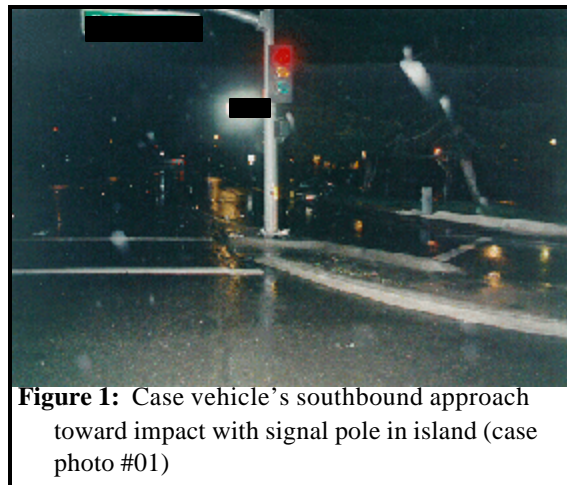
The case vehicle was traveling south at high speed in the southbound through lanes of a divided local street, approaching a four-leg intersection apparently intending to pass through the intersection and continue south. The southbound roadway consisted of (from right to left): a painted island with raised reflectors creating a channelized right turn lane; two through lanes; a left turn lane; a raised median; and the northbound roadway beyond the median. The east-west intersecting roadway had a curbed island creating a channelized right turn lane for eastbound traffic to turn south, with a large steel traffic signal pole mounted in the island. The island with the traffic signal was on the right for southbound traffic (**Figure 1**). It was dark with street lights and it was raining. The traffic signal was operating correctly, there were no roadway defects and the asphalt road surface was wet. The case vehicle veered or drifted to the right while passing through the intersection and entered the traffic island. There is no evidence that the driver attempted any avoidance actions.

Figure 1: Case vehicle's southbound approach toward impact with signal pole in island (case photo #01)

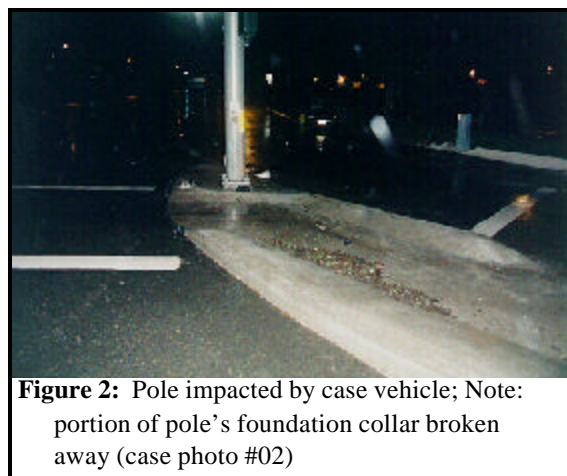
The crash occurred within the traffic island. The case vehicle mounted the island's curb and the front left corner of the case vehicle impacted the traffic signal support pole (**Figure 2**). The left front wheel assembly snagged against the pole and was torn off as the case vehicle rotated counterclockwise off the pole. The case vehicle spun across the channelized right turn lane, mounted the tapered curb onto the sidewalk, struck and broke down a small wooden no parking sign post and came to rest straddling

Figure 2: Pole impacted by case vehicle; Note: portion of pole's foundation collar broken away (case photo #02)

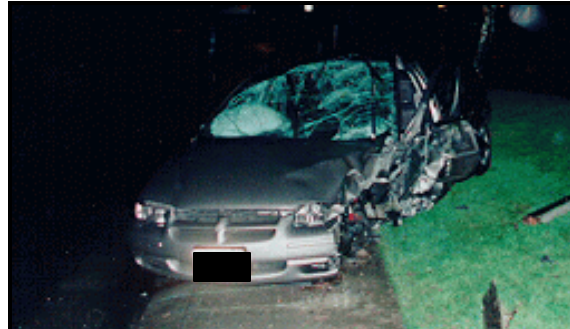
The case vehicle sustained heavy impact damage at the apex of the front left corner, with the left front fender crushed rearward, the left front wheel assembly sheared off, direct contact to the left A-pillar above the belt line and swiping-type damage into the middle of the left front door (**Figure 3**). The left headlight was shattered, the left corner of the bumper fascia was torn away, and the extreme left end of the bumper was bent rearward. The left edge of the hood was folded inward; the windshield was fractured across the entire width; the left A-pillar was displaced rearward; the windshield header, left side rail and roof were buckled; the driver's door was crushed, forced rearward and buckled outward; the driver's door window glazing was shattered (kernalized); and the leading edge of the left back door sustained induced damage (**Figure 4**). There was certainly substantial intrusion into the driver's seat area but the available photographs do not provide any views of specific intruding components. The Police Crash Report includes comments indicating that the rack and pinion assembly was pushed rearward and the floor was pushed up into the driver's foot space. The available photographs do not provide good views of the case vehicle's interior, but the steering wheel adjustment appears to have been tilted upward. The post-crash position of the steering column plus damage to the instrument panel near the steering column suggests that the column was probably compressed and may have separated from its mountings (**Figure 5**). The CDC, estimated from on-scene photographs, is **12-FLAS-8**, with principal direction of force 0 degrees. The

Figure 3: Front of case vehicle at final rest (case photo #09)

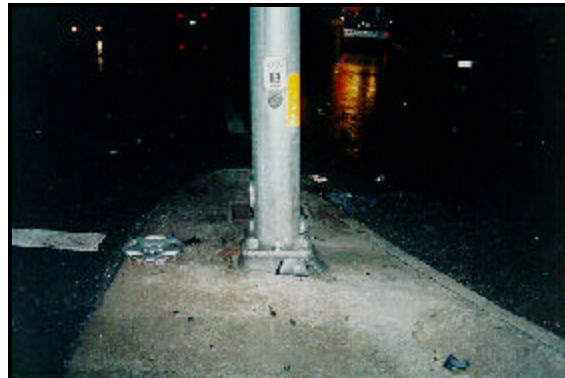
The case vehicle impacted a steel traffic signal support pole that was approximately 30 centimeters (12 inches) in diameter (**Figure 6**). The pole's foundation consisted of four threaded rods and a collar set in concrete. The pole's base plate was set upon the collar and attached by nuts screwed down against a base plate. A small section of the collar was broken away (**Figure 2** above). There was abrading on the surface of the pole in the area of the impact, but there was no evidence that the pole was damaged or that its foundation was disturbed, other than the fractured collar.

Figure 6: Traffic signal pole contacted by case vehicle; Note: broken section of foundation collar set back in place (case photo #03)
