VERIDIAN ON-SITE SCHOOL BUS CRASH INVESTIGATION

VERIDIAN CASE NO. CA99-009

SCHOOL BUS CHASSIS -1999 FREIGHTLINER CONVENTIONAL

BODY - BLUE BIRD 65 PASSENGER CAPACITY

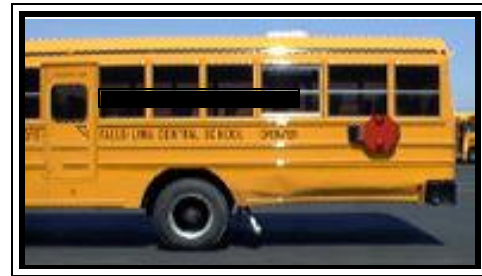
The involved school bus sustained minor left side damage as a result of the right angle collision with the Ford Tempo (**Figure 4**). The direct contact damage began 36.2 cm (14.25 in) forward of the left rear axle and extended rearward 355.0 cm (139.75 in) to the bumper corner. The combined direct and induced contact damage (Field L) was 391.0 cm (154.0 in). Maximum crush was 9.0 cm (3.5 in) located 156.0 cm (61.4 in) forward of the left rear bumper corner.

Six crush measurements were taken at the level of the lower body panel: C1= 0 cm, C2= 5.0 cm (2.0 in), C3= 9.0 cm (3.5 in), C4= 6.4 cm (2.5 in), C5= 0 cm, C6= 0 cm. The resultant direction of force was (+)350 degrees. The riveted aluminum body of the school bus remained intact with no evidence of body panel separation. All window glazing remained intact with no cracks occurring to the laminated windshield. There was no reduction in the length of the wheelbase as a result of the collision.

Figure 4. Left side damage to the 1999 Freightliner school bus.

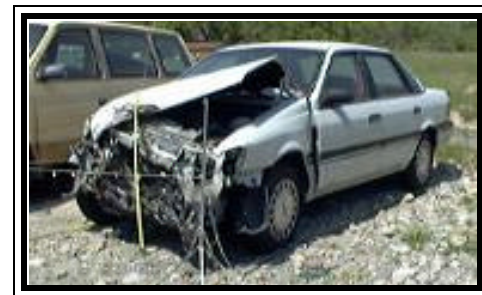
The Ford Tempo sustained moderate frontal damage as a result of the impact with the school bus (**Figure 5**). The direct contact damage began at the front right bumper corner and extended inboard 80.0 cm (31.5 in). The impact deformed the full frontal width resulting in a combined direct and induced damage length (Field L) of 90.9 cm (35.8 in).

Six crush measurements were documented at the level of the (*energy absorbing device*) pistons due to separation of the reinforcement bar: C1= 4.4 cm (1.75 in), C2= 10.2 cm (4.0 in), C3= 16.5 cm (6.5 in), C4= 19.1 cm (7.5 in), C5= 19.7 cm (7.75 in), C6= 21.0 cm (8.25 in). The Collision Deformation Classification (CDC) for this impact to the Tempo was 83-FZEW-2 (principal direction of force incremented to reflect lateral end shifting to the left) with a resultant direction of force of (+)80 degrees. The front bumper assembly separated from the energy absorbing pistons with direct damage documented to the radiator assembly. Damage was noted to both fenders which were displaced laterally to the left from structural end shifting to the vehicle. The right side was displaced approximately 14.0 cm (5.5 in) as the left side was displaced approximately 10.2 cm (4.0 in). Yellow paint and rubber transfers were noted across the hood and bumper fascia. No windshield damage was noted from exterior forces or (interior) occupant contact.

Figure 5. Frontal damage to the 1988 Ford Tempo.

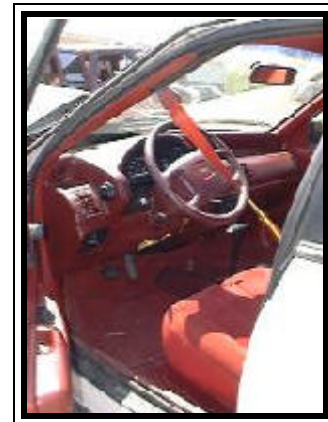
Interior damage to the Ford Tempo was minimal and was attributed to occupant contact (**Figure 7**). Fabric transfers were documented to the webbing of the front left 2-point motorized automatic restraint. Scuff marks were identified at the lower instrument panel on both sides of the steering column. Although wear marks were noted to the front left manual lap restraint, the webbing was found in a pristine condition and therefore presumed not used. No loading was documented on the steering wheel rim which was placed to the full up position. No windshield damage was noted from driver contact or exterior forces. No intrusions were found in the vehicle.

Figure 7. Interior view of the 1988 Ford Tempo.

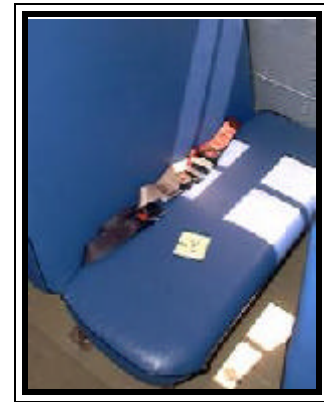
The 6 year old male child seated in the eighth row, left inboard position (**Figure 8**) was properly restrained by the 2-point manual lap belt system. At impact, he initiated a forward trajectory in response to the 12 o'clock impact force and probably contacted the front seat back or (unknown) hand held item (lunch box, etc.) resulting in the minor lip laceration. There was no evidence of contact within the seated area to support a specific injury mechanism. After the collision the bus driver attended to this occupant and found him to be "covered in blood". She discovered a minor cut on the lower lip and cleaned him up before the ambulance arrived, however, he subsequently refused transport to a local hospital for treatment.

Figure 8. Seating location of injured child with lip laceration (seat 8/C).
